## Profile/Photo Observation Report

Street:	<b>POPLAR LN</b>	Flow Control:	<b>Not Controlled</b>
City:	<b>Hobart, IN</b>	Year Renewed:	
Location:	<b>Other</b>	Tape/Media #:	
Purpose:	<b>Not Known</b>	Dia/Height:	<b>8"</b>
Use:	<b>Sanitary</b>	Material:	<b>PVC</b>
Drain Area:	<b>NA</b>	Lining:	
Category:	<b>NA</b>		
Comment:

Location Details:		Direction of Survey:	<b>Upstream</b>
US MH:	<b>M-1004-065</b>	DS MH:	<b>M-1004-066</b>
		Total Length Surveyed (ft):	<b>256.8</b>

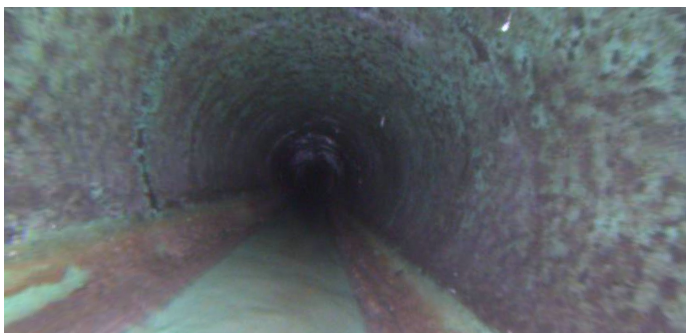
Code: **AMH**  
Description: **Manhole**

Distance (ft): **.0**  
Structural Grade: **0**  
O&M Grade: **0**  
Clock Start/From:  
Clock To:  
1st Value:  
2nd Value:  
Value Percent:  
Continuous Index:  
Within 8" of Joint: **NO**  
Remarks: **M-1004-066**

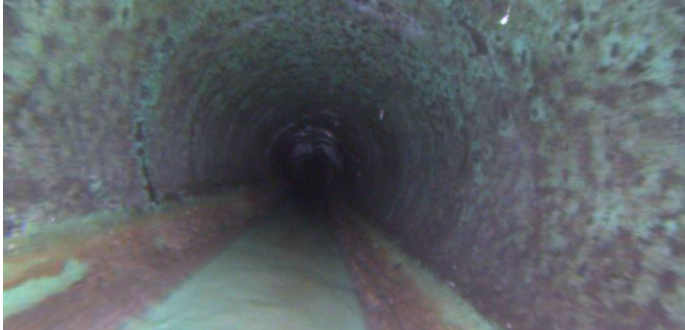
Code:	<b>MWL</b>
Description:	<b>Water Level</b>

Distance (ft):	<b>.0</b>
Structural Grade:	<b>0</b>
O&M Grade:	<b>0</b>
Clock Start/From:	
Clock To:	
1st Value:	
2nd Value:	
Value Percent:	<b>10.000</b>
Continuous Index:	
Within 8" of Joint:	<b>NO</b>
Remarks:

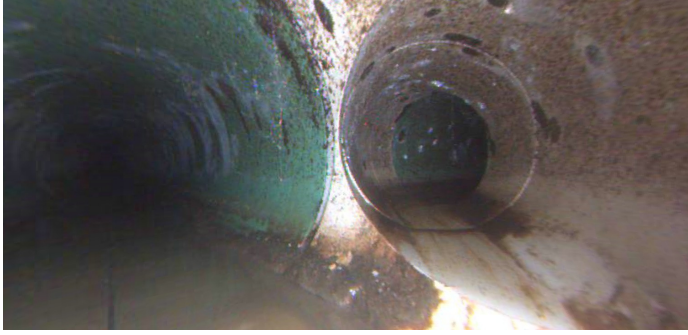
Code: **TF**  
Description: **Tap Factory**

Distance (ft): **49.3**  
Structural Grade: **0**  
O&M Grade: **0**  
Clock Start/From: **9**  
Clock To:  
1st Value: **4.000**  
2nd Value:  
Value Percent:  
Continuous Index:  
Within 8" of Joint:  
Remarks:

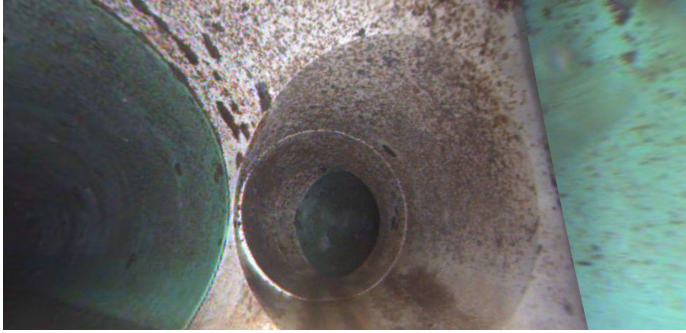
Code: **TF**  
Description: **Tap Factory**

Distance (ft): **186.5**  
Structural Grade: **0**  
O&M Grade: **0**  
Clock Start/From: **9**  
Clock To:  
1st Value: **4.000**  
2nd Value:  
Value Percent:  
Continuous Index:  
Within 8" of Joint:  
Remarks:

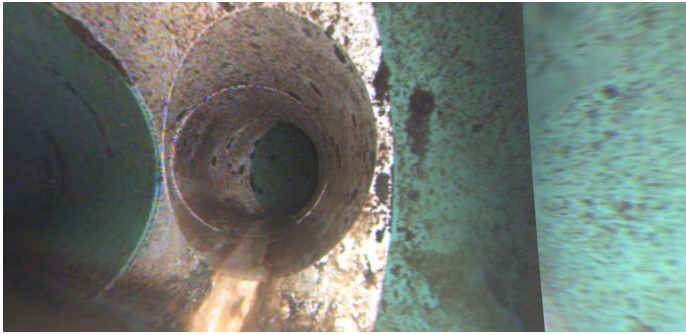
Code: **TFA**  
Description: **Tap Factory Active**

Distance (ft): **228.8**  
Structural Grade: **0**  
O&M Grade: **0**  
Clock Start/From: **9**  
Clock To:  
1st Value: **4.000**  
2nd Value:  
Value Percent:  
Continuous Index:  
Within 8" of Joint:  
Remarks:

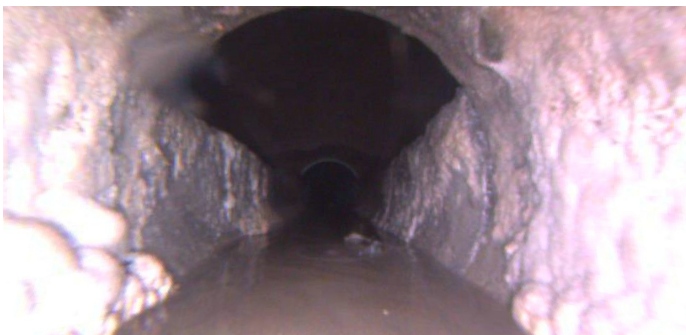
Code: **DAGS**  
Description: **Deposits Attached Grease**

Distance (ft): **254.4**  
Structural Grade: **0**  
O&M Grade: **2**  
Clock Start/From: **8**  
Clock To: **4**  
1st Value:  
2nd Value:  
Value Percent: **5.000**  
Continuous Index:  
Within 8" of Joint: **NO**  
Remarks:

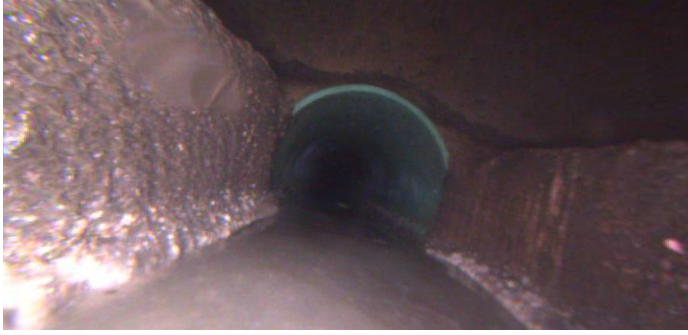
Code:	AMH
Description:	Manhole
Distance (ft):	256.8
Structural Grade:	0
O&M Grade:	0
Clock Start/From:	
Clock To:	
1st Value:	
2nd Value:	
Value Percent:	
Continuous Index:	
Within 8" of Joint:	NO
Remarks:	M-1004-065
