Profile/Photo Observation Report

Date:	04/11/2018	Weather:		Coding:	PACP 6.0
Pipe Length (ft):	262.5	Owner:	NA	Pre Clean:	Not Known
P.O.#:		Surveyor:	Jen Costello	PSR:	P-1004-066-065
Customer:		Clean Date:	01/01/1900	Shape:	C

Street:	Poplar Ln.	Flow Control:	Not Controlled
City:	Hobart, IN	Year Renewed:	
Location:	Other	Tape/Media #:	
Purpose:	Not Known	Dia/Height:	8"
Use:	Sanitary	Material:	PVC
Drain Area:	NA	Lining:	
Category:	NA		
Comment:

Location Details:		Direction of Survey:	Upstream
US MH:	M-1004-065	DS MH:	M-1004-066
		Total Length Surveyed (ft):	256.8

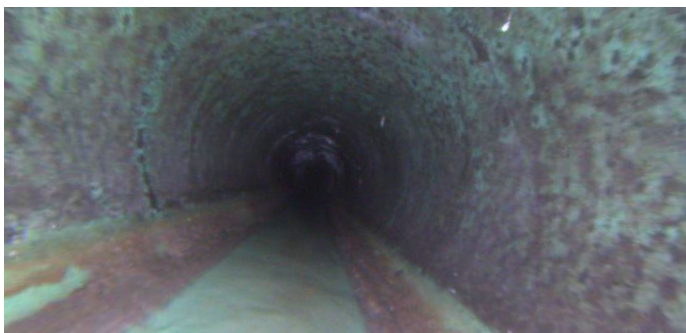
Code: **AMH**
Description: **Manhole**

Distance (ft): **.0**
Structural Grade: **0**
O&M Grade: **0**
Clock Start/From:
Clock To:
1st Value:
2nd Value:
Value Percent:
Continuous Index:
Within 8" of Joint: **NO**
Remarks: **M-1004-066**

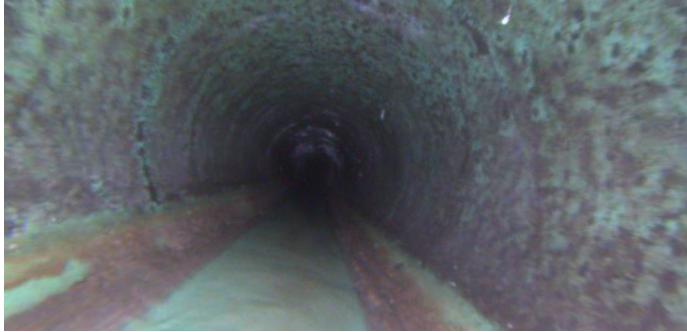
Code: **MWL**
Description: **Water Level**

Distance (ft): **.0**
Structural Grade: **0**
O&M Grade: **0**
Clock Start/From:
Clock To:
1st Value:
2nd Value:
Value Percent: **10.000**
Continuous Index:
Within 8" of Joint: **NO**
Remarks:

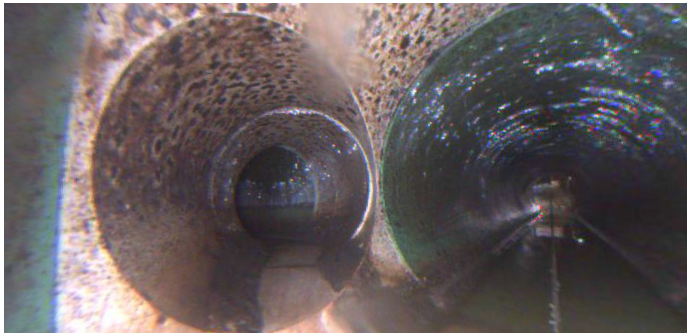
Code: **TFA**
Description: **Tap Factory Active**

Distance (ft): **7.2**
Structural Grade: **0**
O&M Grade: **0**
Clock Start/From: **3**
Clock To:
1st Value: **4.000**
2nd Value:
Value Percent:
Continuous Index:
Within 8" of Joint:
Remarks:

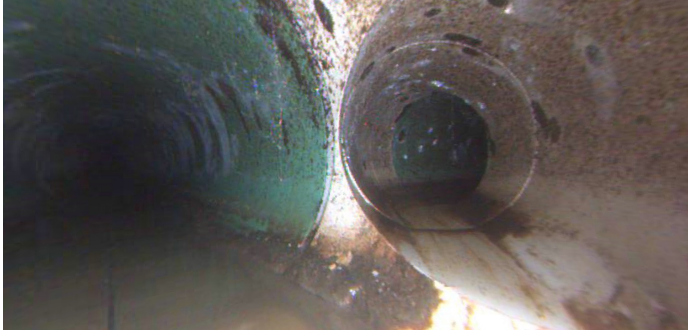
Code: **TF**
Description: **Tap Factory**

Distance (ft): **49.3**
Structural Grade: **0**
O&M Grade: **0**
Clock Start/From: **9**
Clock To:
1st Value: **4.000**
2nd Value:
Value Percent:
Continuous Index:
Within 8" of Joint:
Remarks:

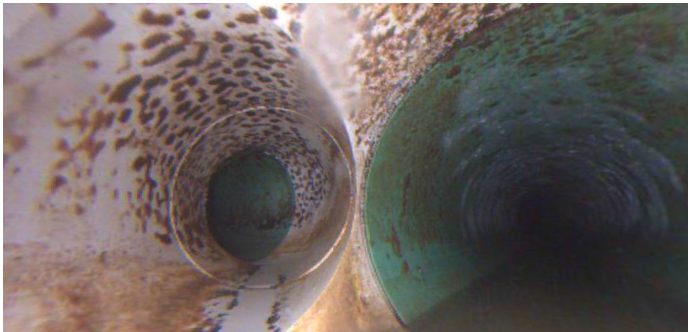
Code: **TF**
Description: **Tap Factory**

Distance (ft): **64.8**
Structural Grade: **0**
O&M Grade: **0**
Clock Start/From: **3**
Clock To:
1st Value: **4.000**
2nd Value:
Value Percent:
Continuous Index:
Within 8" of Joint:
Remarks:

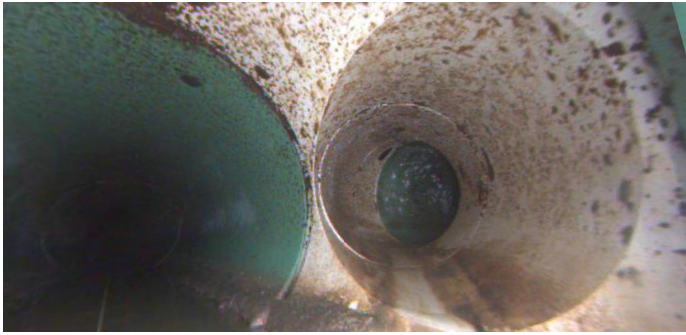
Code: **TFA**
Description: **Tap Factory Active**

Distance (ft): **114.0**
Structural Grade: **0**
O&M Grade: **0**
Clock Start/From: **9**
Clock To:
1st Value: **4.000**
2nd Value:
Value Percent:
Continuous Index:
Within 8" of Joint:
Remarks:

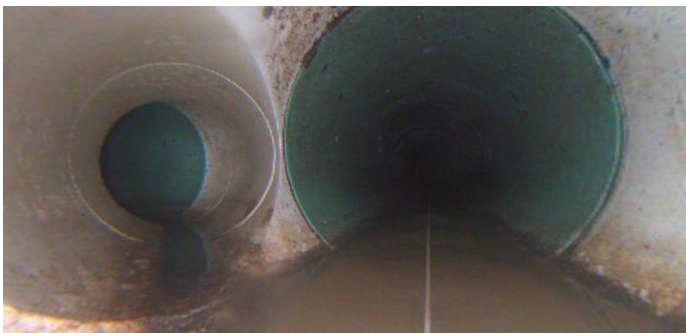
Code: **TFA**
Description: **Tap Factory Active**

Distance (ft): **135.4**
Structural Grade: **0**
O&M Grade: **0**
Clock Start/From: **3**
Clock To:
1st Value: **4.000**
2nd Value:
Value Percent:
Continuous Index:
Within 8" of Joint:
Remarks:

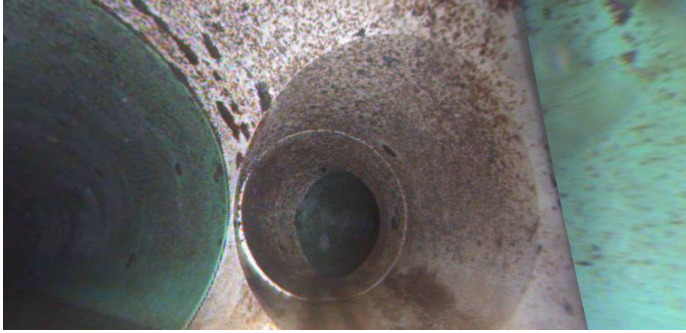
Code: **TF**
Description: **Tap Factory**

Distance (ft): **186.5**
Structural Grade: **0**
O&M Grade: **0**
Clock Start/From: **9**
Clock To:
1st Value: **4.000**
2nd Value:
Value Percent:
Continuous Index:
Within 8" of Joint:
Remarks:

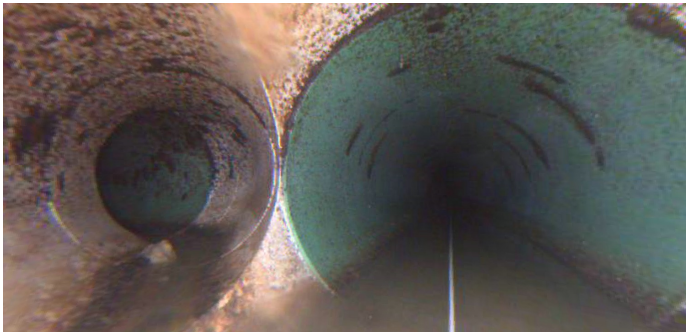
Code: **TFA**
Description: **Tap Factory Active**

Distance (ft): **202.7**
Structural Grade: **0**
O&M Grade: **0**
Clock Start/From: **3**
Clock To:
1st Value: **4.000**
2nd Value:
Value Percent:
Continuous Index:
Within 8" of Joint:
Remarks:

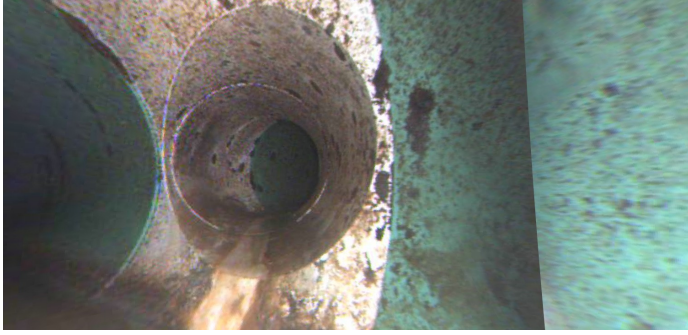
Code: **TFA**
Description: **Tap Factory Active**

Distance (ft): **228.8**
Structural Grade: **0**
O&M Grade: **0**
Clock Start/From: **9**
Clock To:
1st Value: **4.000**
2nd Value:
Value Percent:
Continuous Index:
Within 8" of Joint:
Remarks:

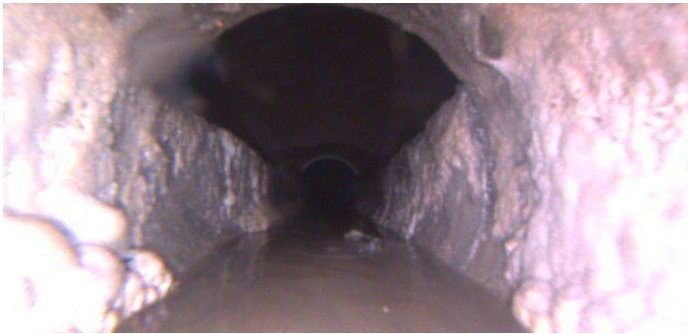
Code: **DAGS**
Description: **Deposits Attached Grease**

Distance (ft): **254.4**
Structural Grade: **0**
O&M Grade: **2**
Clock Start/From: **8**
Clock To: **4**
1st Value:
2nd Value:
Value Percent: **5.000**
Continuous Index:
Within 8" of Joint: **NO**
Remarks:

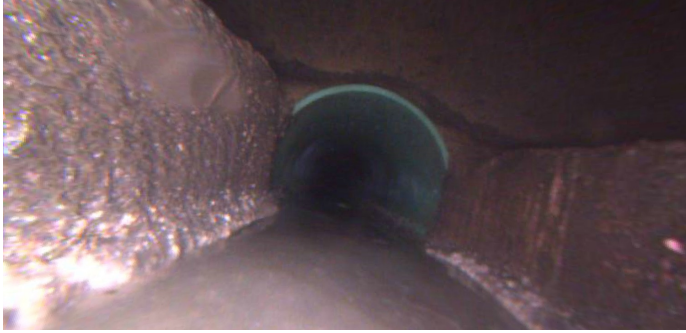
Code:	AMH
Description:	Manhole
Distance (ft):	256.8
Structural Grade:	0
O&M Grade:	0
Clock Start/From:	
Clock To:	
1st Value:	
2nd Value:	
Value Percent:	
Continuous Index:	
Within 8" of Joint:	NO
Remarks:	M-1004-065
