Profile/Photo Observation Report

Date:	04/11/2018	Weather:		Coding:	PACP 6.0
Pipe Length (ft):	110.6	Owner:	NA	Pre Clean:	Not Known
P.O.#:		Surveyor:	Jen Costello	PSR:	P-1004-067-066
Customer:		Clean Date:	01/01/1900	Shape:	C

Street:	POPLAR LN	Flow Control:	Not Controlled
City:	Hobart, IN	Year Renewed:	
Location:	Other	Tape/Media #:	
Purpose:	Not Known	Dia/Height:	8"
Use:	Sanitary	Material:	PVC
Drain Area:	NA	Lining:	
Category:	NA		
Comment:

Location Details:		Direction of Survey:	Downstream
US MH:	M-1004-066	DS MH:	M-1004-067
		Total Length Surveyed (ft):	107.6

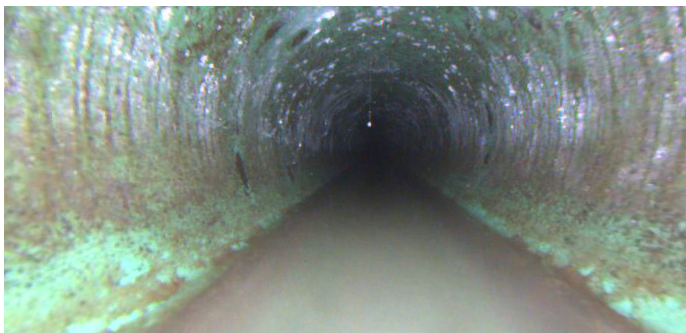
Code: **AMH**
Description: **Manhole**

Distance (ft): **.0**
Structural Grade: **0**
O&M Grade: **0**
Clock Start/From:
Clock To:
1st Value:
2nd Value:
Value Percent:
Continuous Index:
Within 8" of Joint: **NO**
Remarks: **M-1004-066**

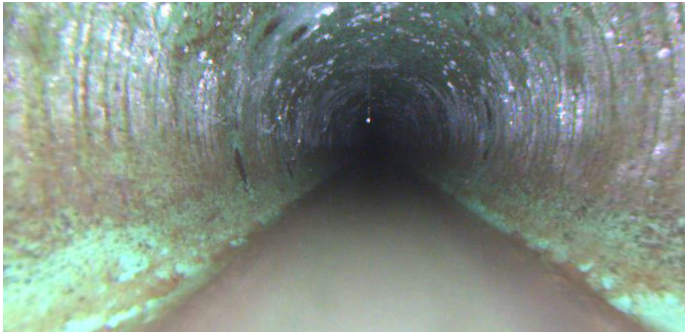
Code:	MWL
Description:	Water Level

Distance (ft):	.0
Structural Grade:	0
O&M Grade:	0
Clock Start/From:	
Clock To:	
1st Value:	
2nd Value:	
Value Percent:	5.000
Continuous Index:	
Within 8" of Joint:	NO
Remarks:

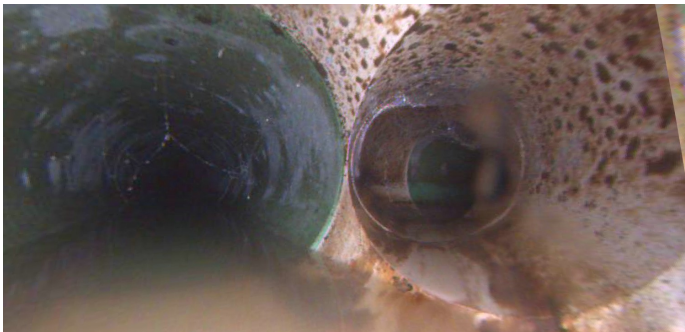
Code:	TFA
Description:	Tap Factory Active

Distance (ft):	48.0
Structural Grade:	0
O&M Grade:	0
Clock Start/From:	3
Clock To:	
1st Value:	4.000
2nd Value:	
Value Percent:	
Continuous Index:	
Within 8" of Joint:	
Remarks:

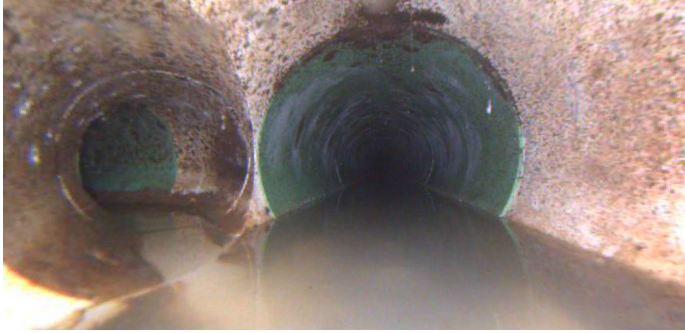
Code: **TFA**
Description: **Tap Factory Active**

Distance (ft): **61.7**
Structural Grade: **0**
O&M Grade: **0**
Clock Start/From: **9**
Clock To:
1st Value: **4.000**
2nd Value:
Value Percent:
Continuous Index:
Within 8" of Joint:
Remarks:

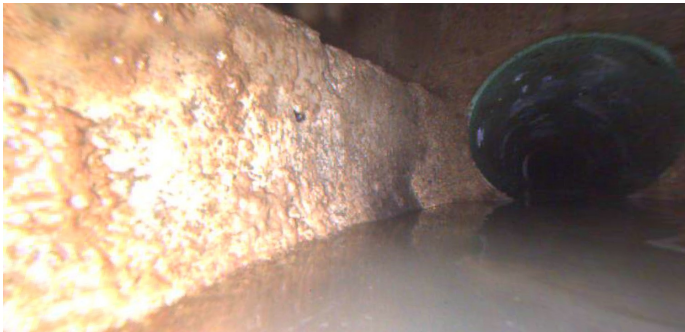
Code: **AMH**
Description: **Manhole**

Distance (ft): **107.6**
Structural Grade: **0**
O&M Grade: **0**
Clock Start/From:
Clock To:
1st Value:
2nd Value:
Value Percent:
Continuous Index:
Within 8" of Joint: **NO**
Remarks: **M-1004-067**
