## Profile/Photo Observation Report

Street:	<b>Poplar Ln.</b>	Flow Control:	<b>Not Controlled</b>
City:	<b>Hobart, IN</b>	Year Renewed:	
Location:	<b>Other</b>	Tape/Media #:	
Purpose:	<b>Not Known</b>	Dia/Height:	<b>8"</b>
Use:	<b>Sanitary</b>	Material:	<b>PVC</b>
Drain Area:	<b>NA</b>	Lining:	
Category:	<b>NA</b>		
Comment:

Location Details:		Direction of Survey:	<b>Downstream</b>
US MH:	<b>M-1004-066</b>	DS MH:	<b>M-1004-067</b>
		Total Length Surveyed (ft):	<b>107.6</b>

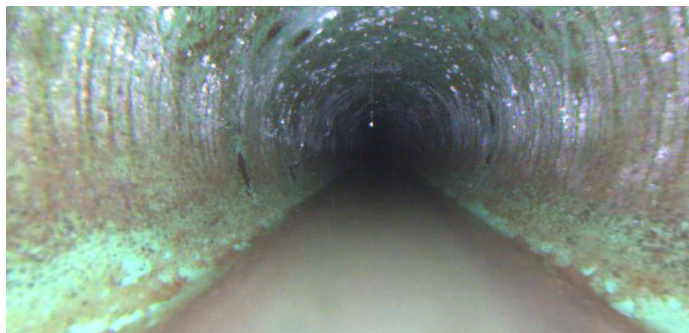
Code: **AMH**  
Description: **Manhole**

Distance (ft): **.0**  
Structural Grade: **0**  
O&M Grade: **0**  
Clock Start/From:  
Clock To:  
1st Value:  
2nd Value:  
Value Percent:  
Continuous Index:  
Within 8" of Joint: **NO**  
Remarks: **M-1004-066**

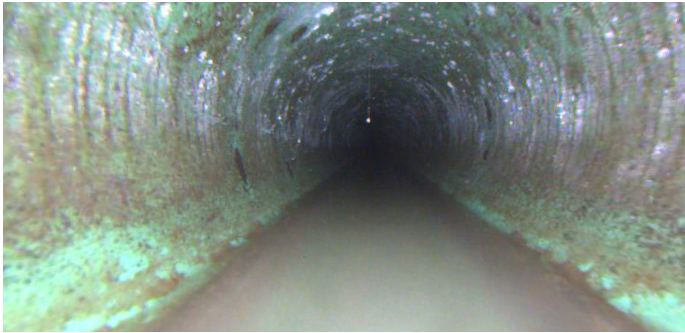
Code:	<b>MWL</b>
Description:	<b>Water Level</b>

Distance (ft):	<b>.0</b>
Structural Grade:	<b>0</b>
O&M Grade:	<b>0</b>
Clock Start/From:	
Clock To:	
1st Value:	
2nd Value:	
Value Percent:	<b>5.000</b>
Continuous Index:	
Within 8" of Joint:	<b>NO</b>
Remarks:

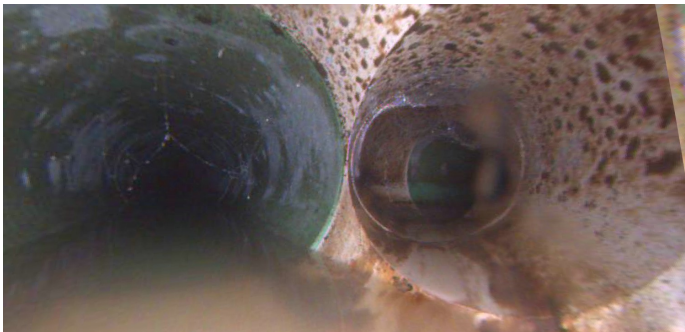
Code:	<b>TFA</b>
Description:	<b>Tap Factory Active</b>

Distance (ft):	<b>48.0</b>
Structural Grade:	<b>0</b>
O&M Grade:	<b>0</b>
Clock Start/From:	<b>3</b>
Clock To:	
1st Value:	<b>4.000</b>
2nd Value:	
Value Percent:	
Continuous Index:	
Within 8" of Joint:	
Remarks:

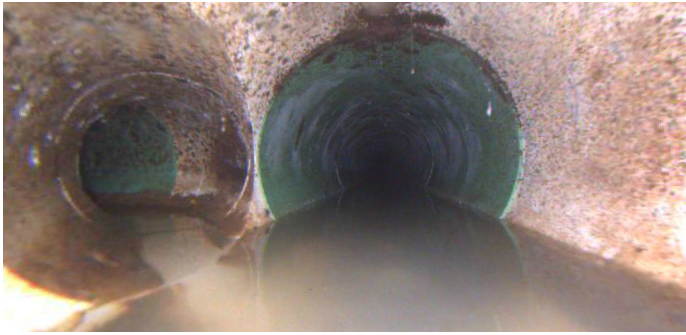
Code: **TFA**  
Description: **Tap Factory Active**

Distance (ft): **61.7**  
Structural Grade: **0**  
O&M Grade: **0**  
Clock Start/From: **9**  
Clock To:  
1st Value: **4.000**  
2nd Value:  
Value Percent:  
Continuous Index:  
Within 8" of Joint:  
Remarks:

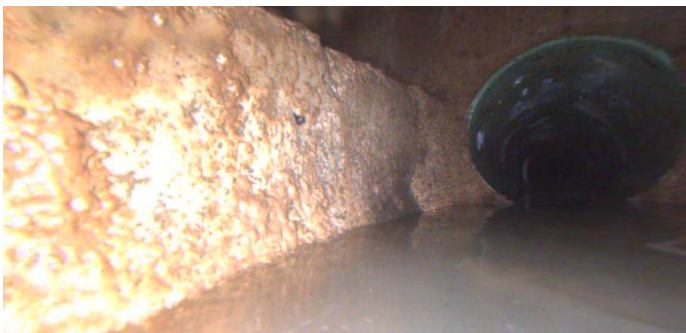
Code: **AMH**  
Description: **Manhole**

Distance (ft): **107.6**  
Structural Grade: **0**  
O&M Grade: **0**  
Clock Start/From:  
Clock To:  
1st Value:  
2nd Value:  
Value Percent:  
Continuous Index:  
Within 8" of Joint: **NO**  
Remarks: **M-1004-067**
