Profile/Photo Observation Report

Date:	04/11/2018	Weather:		Coding:	PACP 6.0
Pipe Length (ft):	113.3	Owner:	NA	Pre Clean:	Not Known
P.O.#:		Surveyor:	Jen Costello	PSR:	P-1004-068-067
Customer:		Clean Date:	01/01/1900	Shape:	C

Street:	Poplar Ln.	Flow Control:	Not Controlled
City:	Hobart, IN	Year Renewed:	
Location:	Other	Tape/Media #:	
Purpose:	Not Known	Dia/Height:	8"
Use:	Sanitary	Material:	PVC
Drain Area:	NA	Lining:	
Category:	NA		
Comment:

Location Details:		Direction of Survey:	Upstream
US MH:	M-1004-067	DS MH:	M-1004-068
		Total Length Surveyed (ft):	111.0

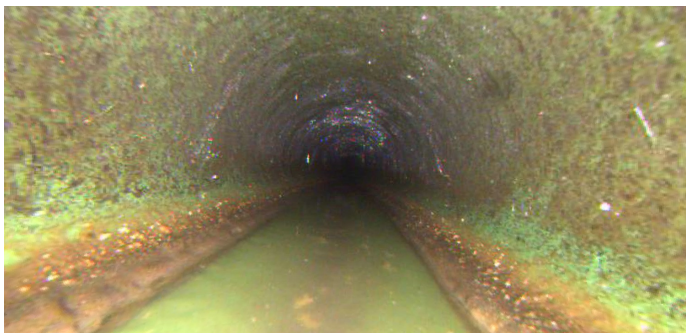
Code: **AMH**
Description: **Manhole**

Distance (ft): **.0**
Structural Grade: **0**
O&M Grade: **0**
Clock Start/From:
Clock To:
1st Value:
2nd Value:
Value Percent:
Continuous Index:
Within 8" of Joint: **NO**
Remarks: **M-1004-068**

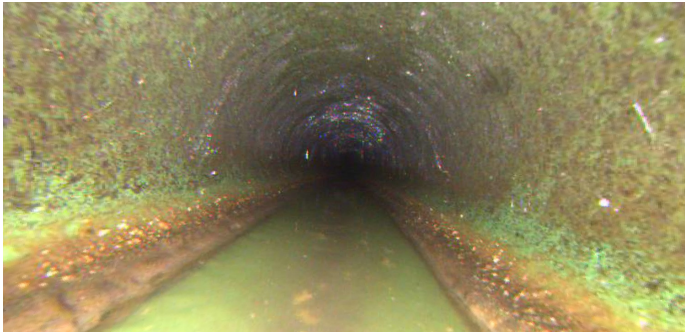
Code: **MWL**
Description: **Water Level**

Distance (ft): **.0**
Structural Grade: **0**
O&M Grade: **0**
Clock Start/From:
Clock To:
1st Value:
2nd Value:
Value Percent: **10.000**
Continuous Index:
Within 8" of Joint: **NO**
Remarks:

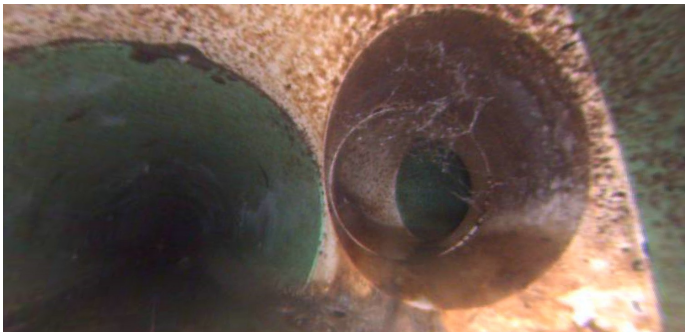
Code: **TF**
Description: **Tap Factory**

Distance (ft): **38.7**
Structural Grade: **0**
O&M Grade: **0**
Clock Start/From: **9**
Clock To:
1st Value: **4.000**
2nd Value:
Value Percent:
Continuous Index:
Within 8" of Joint:
Remarks:

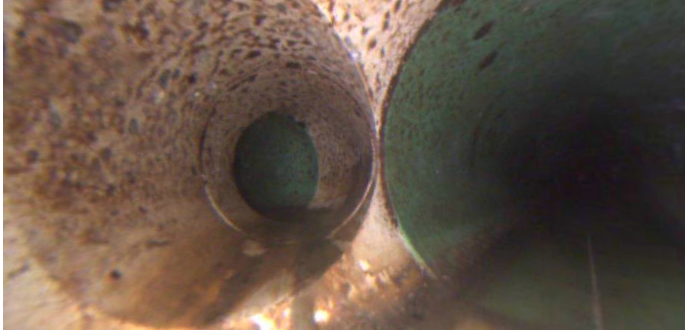
Code: **TF**
Description: **Tap Factory**

Distance (ft): **45.1**
Structural Grade: **0**
O&M Grade: **0**
Clock Start/From: **3**
Clock To:
1st Value: **4.000**
2nd Value:
Value Percent:
Continuous Index:
Within 8" of Joint:
Remarks:

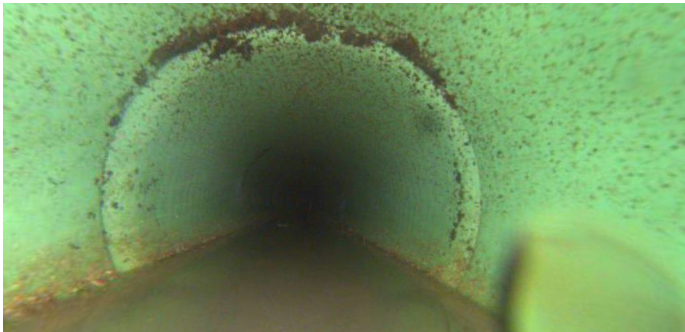
Code: **MWL**
Description: **Water Level**

Distance (ft): **94.9**
Structural Grade: **0**
O&M Grade: **0**
Clock Start/From:
Clock To:
1st Value:
2nd Value:
Value Percent: **20.000**
Continuous Index:
Within 8" of Joint: **NO**
Remarks:

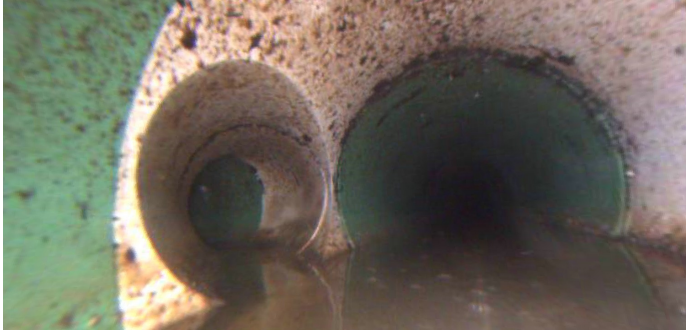
Code: **TFA**
Description: **Tap Factory Active**

Distance (ft): **106.0**
Structural Grade: **0**
O&M Grade: **0**
Clock Start/From: **3**
Clock To:
1st Value: **4.000**
2nd Value:
Value Percent:
Continuous Index:
Within 8" of Joint:
Remarks:

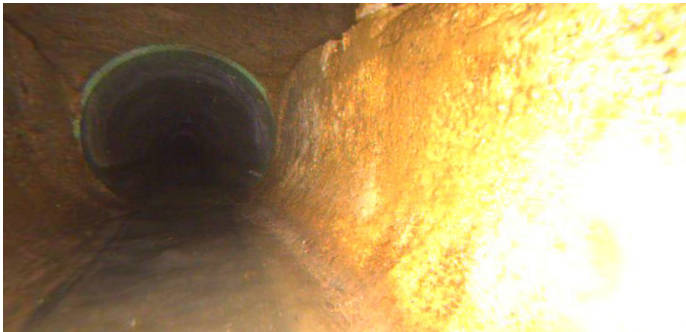
Code: **AMH**
Description: **Manhole**

Distance (ft): **111.0**
Structural Grade: **0**
O&M Grade: **0**
Clock Start/From:
Clock To:
1st Value:
2nd Value:
Value Percent:
Continuous Index:
Within 8" of Joint: **NO**
Remarks: **M-1004-067**
