Profile/Photo Observation Report

Date:	04/11/2018	Weather:		Coding:	PACP 6.0
Pipe Length (ft):	112.3	Owner:	NA	Pre Clean:	Not Known
P.O.#:		Surveyor:	Jen Costello	PSR:	P-1004-069-068
Customer:		Clean Date:	01/01/1900	Shape:	C

Street:	TULIP LN	Flow Control:	Not Controlled
City:	Hobart, IN	Year Renewed:	
Location:	Other	Tape/Media #:	
Purpose:	Not Known	Dia/Height:	8"
Use:	Sanitary	Material:	PVC
Drain Area:	NA	Lining:	
Category:	NA		
Comment:

Location Details:		Direction of Survey:	Downstream
US MH:	M-1004-068	DS MH:	M-1004-069
		Total Length Surveyed (ft):	109.0

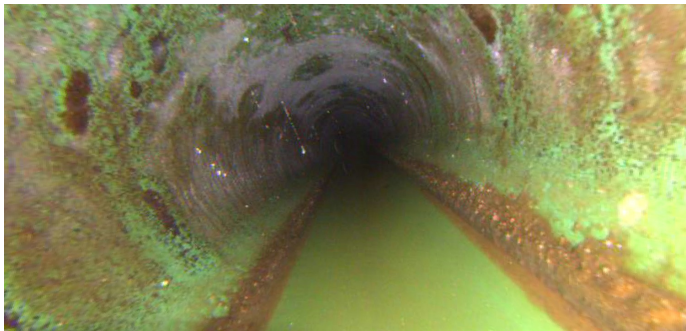
M-1004-069

Camera Direction

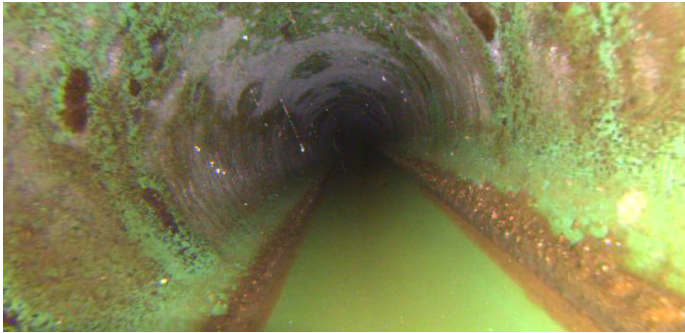
Code:	MWL
Description:	Water Level

Distance (ft):	.0
Structural Grade:	0
O&M Grade:	0
Clock Start/From:	
Clock To:	
1st Value:	
2nd Value:	
Value Percent:	10.000
Continuous Index:	
Within 8" of Joint:	NO
Remarks:

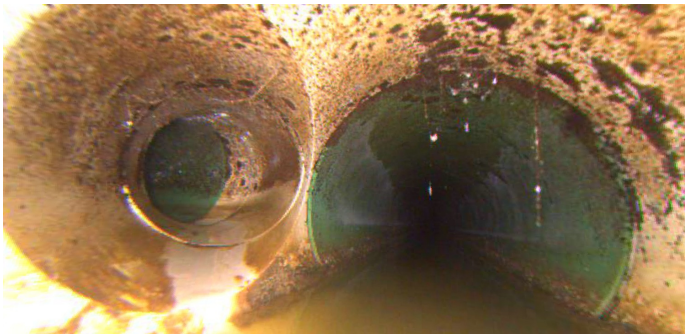
Code:	TF
Description:	Tap Factory

Distance (ft):	7.0
Structural Grade:	0
O&M Grade:	0
Clock Start/From:	9
Clock To:	
1st Value:	4.000
2nd Value:	
Value Percent:	
Continuous Index:	
Within 8" of Joint:	
Remarks:

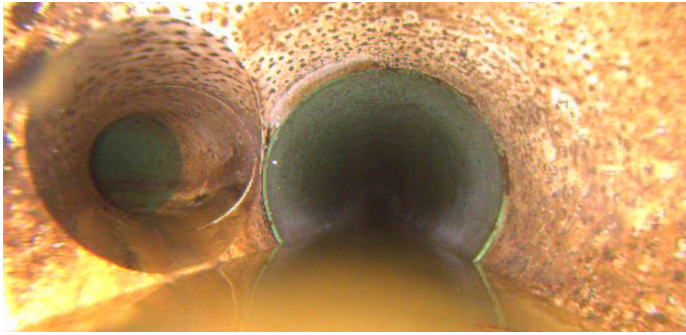
Code: **TF**
Description: **Tap Factory**

Distance (ft): **71.2**
Structural Grade: **0**
O&M Grade: **0**
Clock Start/From: **9**
Clock To:
1st Value: **4.000**
2nd Value:
Value Percent:
Continuous Index:
Within 8" of Joint:
Remarks:

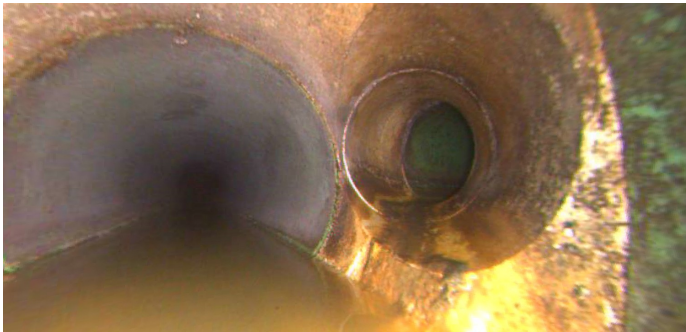
Code: **TF**
Description: **Tap Factory**

Distance (ft): **78.5**
Structural Grade: **0**
O&M Grade: **0**
Clock Start/From: **3**
Clock To:
1st Value: **4.000**
2nd Value:
Value Percent:
Continuous Index:
Within 8" of Joint:
Remarks:

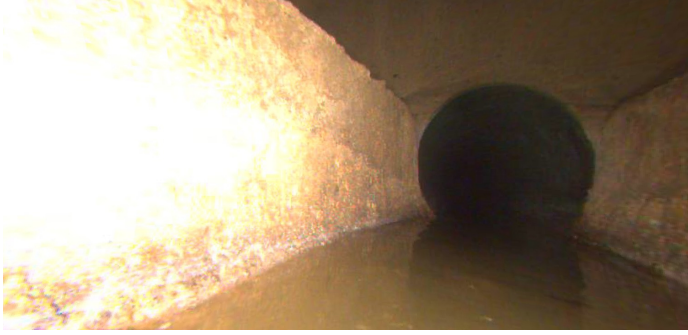
Code:	AMH
Description:	Manhole
Distance (ft):	109.0
Structural Grade:	0
O&M Grade:	0
Clock Start/From:	
Clock To:	
1st Value:	
2nd Value:	
Value Percent:	
Continuous Index:	
Within 8" of Joint:	NO
Remarks:	M-1004-069
