Profile/Photo Observation Report

Street:	Tulip Ln.	Flow Control:	Not Controlled
City:	Hobart, IN	Year Renewed:	
Location:	Other	Tape/Media #:	
Purpose:	Not Known	Dia/Height:	8"
Use:	Sanitary	Material:	PVC
Drain Area:	NA	Lining:	
Category:	NA		
Comment:

Location Details:		Direction of Survey:	Downstream
US MH:	M-1004-068	DS MH:	M-1004-069
		Total Length Surveyed (ft):	109.0

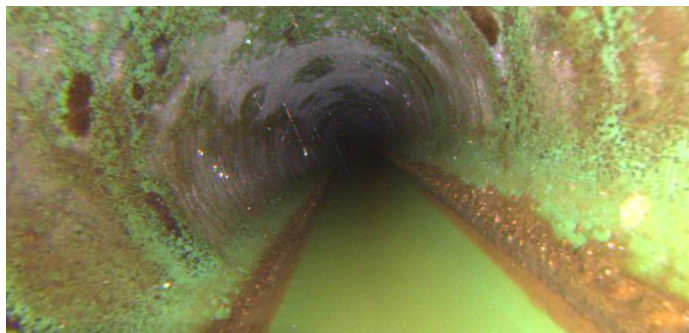
Code: **AMH**
Description: **Manhole**

Distance (ft): **.0**
Structural Grade: **0**
O&M Grade: **0**
Clock Start/From:
Clock To:
1st Value:
2nd Value:
Value Percent:
Continuous Index:
Within 8" of Joint: **NO**
Remarks: **M-1004-068**

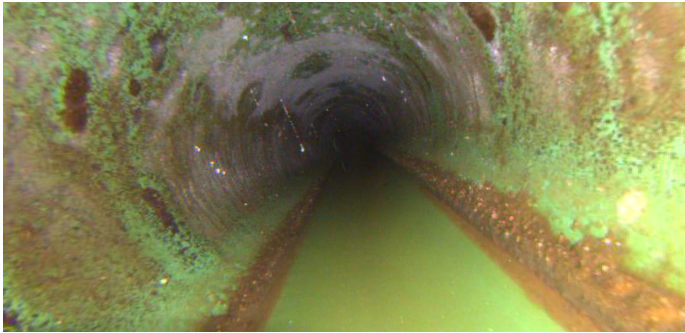
Code:	MWL
Description:	Water Level

Distance (ft):	.0
Structural Grade:	0
O&M Grade:	0
Clock Start/From:	
Clock To:	
1st Value:	
2nd Value:	
Value Percent:	10.000
Continuous Index:	
Within 8" of Joint:	NO
Remarks:

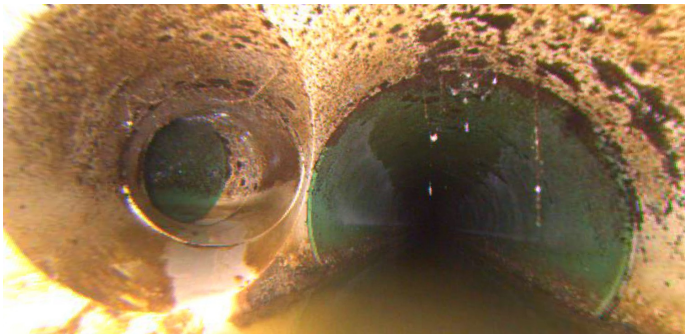
Code:	TF
Description:	Tap Factory

Distance (ft):	7.0
Structural Grade:	0
O&M Grade:	0
Clock Start/From:	9
Clock To:	
1st Value:	4.000
2nd Value:	
Value Percent:	
Continuous Index:	
Within 8" of Joint:	
Remarks:

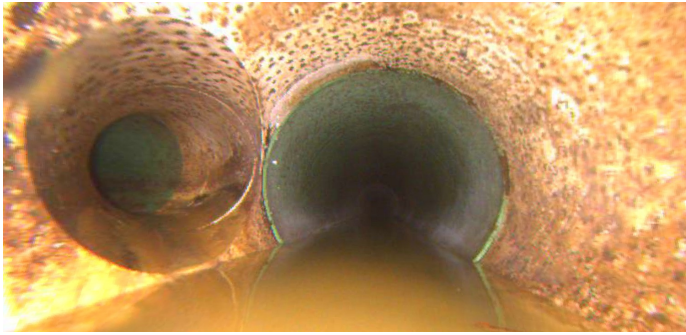
Code: **TF**
Description: **Tap Factory**

Distance (ft): **71.2**
Structural Grade: **0**
O&M Grade: **0**
Clock Start/From: **9**
Clock To:
1st Value: **4.000**
2nd Value:
Value Percent:
Continuous Index:
Within 8" of Joint:
Remarks:

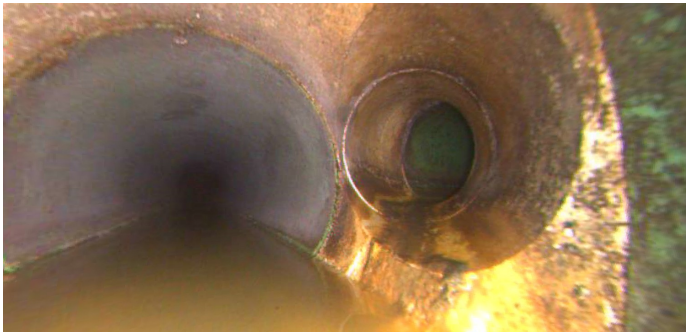
Code: **TF**
Description: **Tap Factory**

Distance (ft): **78.5**
Structural Grade: **0**
O&M Grade: **0**
Clock Start/From: **3**
Clock To:
1st Value: **4.000**
2nd Value:
Value Percent:
Continuous Index:
Within 8" of Joint:
Remarks:

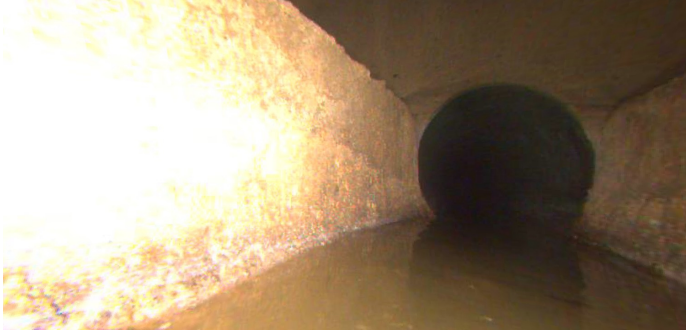
Code:	AMH
Description:	Manhole
Distance (ft):	109.0
Structural Grade:	0
O&M Grade:	0
Clock Start/From:	
Clock To:	
1st Value:	
2nd Value:	
Value Percent:	
Continuous Index:	
Within 8" of Joint:	NO
Remarks:	M-1004-069
