Profile/Photo Observation Report

Street:	TULIP LN	Flow Control:	Not Controlled
City:	Hobart, IN	Year Renewed:	
Location:	Other	Tape/Media #:	
Purpose:	Not Known	Dia/Height:	8"
Use:	Sanitary	Material:	PVC
Drain Area:	NA	Lining:	
Category:	NA		
Comment:

Location Details:		Direction of Survey:	Upstream
US MH:	M-1004-069	DS MH:	M-1004-070
		Total Length Surveyed (ft):	307.4

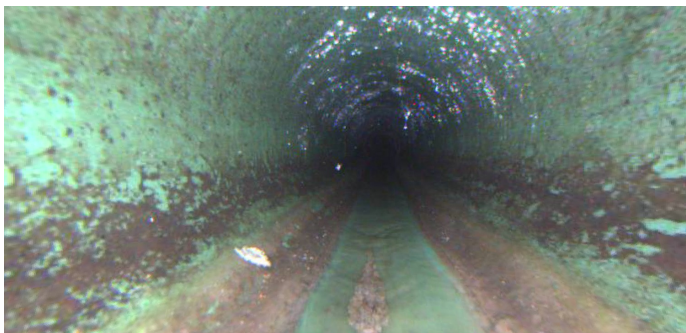
Code: **AMH**
Description: **Manhole**

Distance (ft): **.0**
Structural Grade: **0**
O&M Grade: **0**
Clock Start/From:
Clock To:
1st Value:
2nd Value:
Value Percent:
Continuous Index:
Within 8" of Joint: **NO**
Remarks: **M-1004-070**

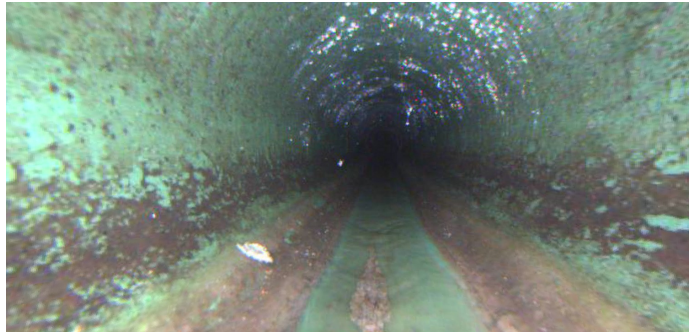
Code: **MWL**
Description: **Water Level**

Distance (ft): **.0**
Structural Grade: **0**
O&M Grade: **0**
Clock Start/From:
Clock To:
1st Value:
2nd Value:
Value Percent: **5.000**
Continuous Index:
Within 8" of Joint: **NO**
Remarks:

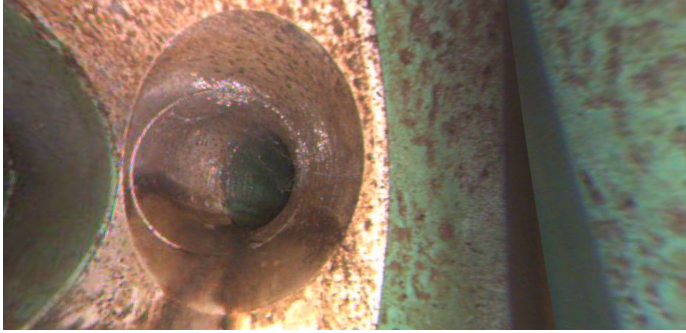
Code: **TF**
Description: **Tap Factory**

Distance (ft): **23.5**
Structural Grade: **0**
O&M Grade: **0**
Clock Start/From: **9**
Clock To:
1st Value: **4.000**
2nd Value:
Value Percent:
Continuous Index:
Within 8" of Joint:
Remarks:

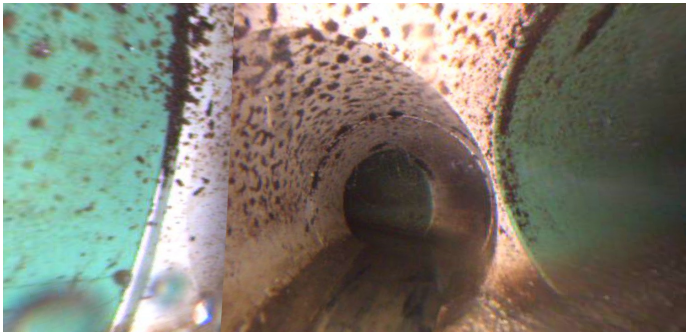
Code: **TFA**
Description: **Tap Factory Active**

Distance (ft): **72.3**
Structural Grade: **0**
O&M Grade: **0**
Clock Start/From: **3**
Clock To:
1st Value: **4.000**
2nd Value:
Value Percent:
Continuous Index:
Within 8" of Joint:
Remarks:

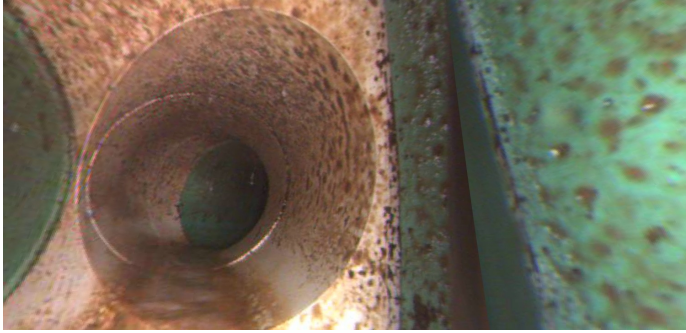
Code: **TFA**
Description: **Tap Factory Active**

Distance (ft): **90.6**
Structural Grade: **0**
O&M Grade: **0**
Clock Start/From: **9**
Clock To:
1st Value: **4.000**
2nd Value:
Value Percent:
Continuous Index:
Within 8" of Joint:
Remarks:

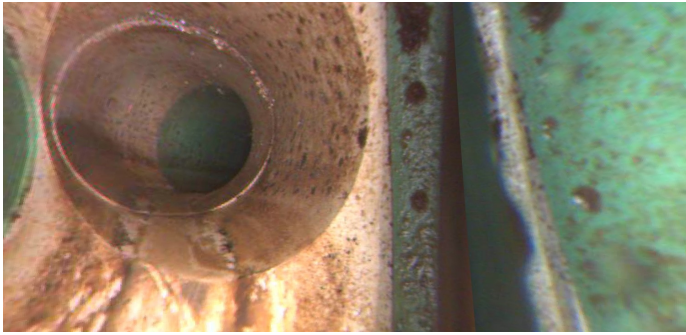
Code: **TFA**
Description: **Tap Factory Active**

Distance (ft): **169.5**
Structural Grade: **0**
O&M Grade: **0**
Clock Start/From: **9**
Clock To:
1st Value: **4.000**
2nd Value:
Value Percent:
Continuous Index:
Within 8" of Joint:
Remarks:

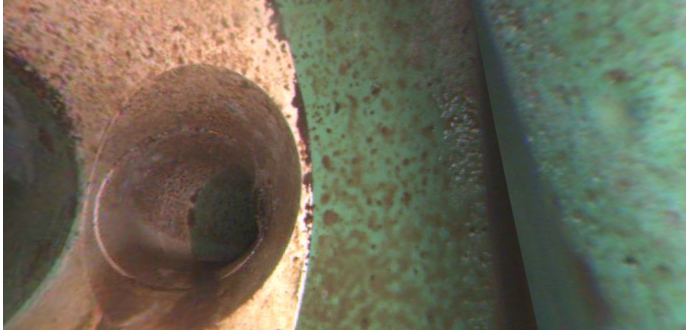
Code: **TFA**
Description: **Tap Factory Active**

Distance (ft): **240.2**
Structural Grade: **0**
O&M Grade: **0**
Clock Start/From: **9**
Clock To:
1st Value: **4.000**
2nd Value:
Value Percent:
Continuous Index:
Within 8" of Joint:
Remarks:

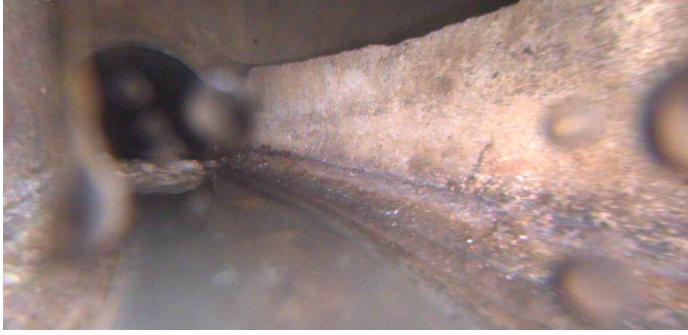
Code:	AMH
Description:	Manhole
Distance (ft):	307.4
Structural Grade:	0
O&M Grade:	0
Clock Start/From:	
Clock To:	
1st Value:	
2nd Value:	
Value Percent:	
Continuous Index:	
Within 8" of Joint:	NO
Remarks:	M-1004-069
