## Profile/Photo Observation Report

Street:	<b>Tulip Ln.</b>	Flow Control:	<b>Not Controlled</b>
City:	<b>Hobart, IN</b>	Year Renewed:	
Location:	<b>Other</b>	Tape/Media #:	
Purpose:	<b>Not Known</b>	Dia/Height:	<b>8"</b>
Use:	<b>Sanitary</b>	Material:	<b>PVC</b>
Drain Area:	<b>NA</b>	Lining:	
Category:	<b>NA</b>		
Comment:

Location Details:		Direction of Survey:	<b>Upstream</b>
US MH:	<b>M-1004-069</b>	DS MH:	<b>M-1004-070</b>
		Total Length Surveyed (ft):	<b>307.4</b>

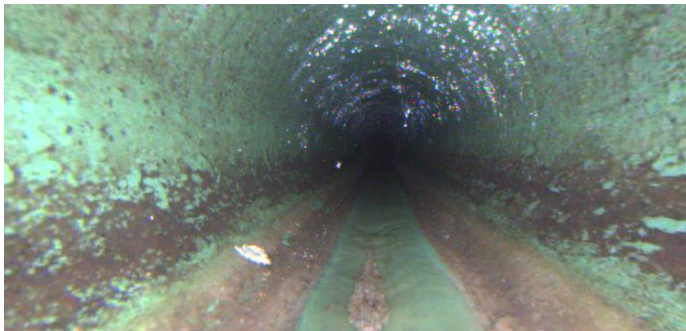
Code: **AMH**  
Description: **Manhole**

Distance (ft): **.0**  
Structural Grade: **0**  
O&M Grade: **0**  
Clock Start/From:  
Clock To:  
1st Value:  
2nd Value:  
Value Percent:  
Continuous Index:  
Within 8" of Joint: **NO**  
Remarks: **M-1004-070**

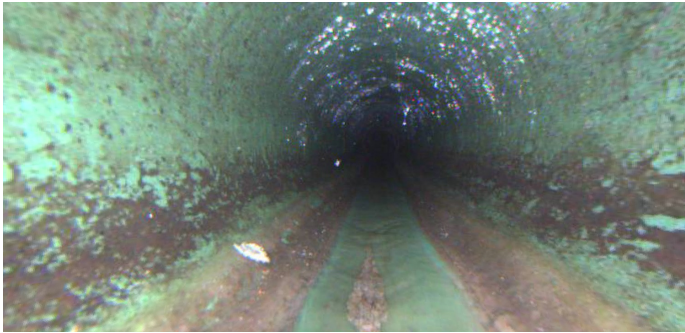
Code: **MWL**  
Description: **Water Level**

Distance (ft): **.0**  
Structural Grade: **0**  
O&M Grade: **0**  
Clock Start/From:  
Clock To:  
1st Value:  
2nd Value:  
Value Percent: **5.000**  
Continuous Index:  
Within 8" of Joint: **NO**  
Remarks:

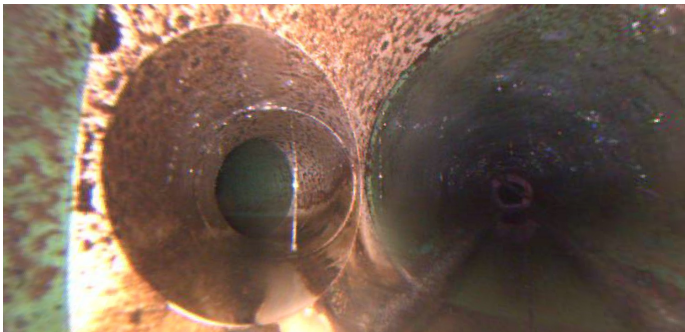
Code: **TFA**  
Description: **Tap Factory Active**

Distance (ft): **7.8**  
Structural Grade: **0**  
O&M Grade: **0**  
Clock Start/From: **3**  
Clock To:  
1st Value: **4.000**  
2nd Value:  
Value Percent:  
Continuous Index:  
Within 8" of Joint:  
Remarks:

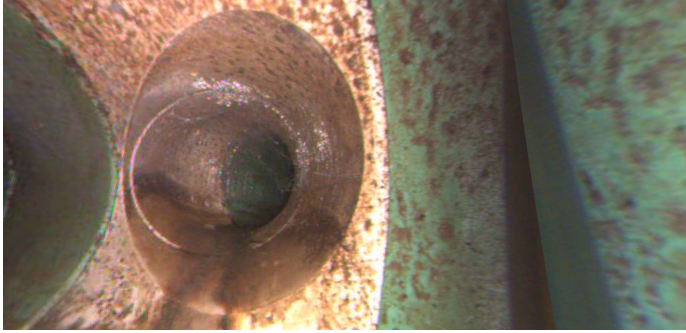
Code: **TF**  
Description: **Tap Factory**

Distance (ft): **23.5**  
Structural Grade: **0**  
O&M Grade: **0**  
Clock Start/From: **9**  
Clock To:  
1st Value: **4.000**  
2nd Value:  
Value Percent:  
Continuous Index:  
Within 8" of Joint:  
Remarks:

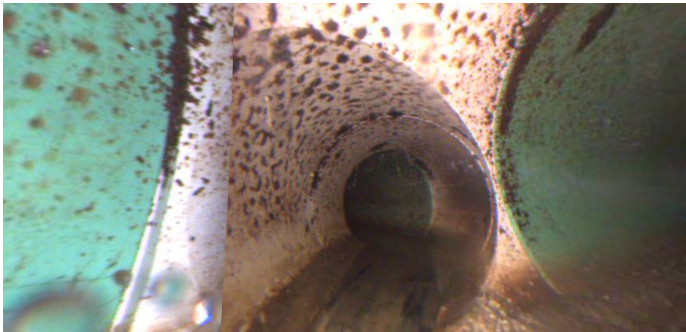
Code: **TFA**  
Description: **Tap Factory Active**

Distance (ft): **72.3**  
Structural Grade: **0**  
O&M Grade: **0**  
Clock Start/From: **3**  
Clock To:  
1st Value: **4.000**  
2nd Value:  
Value Percent:  
Continuous Index:  
Within 8" of Joint:  
Remarks:

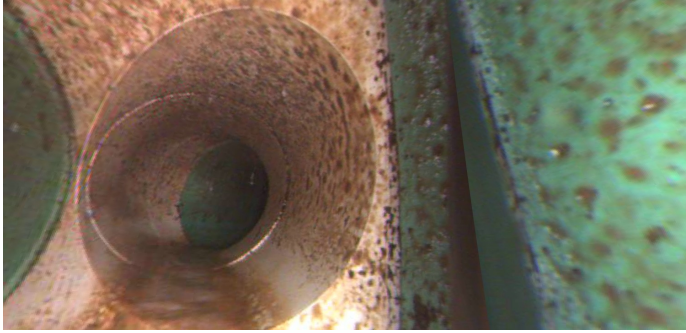
Code: **TFA**  
Description: **Tap Factory Active**

Distance (ft): **90.6**  
Structural Grade: **0**  
O&M Grade: **0**  
Clock Start/From: **9**  
Clock To:  
1st Value: **4.000**  
2nd Value:  
Value Percent:  
Continuous Index:  
Within 8" of Joint:  
Remarks:

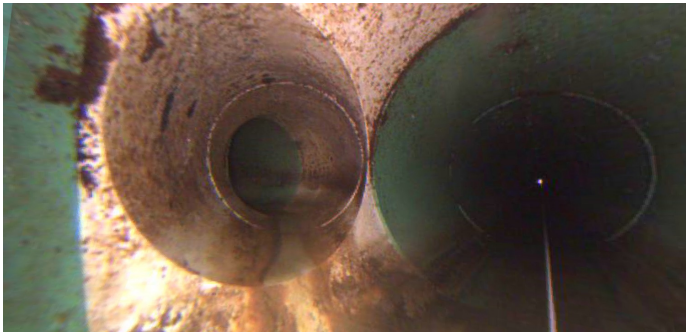
Code: **TFA**  
Description: **Tap Factory Active**

Distance (ft): **139.7**  
Structural Grade: **0**  
O&M Grade: **0**  
Clock Start/From: **3**  
Clock To:  
1st Value: **4.000**  
2nd Value:  
Value Percent:  
Continuous Index:  
Within 8" of Joint:  
Remarks:

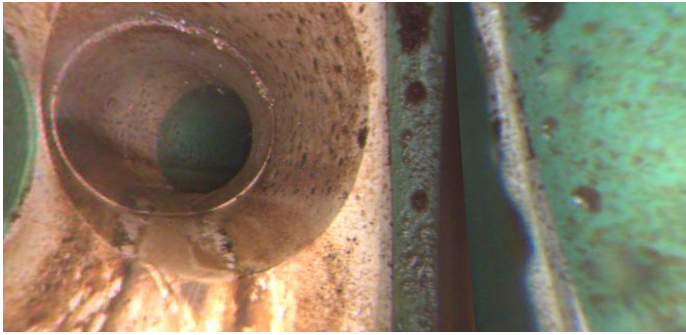
Code: **TFA**  
Description: **Tap Factory Active**

Distance (ft): **169.5**  
Structural Grade: **0**  
O&M Grade: **0**  
Clock Start/From: **9**  
Clock To:  
1st Value: **4.000**  
2nd Value:  
Value Percent:  
Continuous Index:  
Within 8" of Joint:  
Remarks:

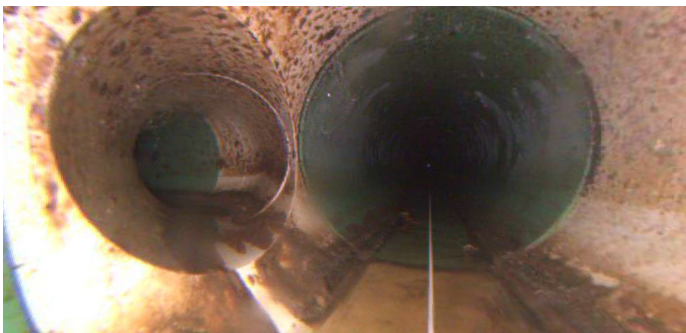
Code: **TF**  
Description: **Tap Factory**

Distance (ft): **210.3**  
Structural Grade: **0**  
O&M Grade: **0**  
Clock Start/From: **3**  
Clock To:  
1st Value: **4.000**  
2nd Value:  
Value Percent:  
Continuous Index:  
Within 8" of Joint:  
Remarks:

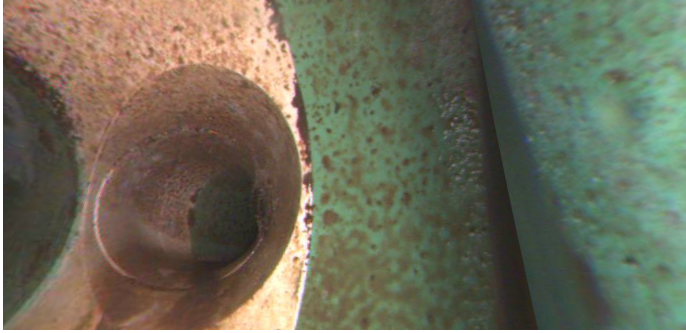
Code: **TFA**  
Description: **Tap Factory Active**

Distance (ft): **240.2**  
Structural Grade: **0**  
O&M Grade: **0**  
Clock Start/From: **9**  
Clock To:  
1st Value: **4.000**  
2nd Value:  
Value Percent:  
Continuous Index:  
Within 8" of Joint:  
Remarks:

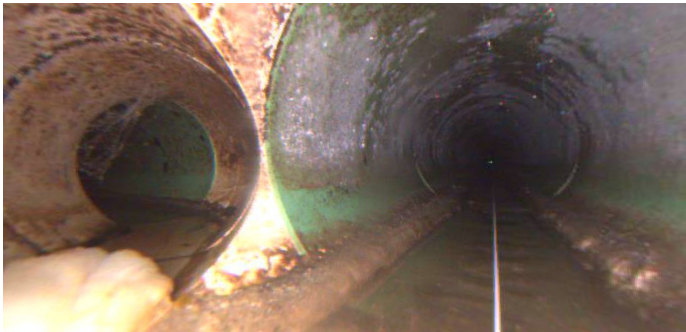
Code: **TFA**  
Description: **Tap Factory Active**

Distance (ft): **282.2**  
Structural Grade: **0**  
O&M Grade: **0**  
Clock Start/From: **3**  
Clock To:  
1st Value: **4.000**  
2nd Value:  
Value Percent:  
Continuous Index:  
Within 8" of Joint:  
Remarks:

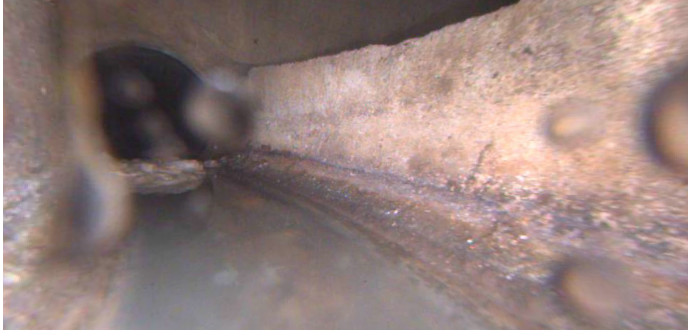
Code:	AMH
Description:	Manhole
Distance (ft):	307.4
Structural Grade:	0
O&M Grade:	0
Clock Start/From:	
Clock To:	
1st Value:	
2nd Value:	
Value Percent:	
Continuous Index:	
Within 8" of Joint:	NO
Remarks:	M-1004-069
