Profile/Photo Observation Report

Street:	TULIP LN	Flow Control:	Not Controlled
City:	Hobart, IN	Year Renewed:	
Location:	Other	Tape/Media #:	
Purpose:	Not Known	Dia/Height:	8"
Use:	Sanitary	Material:	PVC
Drain Area:	NA	Lining:	
Category:	NA		
Comment:

Location Details:		Direction of Survey:	Downstream
US MH:	M-1004-070	DS MH:	M-1004-071
		Total Length Surveyed (ft):	305.6

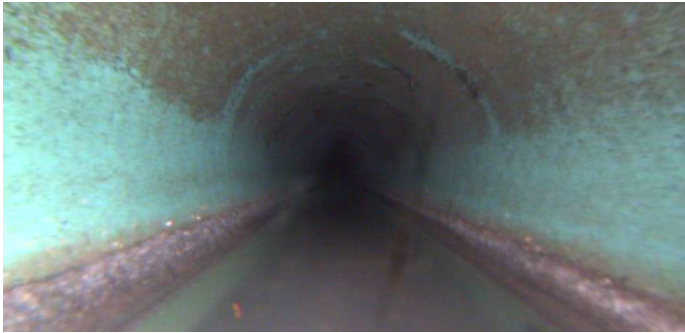
Code:	MWL
Description:	Water Level

Distance (ft):	.0
Structural Grade:	0
O&M Grade:	0
Clock Start/From:	
Clock To:	
1st Value:	
2nd Value:	
Value Percent:	10.000
Continuous Index:	
Within 8" of Joint:	NO
Remarks:

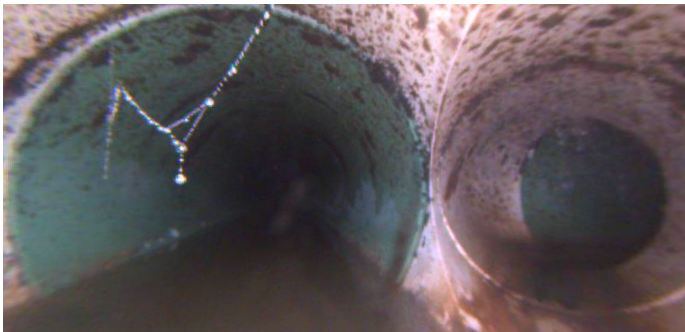
Code:	TFA
Description:	Tap Factory Active

Distance (ft):	43.8
Structural Grade:	0
O&M Grade:	0
Clock Start/From:	3
Clock To:	
1st Value:	4.000
2nd Value:	
Value Percent:	
Continuous Index:	
Within 8" of Joint:	
Remarks:

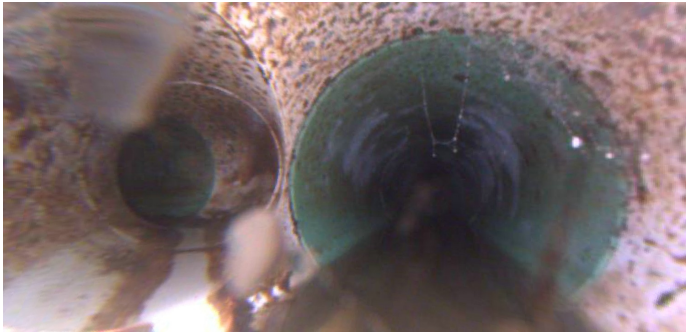
Code: **TFA**
Description: **Tap Factory Active**

Distance (ft): **61.4**
Structural Grade: **0**
O&M Grade: **0**
Clock Start/From: **9**
Clock To:
1st Value: **4.000**
2nd Value:
Value Percent:
Continuous Index:
Within 8" of Joint:
Remarks:

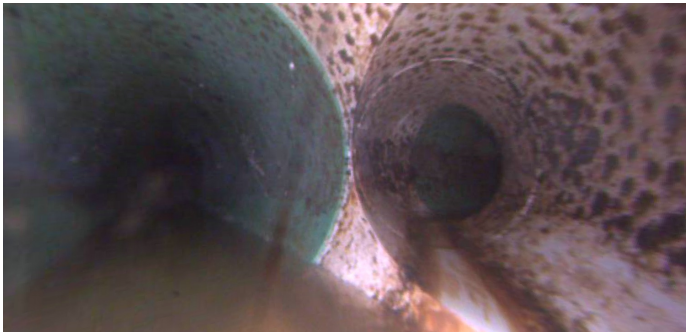
Code: **TF**
Description: **Tap Factory**

Distance (ft): **116.1**
Structural Grade: **0**
O&M Grade: **0**
Clock Start/From: **3**
Clock To:
1st Value: **4.000**
2nd Value:
Value Percent:
Continuous Index:
Within 8" of Joint:
Remarks:

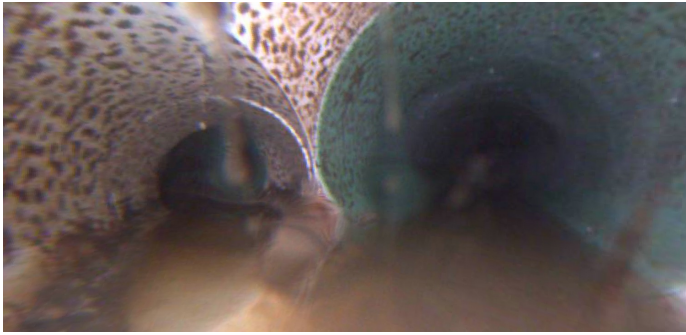
Code: **TFA**
Description: **Tap Factory Active**

Distance (ft): **127.5**
Structural Grade: **0**
O&M Grade: **0**
Clock Start/From: **9**
Clock To:
1st Value: **4.000**
2nd Value:
Value Percent:
Continuous Index:
Within 8" of Joint:
Remarks:

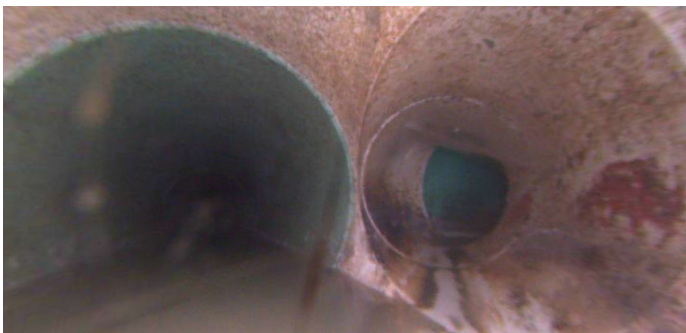
Code: **TF**
Description: **Tap Factory**

Distance (ft): **188.5**
Structural Grade: **0**
O&M Grade: **0**
Clock Start/From: **3**
Clock To:
1st Value: **4.000**
2nd Value:
Value Percent:
Continuous Index:
Within 8" of Joint:
Remarks:

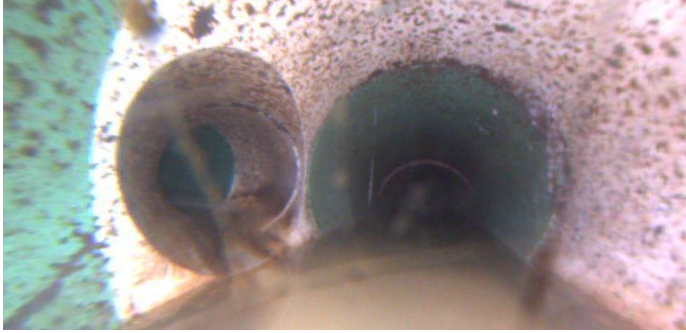
Code: **TF**
Description: **Tap Factory**

Distance (ft): **206.7**
Structural Grade: **0**
O&M Grade: **0**
Clock Start/From: **9**
Clock To:
1st Value: **4.000**
2nd Value:
Value Percent:
Continuous Index:
Within 8" of Joint:
Remarks:

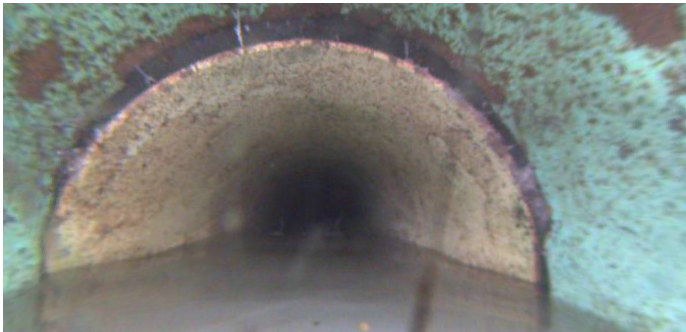
Code: **JOM**
Description: **Joint Offset Medium**

Distance (ft): **209.0**
Structural Grade: **1**
O&M Grade: **0**
Clock Start/From:
Clock To:
1st Value:
2nd Value:
Value Percent:
Continuous Index:
Within 8" of Joint: **NO**
Remarks:

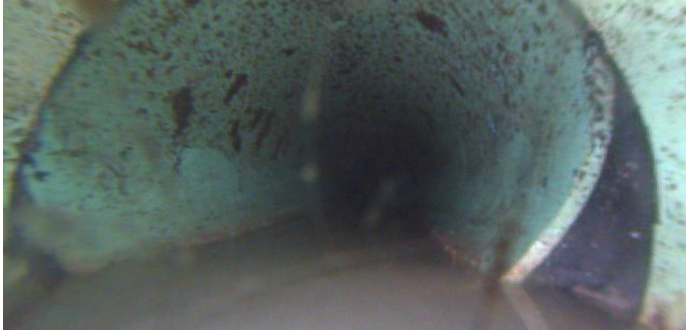
Code: **JOL**
Description: **Joint Offset Large**

Distance (ft): **212.4**
Structural Grade: **2**
O&M Grade: **0**
Clock Start/From:
Clock To:
1st Value:
2nd Value:
Value Percent:
Continuous Index:
Within 8" of Joint: **NO**
Remarks:

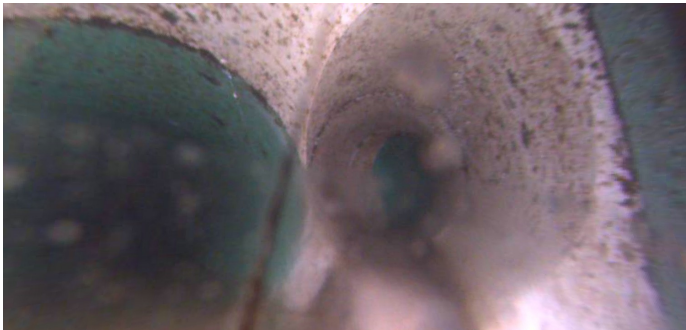
Code: **TFA**
Description: **Tap Factory Active**

Distance (ft): **258.2**
Structural Grade: **0**
O&M Grade: **0**
Clock Start/From: **3**
Clock To:
1st Value: **4.000**
2nd Value:
Value Percent:
Continuous Index:
Within 8" of Joint:
Remarks:

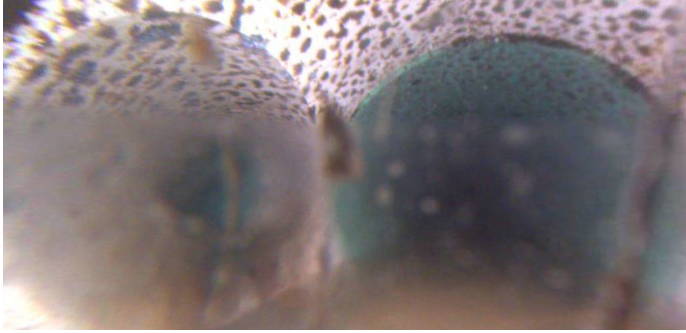
Code: **TF**
Description: **Tap Factory**

Distance (ft): **265.5**
Structural Grade: **0**
O&M Grade: **0**
Clock Start/From: **9**
Clock To:
1st Value: **4.000**
2nd Value:
Value Percent:
Continuous Index:
Within 8" of Joint:
Remarks:

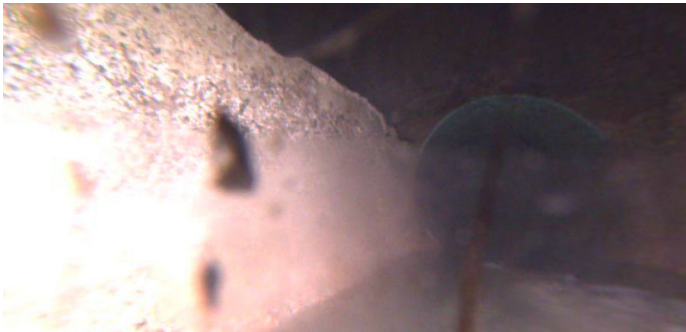
Code: **AMH**
Description: **Manhole**

Distance (ft): **305.6**
Structural Grade: **0**
O&M Grade: **0**
Clock Start/From:
Clock To:
1st Value:
2nd Value:
Value Percent:
Continuous Index:
Within 8" of Joint: **NO**
Remarks: **M-1004-071**
