## Profile/Photo Observation Report

Street:	<b>Tulip Ln.</b>	Flow Control:	<b>Not Controlled</b>
City:	<b>Hobart, IN</b>	Year Renewed:	
Location:	<b>Other</b>	Tape/Media #:	
Purpose:	<b>Not Known</b>	Dia/Height:	<b>8"</b>
Use:	<b>Sanitary</b>	Material:	<b>PVC</b>
Drain Area:	<b>NA</b>	Lining:	
Category:	<b>NA</b>		
Comment:

Location Details:		Direction of Survey:	<b>Downstream</b>
US MH:	<b>M-1004-070</b>	DS MH:	<b>M-1004-071</b>
		Total Length Surveyed (ft):	<b>305.6</b>

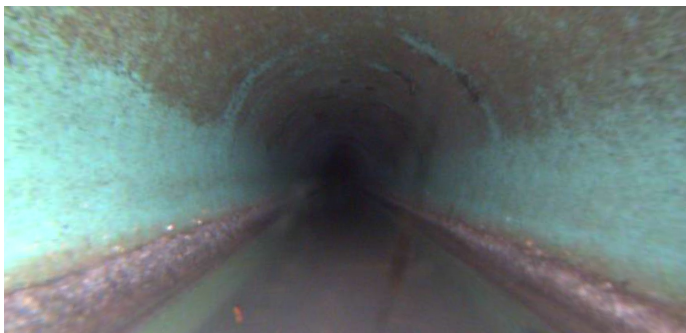
Code: **AMH**  
Description: **Manhole**

Distance (ft): **.0**  
Structural Grade: **0**  
O&M Grade: **0**  
Clock Start/From:  
Clock To:  
1st Value:  
2nd Value:  
Value Percent:  
Continuous Index:  
Within 8" of Joint: **NO**  
Remarks: **M-1004-070**

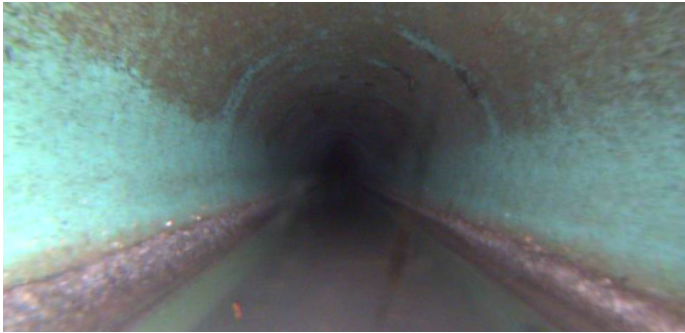
Code:	<b>MWL</b>
Description:	<b>Water Level</b>

Distance (ft):	<b>.0</b>
Structural Grade:	<b>0</b>
O&M Grade:	<b>0</b>
Clock Start/From:	
Clock To:	
1st Value:	
2nd Value:	
Value Percent:	<b>10.000</b>
Continuous Index:	
Within 8" of Joint:	<b>NO</b>
Remarks:

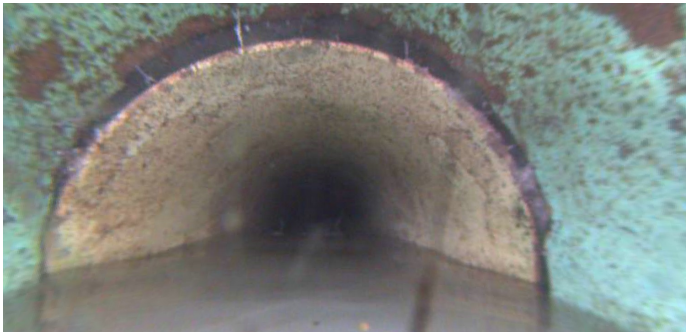
Code: **JOM**  
Description: **Joint Offset Medium**

Distance (ft): **209.0**  
Structural Grade: **1**  
O&M Grade: **0**  
Clock Start/From:  
Clock To:  
1st Value:  
2nd Value:  
Value Percent:  
Continuous Index:  
Within 8" of Joint: **NO**  
Remarks:

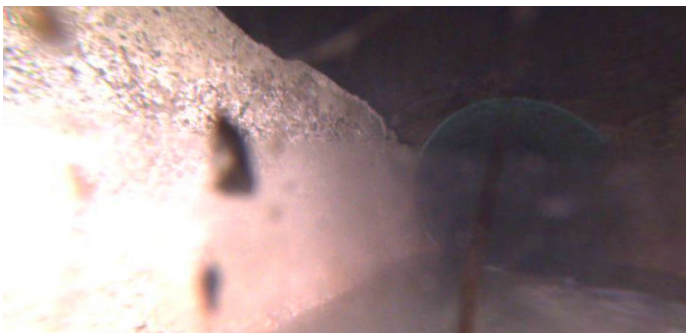
Code: **AMH**  
Description: **Manhole**

Distance (ft): **305.6**  
Structural Grade: **0**  
O&M Grade: **0**  
Clock Start/From:  
Clock To:  
1st Value:  
2nd Value:  
Value Percent:  
Continuous Index:  
Within 8" of Joint: **NO**  
Remarks: **M-1004-071**
