Profile/Photo Observation Report

Street:	TULIP LN	Flow Control:	Not Controlled
City:	Hobart, IN	Year Renewed:	
Location:	Other	Tape/Media #:	
Purpose:	Not Known	Dia/Height:	8"
Use:	Sanitary	Material:	PVC
Drain Area:	NA	Lining:	
Category:	NA		
Comment:

Location Details:		Direction of Survey:	Upstream
US MH:	M-1004-071	DS MH:	M-1004-072
		Total Length Surveyed (ft):	89.7

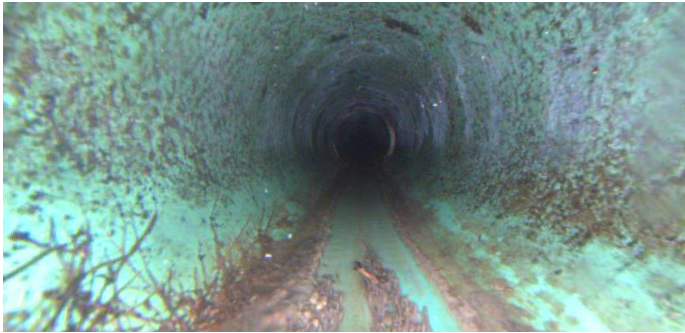
Code:	MWL
Description:	Water Level

Distance (ft):	.0
Structural Grade:	0
O&M Grade:	0
Clock Start/From:	
Clock To:	
1st Value:	
2nd Value:	
Value Percent:	5.000
Continuous Index:	
Within 8" of Joint:	NO
Remarks:

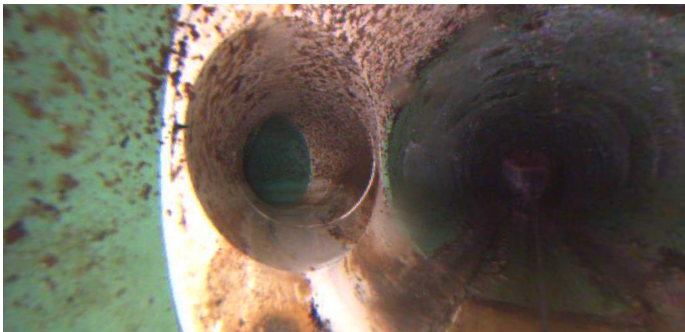
Code:	TF
Description:	Tap Factory

Distance (ft):	5.4
Structural Grade:	0
O&M Grade:	0
Clock Start/From:	3
Clock To:	
1st Value:	4.000
2nd Value:	
Value Percent:	
Continuous Index:	
Within 8" of Joint:	
Remarks:

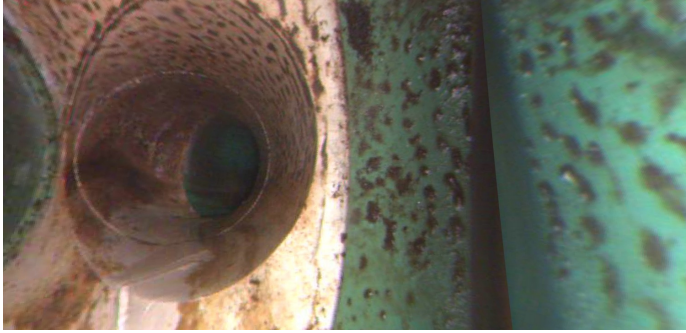
Code: **TFA**
Description: **Tap Factory Active**

Distance (ft): **35.6**
Structural Grade: **0**
O&M Grade: **0**
Clock Start/From: **9**
Clock To:
1st Value: **4.000**
2nd Value:
Value Percent:
Continuous Index:
Within 8" of Joint:
Remarks:

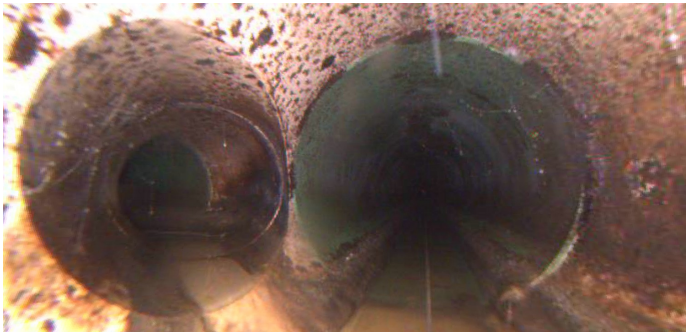
Code: **TFA**
Description: **Tap Factory Active**

Distance (ft): **72.3**
Structural Grade: **0**
O&M Grade: **0**
Clock Start/From: **3**
Clock To:
1st Value: **4.000**
2nd Value:
Value Percent:
Continuous Index:
Within 8" of Joint:
Remarks:

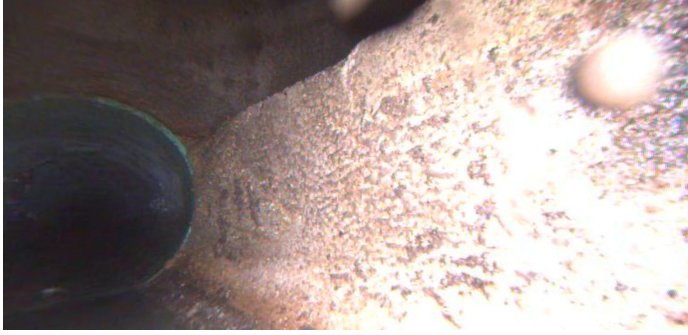
Code:	AMH
Description:	Manhole
Distance (ft):	89.7
Structural Grade:	0
O&M Grade:	0
Clock Start/From:	
Clock To:	
1st Value:	
2nd Value:	
Value Percent:	
Continuous Index:	
Within 8" of Joint:	NO
Remarks:	M-1004-071
