Profile/Photo Observation Report

Street:	Tulip Ln.	Flow Control:	Not Controlled
City:	Hobart, IN	Year Renewed:	
Location:	Other	Tape/Media #:	
Purpose:	Not Known	Dia/Height:	8"
Use:	Sanitary	Material:	PVC
Drain Area:	NA	Lining:	
Category:	NA		
Comment:

Location Details:		Direction of Survey:	Upstream
US MH:	M-1004-071	DS MH:	M-1004-072
		Total Length Surveyed (ft):	89.7

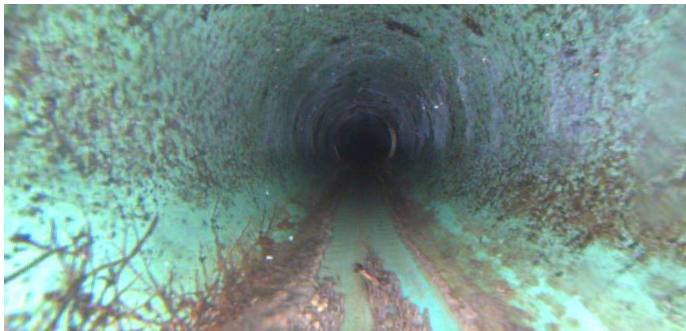
Code: **AMH**
Description: **Manhole**

Distance (ft): **.0**
Structural Grade: **0**
O&M Grade: **0**
Clock Start/From:
Clock To:
1st Value:
2nd Value:
Value Percent:
Continuous Index:
Within 8" of Joint: **NO**
Remarks: **M-1004-072**

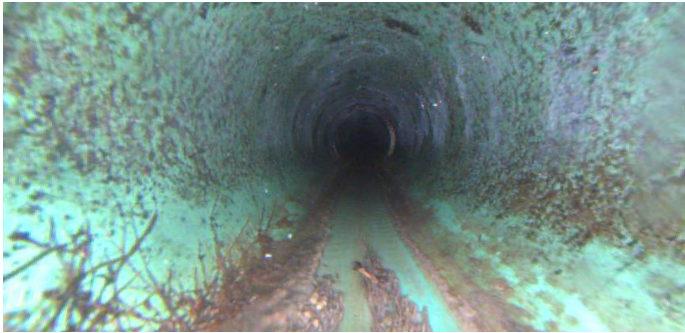
Code:	MWL
Description:	Water Level

Distance (ft):	.0
Structural Grade:	0
O&M Grade:	0
Clock Start/From:	
Clock To:	
1st Value:	
2nd Value:	
Value Percent:	5.000
Continuous Index:	
Within 8" of Joint:	NO
Remarks:

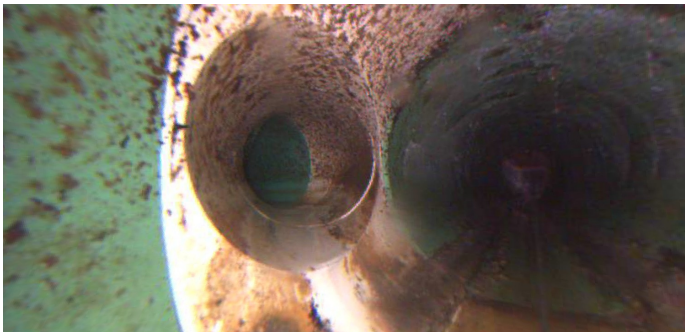
Code:	TF
Description:	Tap Factory

Distance (ft):	5.4
Structural Grade:	0
O&M Grade:	0
Clock Start/From:	3
Clock To:	
1st Value:	4.000
2nd Value:	
Value Percent:	
Continuous Index:	
Within 8" of Joint:	
Remarks:

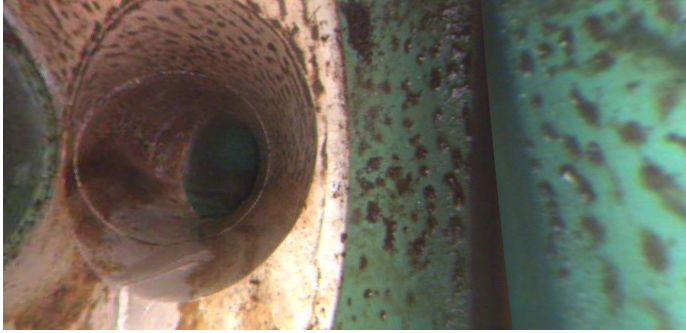
Code: **TFA**
Description: **Tap Factory Active**

Distance (ft): **35.6**
Structural Grade: **0**
O&M Grade: **0**
Clock Start/From: **9**
Clock To:
1st Value: **4.000**
2nd Value:
Value Percent:
Continuous Index:
Within 8" of Joint:
Remarks:

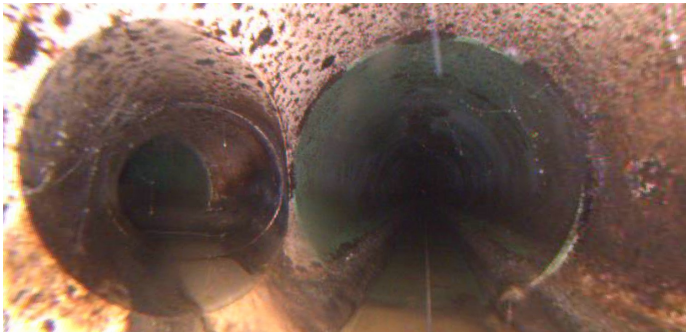
Code: **TFA**
Description: **Tap Factory Active**

Distance (ft): **72.3**
Structural Grade: **0**
O&M Grade: **0**
Clock Start/From: **3**
Clock To:
1st Value: **4.000**
2nd Value:
Value Percent:
Continuous Index:
Within 8" of Joint:
Remarks:

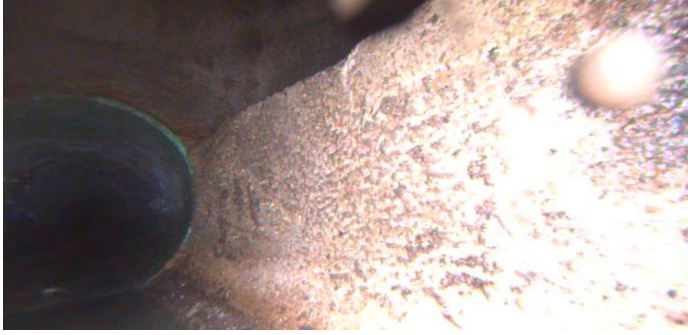
Code:	AMH
Description:	Manhole
Distance (ft):	89.7
Structural Grade:	0
O&M Grade:	0
Clock Start/From:	
Clock To:	
1st Value:	
2nd Value:	
Value Percent:	
Continuous Index:	
Within 8" of Joint:	NO
Remarks:	M-1004-071
