Profile/Photo Observation Report

Street:	Tulip Ln.	Flow Control:	Not Controlled
City:	Hobart, IN	Year Renewed:	
Location:	Other	Tape/Media #:	
Purpose:	Not Known	Dia/Height:	8"
Use:	Sanitary	Material:	PVC
Drain Area:	NA	Lining:	
Category:	NA		
Comment:

Location Details:		Direction of Survey:	Downstream
US MH:	M-1004-072	DS MH:	M-1004-073
		Total Length Surveyed (ft):	93.9

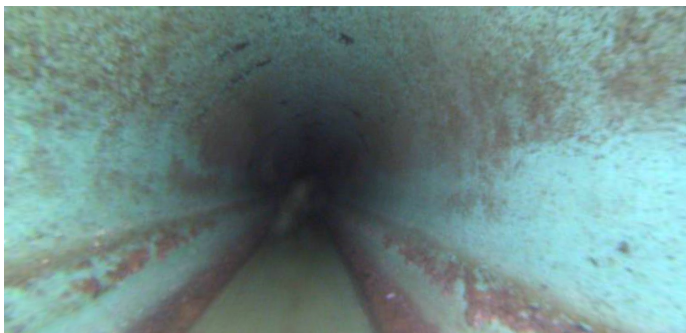
Code: **AMH**
Description: **Manhole**

Distance (ft): **.0**
Structural Grade: **0**
O&M Grade: **0**
Clock Start/From:
Clock To:
1st Value:
2nd Value:
Value Percent:
Continuous Index:
Within 8" of Joint: **NO**
Remarks: **M-1004-072**

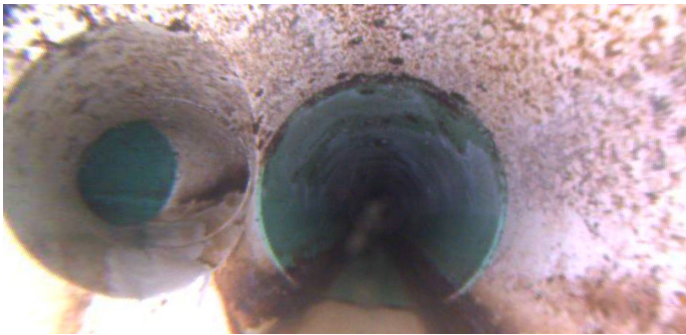
Code:	TFA
Description:	Tap Factory Active

Distance (ft):	21.4
Structural Grade:	0
O&M Grade:	0
Clock Start/From:	9
Clock To:	
1st Value:	4.000
2nd Value:	
Value Percent:	
Continuous Index:	
Within 8" of Joint:	
Remarks:
