Profile/Photo Observation Report

Date: 04/13/2018 Weather: **PACP 4.2** Coding: Pipe Length (ft): 221.1 Owner: **City of Hobart** Pre Clean: No Pre-Cleaning P.O.#: 2004 PSR: P-803-059-040 Surveyor: SAN **Red Zone** Customer: Clean Date: Shape:

Street: Rand St Flow Control: Not Controlled

US MH: M-803-059 DS MH: M-803-040 Total Length Surveyed (ft): 221.1

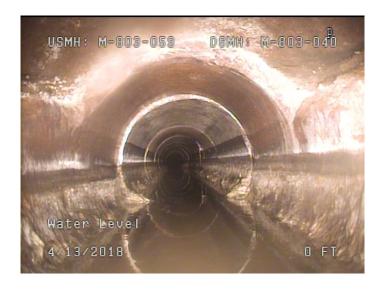
Code: MWL

Description: Water Level

Distance (ft): .0
Structural Grade: 0
O&M Grade: 0

Value Percent: 10.000

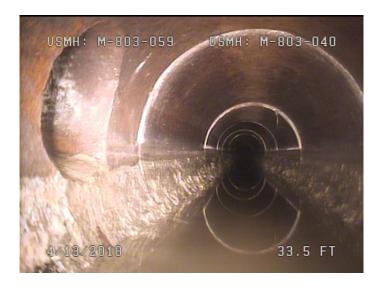
Code: **TF**

Description: Tap Factory

Distance (ft): 33.5
Structural Grade: 0
O&M Grade: 0
Clock Start/From: 9

1st Value: **6.000**

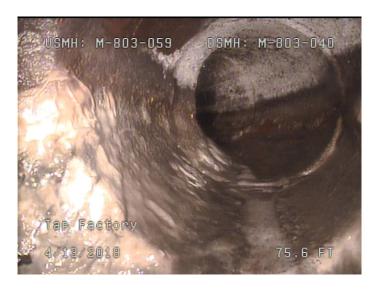
Code: TF

Description: Tap Factory

Distance (ft): 75.6
Structural Grade: 0

Clock Start/From: 9

1st Value: **6.000**

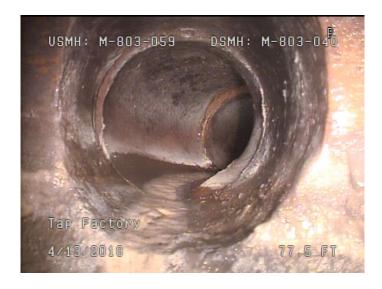
Code: TF

Description: **Tap Factory**

Distance (ft): 77.5 Structural Grade: 0 O&M Grade: 0 Clock Start/From: 3

1st Value: 6.000

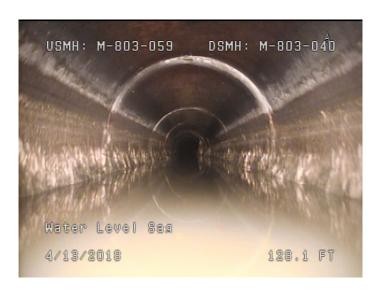
Code: **MWLS**

Description: **Water Level Sag**

Distance (ft): 128.1 Structural Grade: 2 O&M Grade: 3

30.000 Value Percent: Continuous Index: S02 Within 8" of Joint: NO

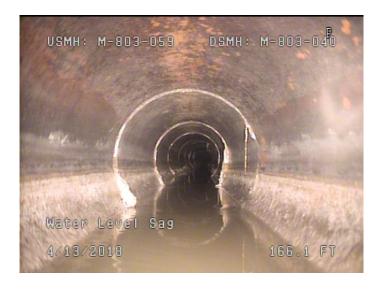
Code: MWLS

Description: Water Level Sag

Distance (ft): 166.1
Structural Grade: 2
O&M Grade: 3

Value Percent: 30.000
Continuous Index: F02
Within 8" of Joint: NO

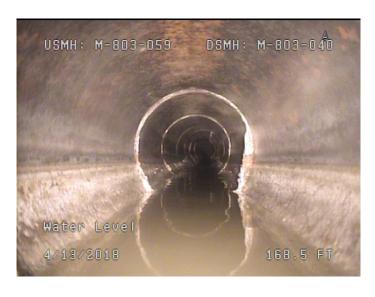
Code: MWL

Description: Water Level

Distance (ft): 168.5
Structural Grade: 0
O&M Grade: 0

Value Percent: 10.000

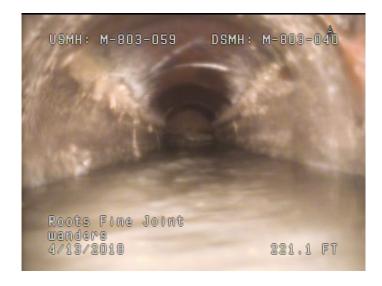
Code: RFJ

Description: Roots Fine Joint

Distance (ft): 221.1
Structural Grade: 0
O&M Grade: 1
Clock Start/From: 3
Clock To: 9

Continuous Index: F01
Within 8" of Joint: YES

Remarks: wanders

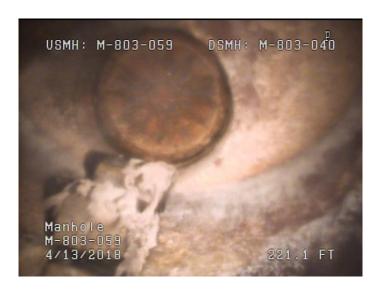
Code: AMH
Description: Manhole

Distance (ft): 221.1
Structural Grade: 0

Remarks: M-803-059
