## Profile/Photo Observation Report

Street:	<b>TULIP LN</b>	Flow Control:	<b>Not Controlled</b>
City:	<b>Hobart, IN</b>	Year Renewed:	
Location:	<b>Other</b>	Tape/Media #:	
Purpose:	<b>Not Known</b>	Dia/Height:	<b>8"</b>
Use:	<b>Sanitary</b>	Material:	<b>PVC</b>
Drain Area:	<b>NA</b>	Lining:	
Category:	<b>NA</b>		
Comment:

Location Details:		Direction of Survey:	<b>Downstream</b>
US MH:	<b>M-1004-073</b>	DS MH:	<b>M-1004-074</b>
		Total Length Surveyed (ft):	<b>120.1</b>

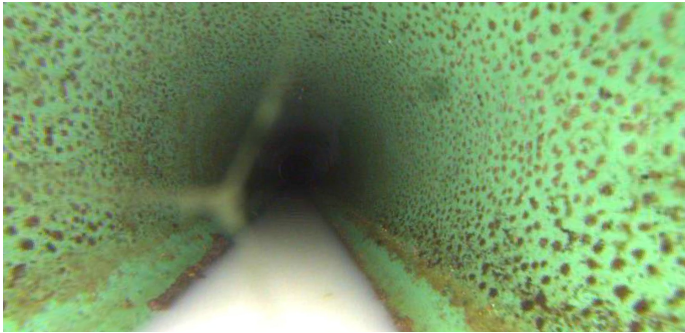
Code:	<b>MWL</b>
Description:	<b>Water Level</b>

Distance (ft):	<b>.0</b>
Structural Grade:	<b>0</b>
O&M Grade:	<b>0</b>
Clock Start/From:	
Clock To:	
1st Value:	
2nd Value:	
Value Percent:	<b>5.000</b>
Continuous Index:	
Within 8" of Joint:	<b>NO</b>
Remarks:

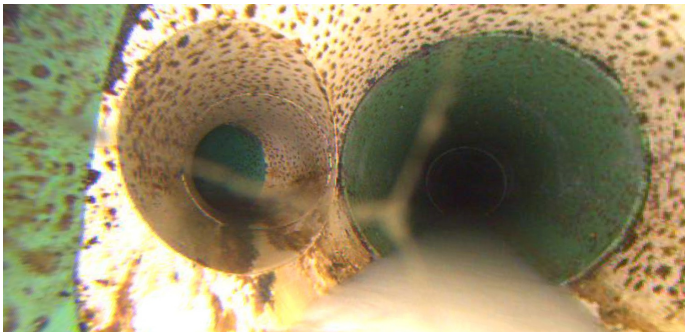
Code:	<b>TF</b>
Description:	<b>Tap Factory</b>

Distance (ft):	<b>7.3</b>
Structural Grade:	<b>0</b>
O&M Grade:	<b>0</b>
Clock Start/From:	<b>9</b>
Clock To:	
1st Value:	<b>4.000</b>
2nd Value:	
Value Percent:	
Continuous Index:	
Within 8" of Joint:	
Remarks:

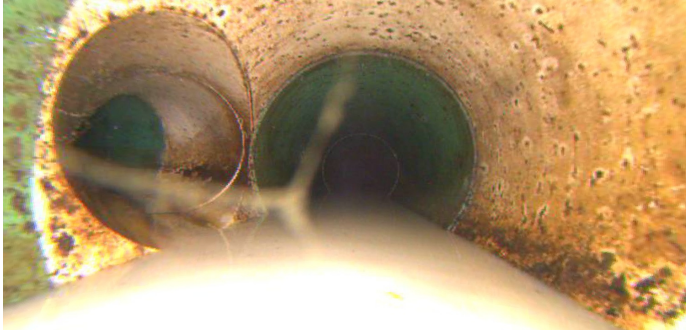
Code: **TF**  
Description: **Tap Factory**

Distance (ft): **59.1**  
Structural Grade: **0**  
O&M Grade: **0**  
Clock Start/From: **9**  
Clock To:  
1st Value: **4.000**  
2nd Value:  
Value Percent:  
Continuous Index:  
Within 8" of Joint:  
Remarks:

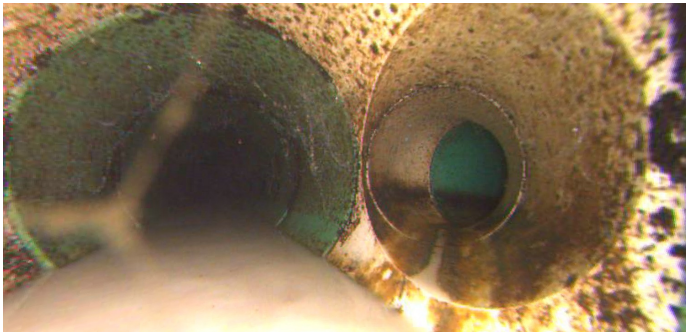
Code: **TF**  
Description: **Tap Factory**

Distance (ft): **86.8**  
Structural Grade: **0**  
O&M Grade: **0**  
Clock Start/From: **3**  
Clock To:  
1st Value: **4.000**  
2nd Value:  
Value Percent:  
Continuous Index:  
Within 8" of Joint:  
Remarks:

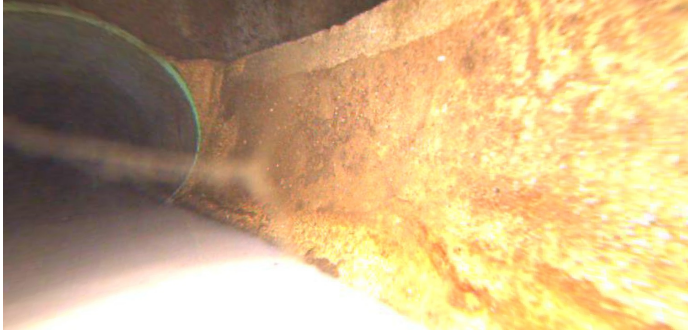
Code:	<b>AMH</b>
Description:	<b>Manhole</b>
Distance (ft):	<b>120.1</b>
Structural Grade:	<b>0</b>
O&M Grade:	<b>0</b>
Clock Start/From:	
Clock To:	
1st Value:	
2nd Value:	
Value Percent:	
Continuous Index:	
Within 8" of Joint:	<b>NO</b>
Remarks:	<b>M-1004-074</b>
