Profile/Photo Observation Report

Street:	Tulip Ln.	Flow Control:	Not Controlled
City:	Hobart, IN	Year Renewed:	
Location:	Other	Tape/Media #:	
Purpose:	Not Known	Dia/Height:	8"
Use:	Sanitary	Material:	PVC
Drain Area:	NA	Lining:	
Category:	NA		
Comment:

Location Details:		Direction of Survey:	Downstream
US MH:	M-1004-073	DS MH:	M-1004-074
		Total Length Surveyed (ft):	120.1

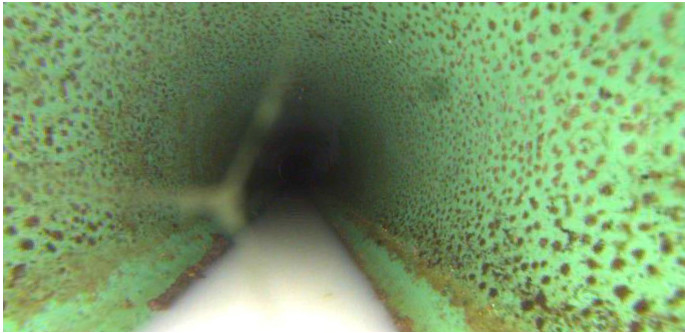
Code:	MWL
Description:	Water Level

Distance (ft):	.0
Structural Grade:	0
O&M Grade:	0
Clock Start/From:	
Clock To:	
1st Value:	
2nd Value:	
Value Percent:	5.000
Continuous Index:	
Within 8" of Joint:	NO
Remarks:

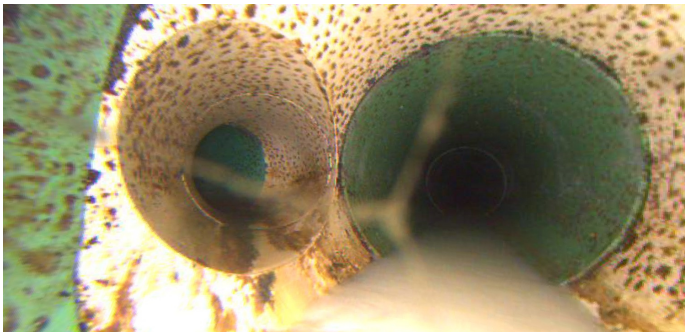
Code:	TF
Description:	Tap Factory

Distance (ft):	7.3
Structural Grade:	0
O&M Grade:	0
Clock Start/From:	9
Clock To:	
1st Value:	4.000
2nd Value:	
Value Percent:	
Continuous Index:	
Within 8" of Joint:	
Remarks:

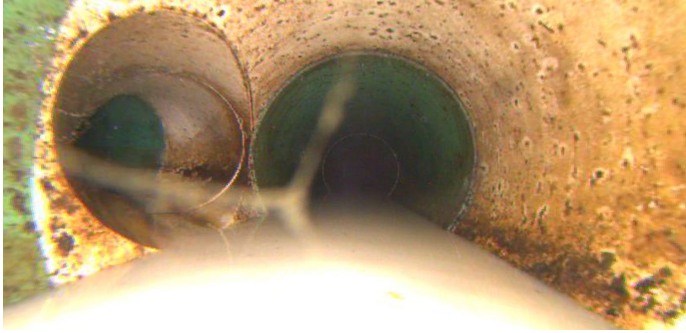
Code: **TF**
Description: **Tap Factory**

Distance (ft): **59.1**
Structural Grade: **0**
O&M Grade: **0**
Clock Start/From: **9**
Clock To:
1st Value: **4.000**
2nd Value:
Value Percent:
Continuous Index:
Within 8" of Joint:
Remarks:

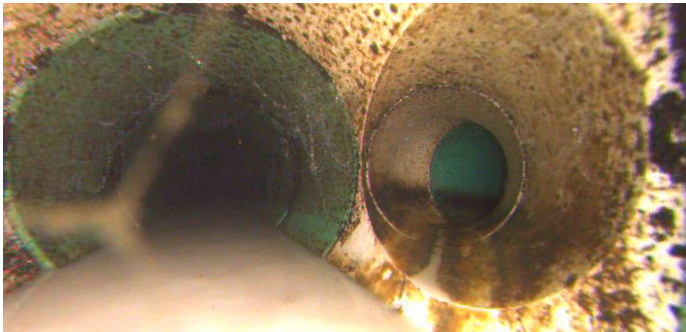
Code: **TF**
Description: **Tap Factory**

Distance (ft): **86.8**
Structural Grade: **0**
O&M Grade: **0**
Clock Start/From: **3**
Clock To:
1st Value: **4.000**
2nd Value:
Value Percent:
Continuous Index:
Within 8" of Joint:
Remarks:

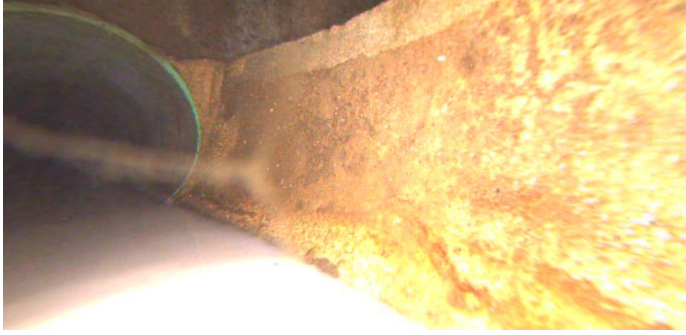
Code:	AMH
Description:	Manhole
Distance (ft):	120.1
Structural Grade:	0
O&M Grade:	0
Clock Start/From:	
Clock To:	
1st Value:	
2nd Value:	
Value Percent:	
Continuous Index:	
Within 8" of Joint:	NO
Remarks:	M-1004-074
