Profile/Photo Observation Report

Street:	TULIP LN	Flow Control:	Not Controlled
City:	Hobart, IN	Year Renewed:	
Location:	Other	Tape/Media #:	
Purpose:	Not Known	Dia/Height:	8"
Use:	Sanitary	Material:	PVC
Drain Area:	NA	Lining:	
Category:	NA		
Comment:

Location Details:		Direction of Survey:	Downstream
US MH:	M-1004-073	DS MH:	M-1004-074
		Total Length Surveyed (ft):	120.7

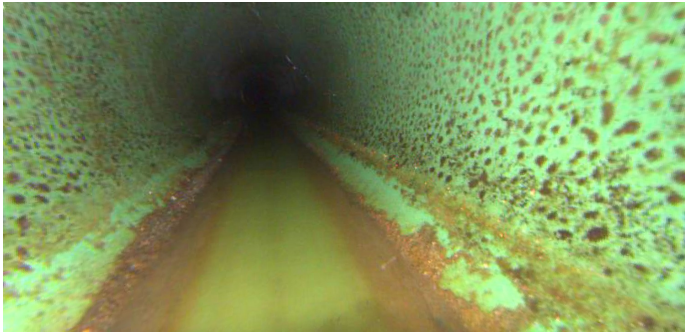
Code:	MWL
Description:	Water Level

Distance (ft):	.0
Structural Grade:	0
O&M Grade:	0
Clock Start/From:	
Clock To:	
1st Value:	
2nd Value:	
Value Percent:	5.000
Continuous Index:	
Within 8" of Joint:	NO
Remarks:

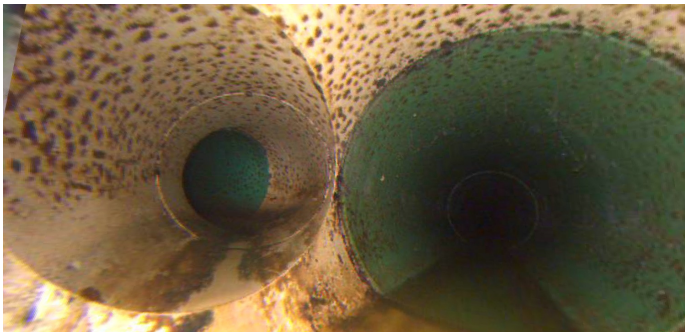
Code:	TFA
Description:	Tap Factory Active

Distance (ft):	7.6
Structural Grade:	0
O&M Grade:	0
Clock Start/From:	9
Clock To:	
1st Value:	4.000
2nd Value:	
Value Percent:	
Continuous Index:	
Within 8" of Joint:	
Remarks:

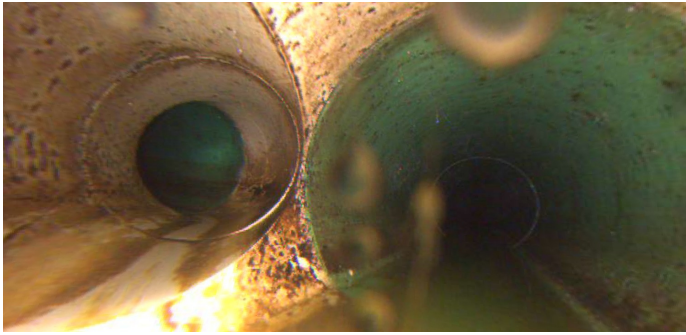
Code: **TFA**
Description: **Tap Factory Active**

Distance (ft): **59.6**
Structural Grade: **0**
O&M Grade: **0**
Clock Start/From: **9**
Clock To:
1st Value: **4.000**
2nd Value:
Value Percent:
Continuous Index:
Within 8" of Joint:
Remarks:

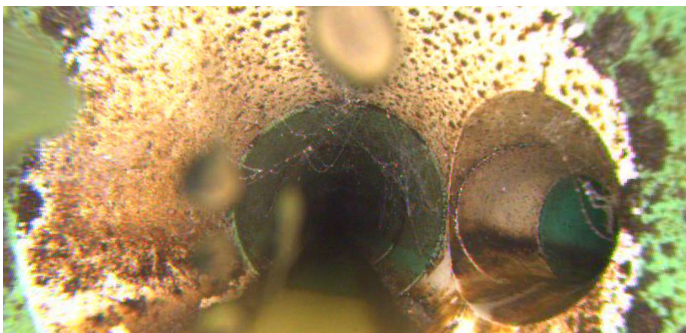
Code: **TF**
Description: **Tap Factory**

Distance (ft): **86.6**
Structural Grade: **0**
O&M Grade: **0**
Clock Start/From: **3**
Clock To:
1st Value: **4.000**
2nd Value:
Value Percent:
Continuous Index:
Within 8" of Joint:
Remarks:

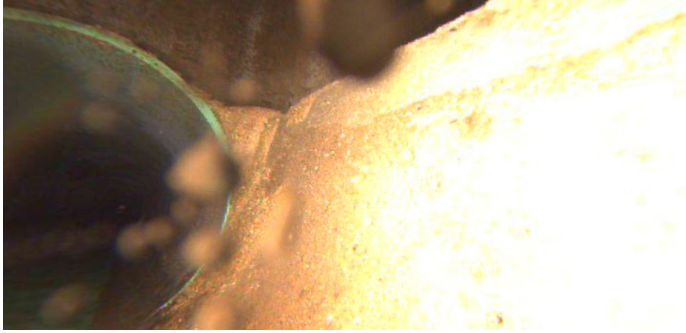
Code:	AMH
Description:	Manhole
Distance (ft):	120.7
Structural Grade:	0
O&M Grade:	0
Clock Start/From:	
Clock To:	
1st Value:	
2nd Value:	
Value Percent:	
Continuous Index:	
Within 8" of Joint:	NO
Remarks:	M-1004-074
