Profile/Photo Observation Report

Street:	Tulip Ln.	Flow Control:	Not Controlled
City:	Hobart, IN	Year Renewed:	
Location:	Other	Tape/Media #:	
Purpose:	Not Known	Dia/Height:	8"
Use:	Sanitary	Material:	PVC
Drain Area:	NA	Lining:	
Category:	NA		
Comment:

Location Details:		Direction of Survey:	Downstream
US MH:	M-1004-073	DS MH:	M-1004-074
		Total Length Surveyed (ft):	120.7

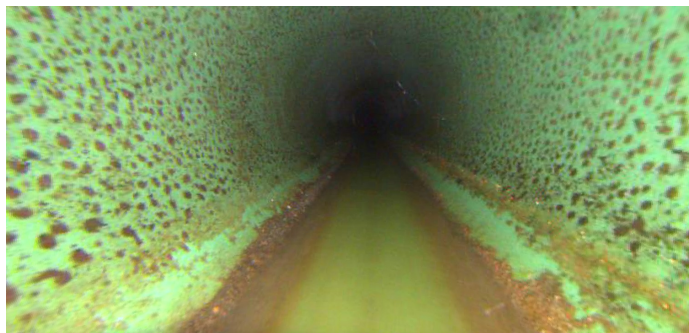
Code: **AMH**
 Description: **Manhole**

Distance (ft): **.0**
 Structural Grade: **0**
 O&M Grade: **0**
 Clock Start/From:
 Clock To:
 1st Value:
 2nd Value:
 Value Percent:
 Continuous Index:
 Within 8" of Joint: **NO**
 Remarks: **M-1004-073**

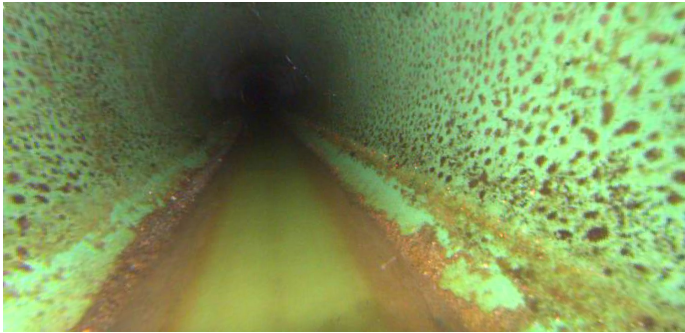
Code:	MWL
Description:	Water Level

Distance (ft):	.0
Structural Grade:	0
O&M Grade:	0
Clock Start/From:	
Clock To:	
1st Value:	
2nd Value:	
Value Percent:	5.000
Continuous Index:	
Within 8" of Joint:	NO
Remarks:

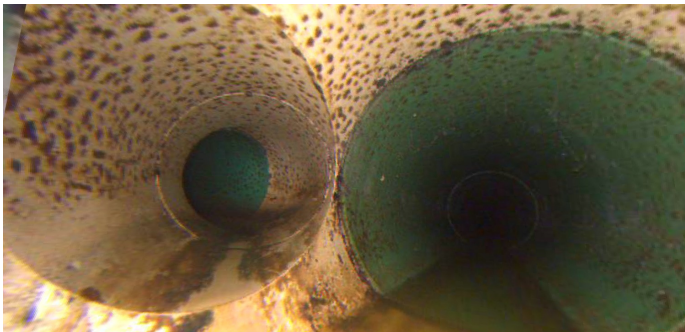
Code:	TFA
Description:	Tap Factory Active

Distance (ft):	7.6
Structural Grade:	0
O&M Grade:	0
Clock Start/From:	9
Clock To:	
1st Value:	4.000
2nd Value:	
Value Percent:	
Continuous Index:	
Within 8" of Joint:	
Remarks:

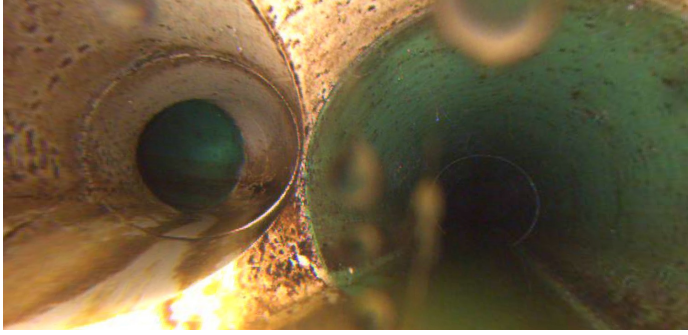
Code: **TFA**
Description: **Tap Factory Active**

Distance (ft): **59.6**
Structural Grade: **0**
O&M Grade: **0**
Clock Start/From: **9**
Clock To:
1st Value: **4.000**
2nd Value:
Value Percent:
Continuous Index:
Within 8" of Joint:
Remarks:

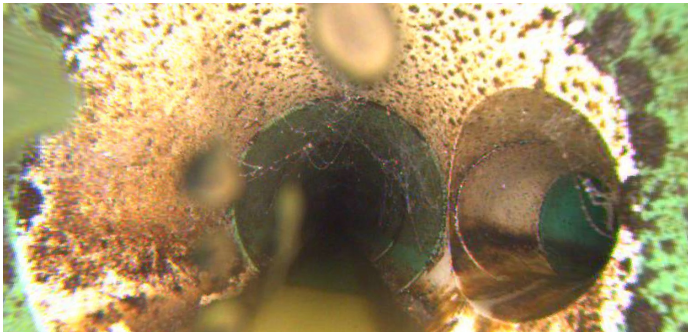
Code: **TF**
Description: **Tap Factory**

Distance (ft): **86.6**
Structural Grade: **0**
O&M Grade: **0**
Clock Start/From: **3**
Clock To:
1st Value: **4.000**
2nd Value:
Value Percent:
Continuous Index:
Within 8" of Joint:
Remarks:

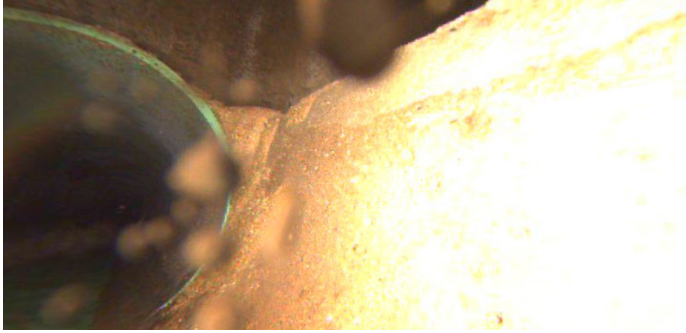
Code:	AMH
Description:	Manhole
Distance (ft):	120.7
Structural Grade:	0
O&M Grade:	0
Clock Start/From:	
Clock To:	
1st Value:	
2nd Value:	
Value Percent:	
Continuous Index:	
Within 8" of Joint:	NO
Remarks:	M-1004-074
