Profile/Photo Observation Report

Street:	TULIP LN	Flow Control:	Not Controlled
City:	Hobart, IN	Year Renewed:	
Location:	Other	Tape/Media #:	
Purpose:	Not Known	Dia/Height:	8"
Use:	Sanitary	Material:	PVC
Drain Area:	NA	Lining:	
Category:	NA		
Comment:

Location Details:		Direction of Survey:	Upstream
US MH:	M-1004-074	DS MH:	M-1004-075
		Total Length Surveyed (ft):	72.7

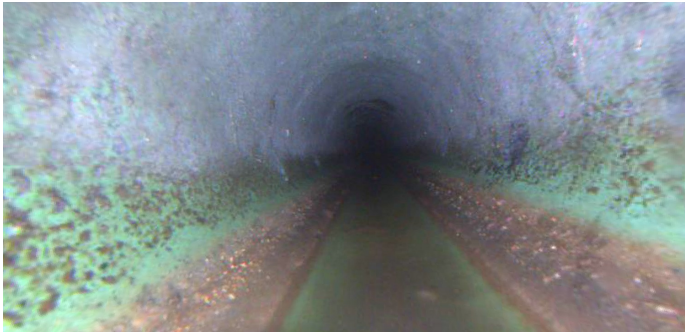
Code:	MWL
Description:	Water Level

Distance (ft):	.0
Structural Grade:	0
O&M Grade:	0
Clock Start/From:	
Clock To:	
1st Value:	
2nd Value:	
Value Percent:	5.000
Continuous Index:	
Within 8" of Joint:	NO
Remarks:

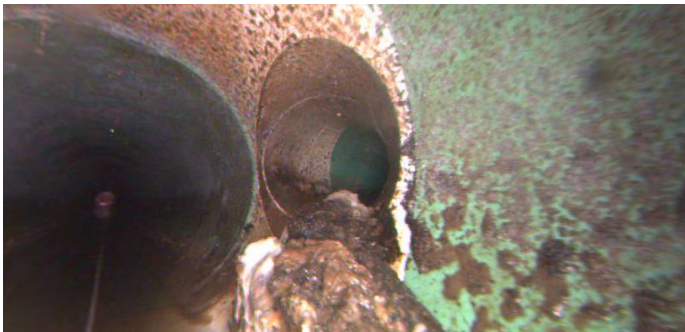
Code:	TFD
Description:	Tap Factory Defective

Distance (ft):	25.0
Structural Grade:	0
O&M Grade:	2
Clock Start/From:	9
Clock To:	
1st Value:	4.000
2nd Value:	
Value Percent:	
Continuous Index:	
Within 8" of Joint:	
Remarks:	DAGS

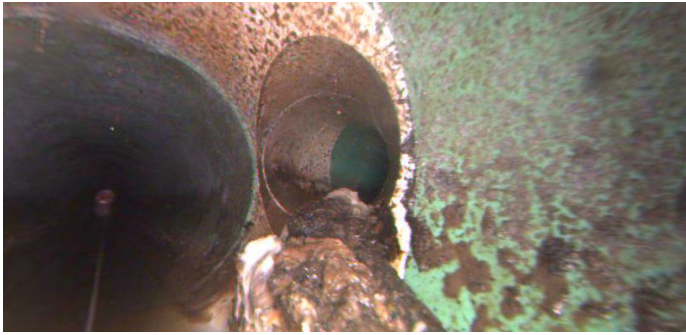
Code: **DAGS**
Description: **Deposits Attached Grease**

Distance (ft): **25.0**
Structural Grade: **0**
O&M Grade: **2**
Clock Start/From: **8**
Clock To: **9**
1st Value:
2nd Value:
Value Percent: **10.000**
Continuous Index:
Within 8" of Joint: **NO**
Remarks:

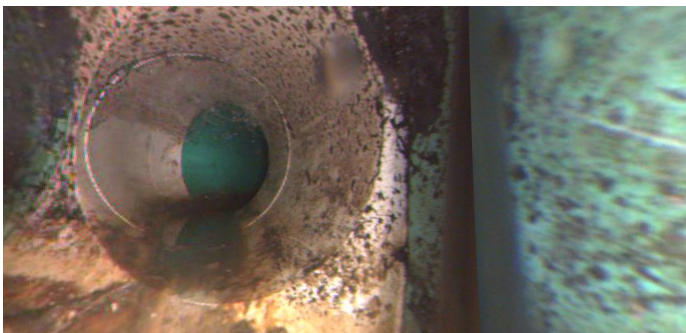
Code: **TFA**
Description: **Tap Factory Active**

Distance (ft): **67.5**
Structural Grade: **0**
O&M Grade: **0**
Clock Start/From: **9**
Clock To:
1st Value: **4.000**
2nd Value:
Value Percent:
Continuous Index:
Within 8" of Joint:
Remarks:

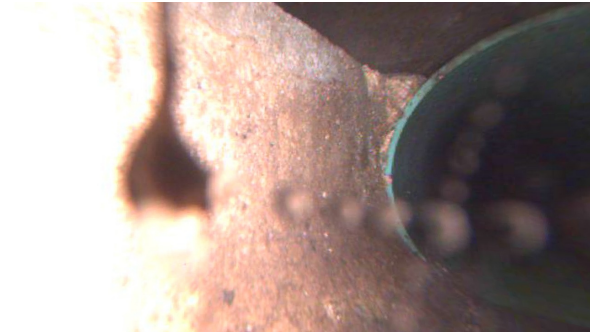
Code:	AMH
Description:	Manhole
Distance (ft):	72.7
Structural Grade:	0
O&M Grade:	0
Clock Start/From:	
Clock To:	
1st Value:	
2nd Value:	
Value Percent:	
Continuous Index:	
Within 8" of Joint:	NO
Remarks:	M-1004-074
