Profile/Photo Observation Report

Street:	Tulip Ln.	Flow Control:	Not Controlled
City:	Hobart, IN	Year Renewed:	
Location:	Other	Tape/Media #:	
Purpose:	Not Known	Dia/Height:	8"
Use:	Sanitary	Material:	PVC
Drain Area:	NA	Lining:	
Category:	NA		
Comment:

Location Details:		Direction of Survey:	Upstream
US MH:	M-1004-074	DS MH:	M-1004-075
		Total Length Surveyed (ft):	72.7

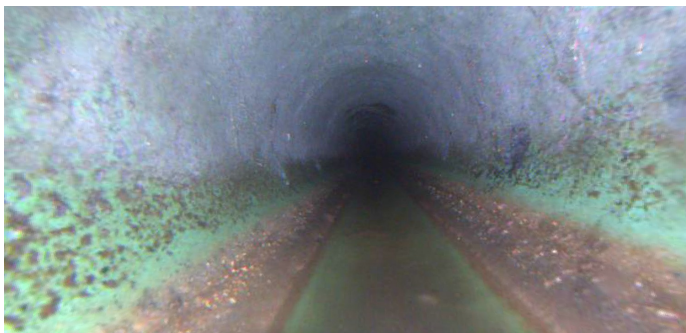
Code: **AMH**
Description: **Manhole**

Distance (ft): **.0**
Structural Grade: **0**
O&M Grade: **0**
Clock Start/From:
Clock To:
1st Value:
2nd Value:
Value Percent:
Continuous Index:
Within 8" of Joint: **NO**
Remarks: **M-1004-075**

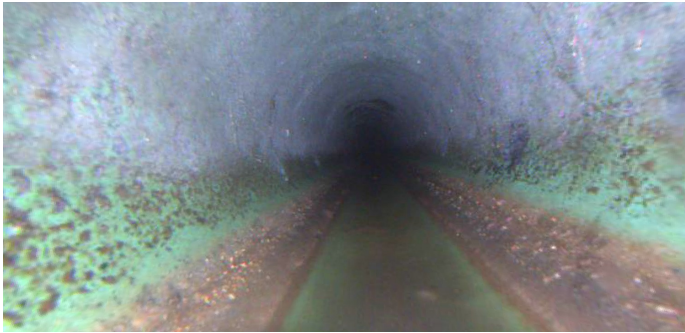
Code:	MWL
Description:	Water Level

Distance (ft):	.0
Structural Grade:	0
O&M Grade:	0
Clock Start/From:	
Clock To:	
1st Value:	
2nd Value:	
Value Percent:	5.000
Continuous Index:	
Within 8" of Joint:	NO
Remarks:

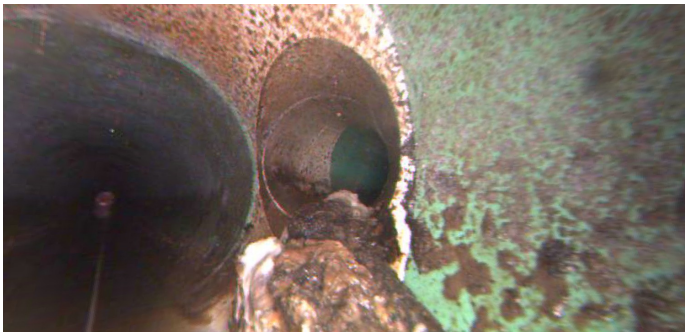
Code:	TFD
Description:	Tap Factory Defective

Distance (ft):	25.0
Structural Grade:	0
O&M Grade:	2
Clock Start/From:	9
Clock To:	
1st Value:	4.000
2nd Value:	
Value Percent:	
Continuous Index:	
Within 8" of Joint:	
Remarks:	DAGS

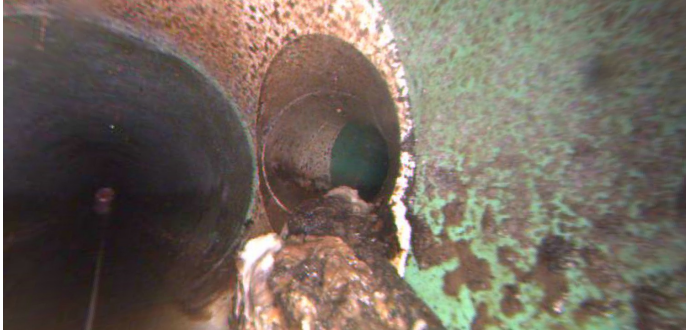
Code: **DAGS**
Description: **Deposits Attached Grease**

Distance (ft): **25.0**
Structural Grade: **0**
O&M Grade: **2**
Clock Start/From: **8**
Clock To: **9**
1st Value:
2nd Value:
Value Percent: **10.000**
Continuous Index:
Within 8" of Joint: **NO**
Remarks:

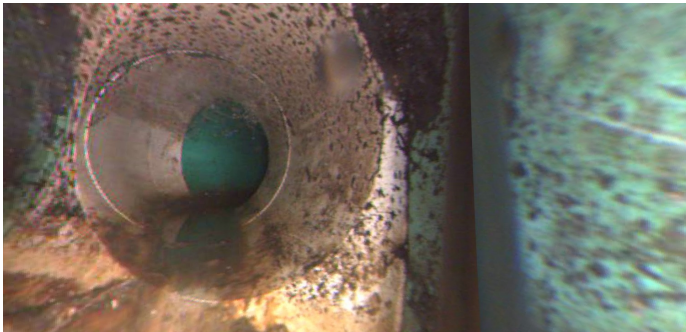
Code: **TFA**
Description: **Tap Factory Active**

Distance (ft): **67.5**
Structural Grade: **0**
O&M Grade: **0**
Clock Start/From: **9**
Clock To:
1st Value: **4.000**
2nd Value:
Value Percent:
Continuous Index:
Within 8" of Joint:
Remarks:

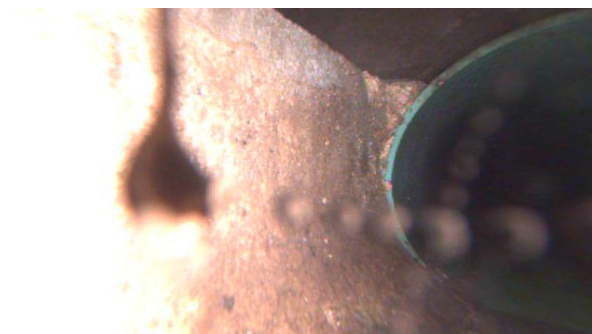
Code:	AMH
Description:	Manhole
Distance (ft):	72.7
Structural Grade:	0
O&M Grade:	0
Clock Start/From:	
Clock To:	
1st Value:	
2nd Value:	
Value Percent:	
Continuous Index:	
Within 8" of Joint:	NO
Remarks:	M-1004-074
