## Profile/Photo Observation Report

Street:	<b>TULIP LN</b>	Flow Control:	<b>Not Controlled</b>
City:	<b>Hobart, IN</b>	Year Renewed:	
Location:	<b>Other</b>	Tape/Media #:	
Purpose:	<b>Not Known</b>	Dia/Height:	<b>8"</b>
Use:	<b>Sanitary</b>	Material:	<b>PVC</b>
Drain Area:	<b>NA</b>	Lining:	
Category:	<b>NA</b>		
Comment:	<b>NULL - MH-M-704-063 Debris at entrance</b>

Location Details:		Direction of Survey:	<b>Downstream</b>
US MH:	<b>M-1004-075</b>	DS MH:	<b>M-1004-076</b>
		Total Length Surveyed (ft):	<b>154.5</b>

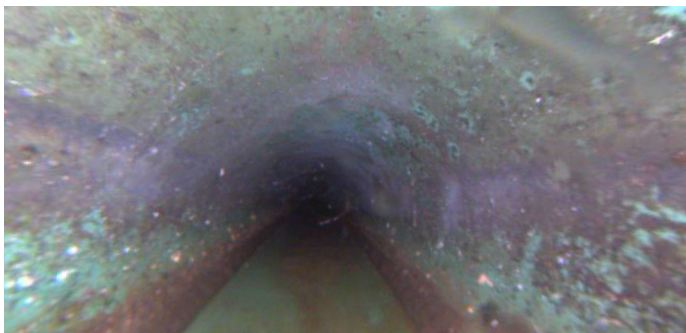
Code: **AMH**  
Description: **Manhole**

Distance (ft): **.0**  
Structural Grade: **0**  
O&M Grade: **0**  
Clock Start/From:  
Clock To:  
1st Value:  
2nd Value:  
Value Percent:  
Continuous Index:  
Within 8" of Joint: **NO**  
Remarks: **M-1004-075**

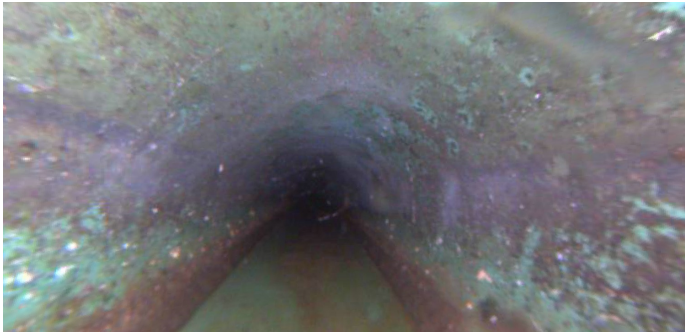
Code:	<b>MWL</b>
Description:	<b>Water Level</b>

Distance (ft):	<b>.0</b>
Structural Grade:	<b>0</b>
O&M Grade:	<b>0</b>
Clock Start/From:	
Clock To:	
1st Value:	
2nd Value:	
Value Percent:	<b>10.000</b>
Continuous Index:	
Within 8" of Joint:	<b>NO</b>
Remarks:

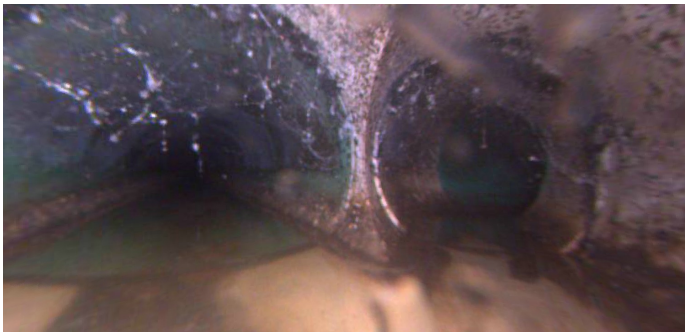
Code:	<b>TFA</b>
Description:	<b>Tap Factory Active</b>

Distance (ft):	<b>3.3</b>
Structural Grade:	<b>0</b>
O&M Grade:	<b>0</b>
Clock Start/From:	<b>3</b>
Clock To:	
1st Value:	<b>4.000</b>
2nd Value:	
Value Percent:	
Continuous Index:	
Within 8" of Joint:	
Remarks:

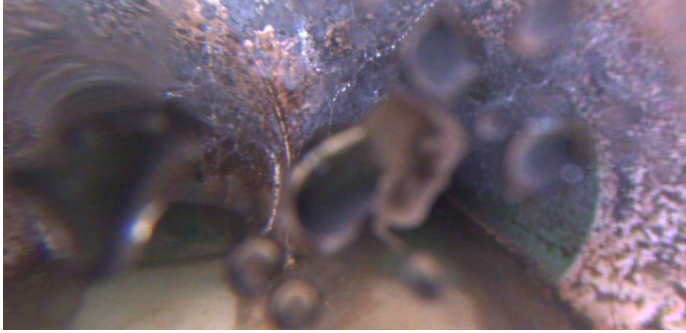
Code: **TFA**  
Description: **Tap Factory Active**

Distance (ft): **16.4**  
Structural Grade: **0**  
O&M Grade: **0**  
Clock Start/From: **9**  
Clock To:  
1st Value: **4.000**  
2nd Value:  
Value Percent:  
Continuous Index:  
Within 8" of Joint:  
Remarks:

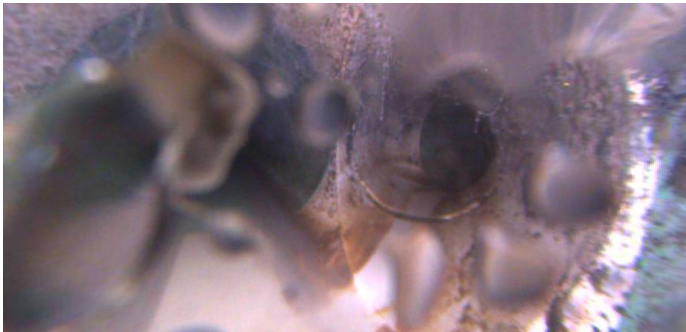
Code: **TFA**  
Description: **Tap Factory Active**

Distance (ft): **49.6**  
Structural Grade: **0**  
O&M Grade: **0**  
Clock Start/From: **3**  
Clock To:  
1st Value: **4.000**  
2nd Value:  
Value Percent:  
Continuous Index:  
Within 8" of Joint:  
Remarks:

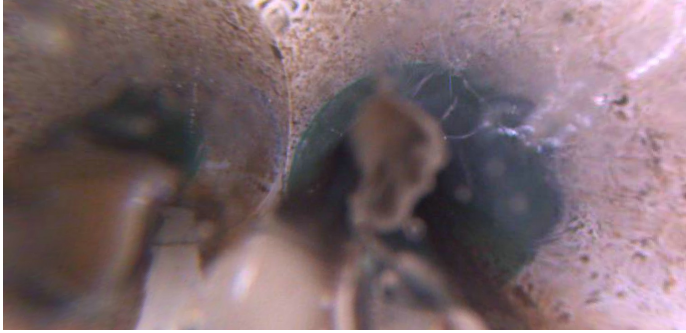
Code: **TFA**  
Description: **Tap Factory Active**

Distance (ft): **112.8**  
Structural Grade: **0**  
O&M Grade: **0**  
Clock Start/From: **9**  
Clock To:  
1st Value: **4.000**  
2nd Value:  
Value Percent:  
Continuous Index:  
Within 8" of Joint:  
Remarks:

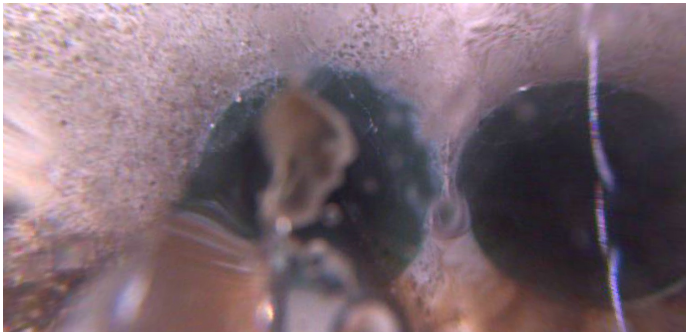
Code: **TF**  
Description: **Tap Factory**

Distance (ft): **126.0**  
Structural Grade: **0**  
O&M Grade: **0**  
Clock Start/From: **3**  
Clock To:  
1st Value: **4.000**  
2nd Value:  
Value Percent:  
Continuous Index:  
Within 8" of Joint:  
Remarks:

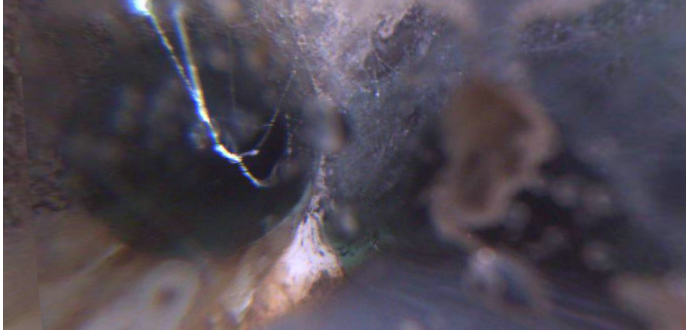
Code: **TF**  
Description: **Tap Factory**

Distance (ft): **139.5**  
Structural Grade: **0**  
O&M Grade: **0**  
Clock Start/From: **9**  
Clock To:  
1st Value: **4.000**  
2nd Value:  
Value Percent:  
Continuous Index:  
Within 8" of Joint:  
Remarks:

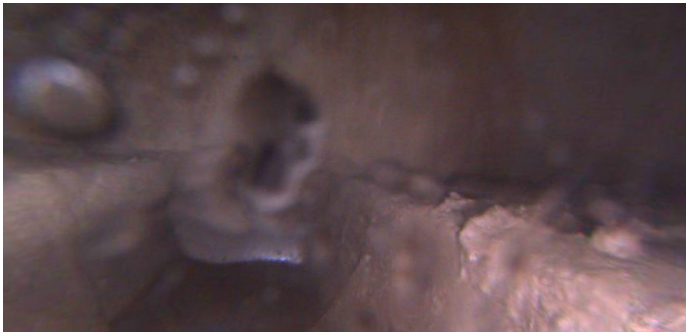
Code: **AMH**  
Description: **Manhole**

Distance (ft): **154.5**  
Structural Grade: **0**  
O&M Grade: **0**  
Clock Start/From:  
Clock To:  
1st Value:  
2nd Value:  
Value Percent:  
Continuous Index:  
Within 8" of Joint: **NO**  
Remarks: **M-1004-076**
