Profile/Photo Observation Report

Date:	01/08/2023	Weather:		Coding:	PACP 7.0
Pipe Length (ft):	372.0	Owner:	City of Hobart	Pre Clean:	Heavy Cleaning
P.O.#:	YES502259	Surveyor:	S. Bucklin	PSR:	P-1004-079-078
Customer:	City of Hobart	Clean Date:	10/29/2022	Shape:	C

Street:	Tulip Lane	Flow Control:	Not Controlled
City:	Hobart, IN	Year Renewed:	
Location:	Easement/Right of Way	Tape/Media #:	
Purpose:	Routine Assessment	Dia/Height:	10"
Use:	Sanitary Sewage Pipe	Material:	PVC
Drain Area:		Lining:	None
Category:	NA		
Comment:			
Location Details:		Direction of Survey:	Upstream
US MH:	M-1004-078	DS MH:	M-1004-079
		Total Length Surveyed (ft):	371.2

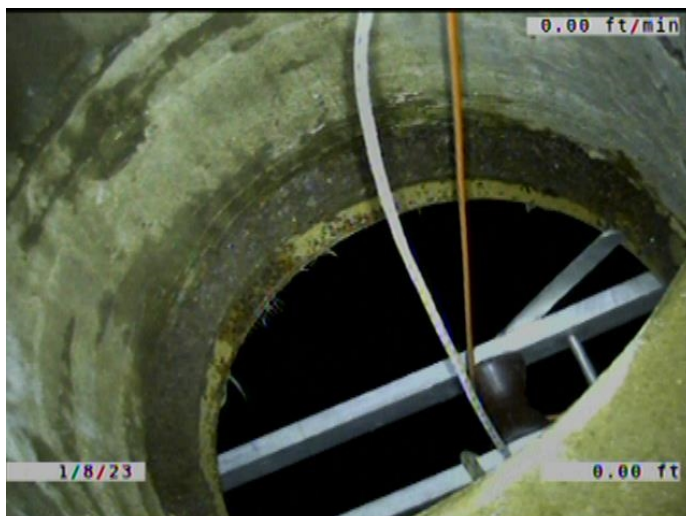
Code: **AMH**
Description: **Manhole**

Distance (ft): **.0**
Structural Grade: **0**
O&M Grade: **0**
Clock Start/From:
Clock To:
1st Value:
2nd Value:
Value Percent:
Continuous Index:
Within 8" of Joint: **NO**
Remarks: **M-1004-079**

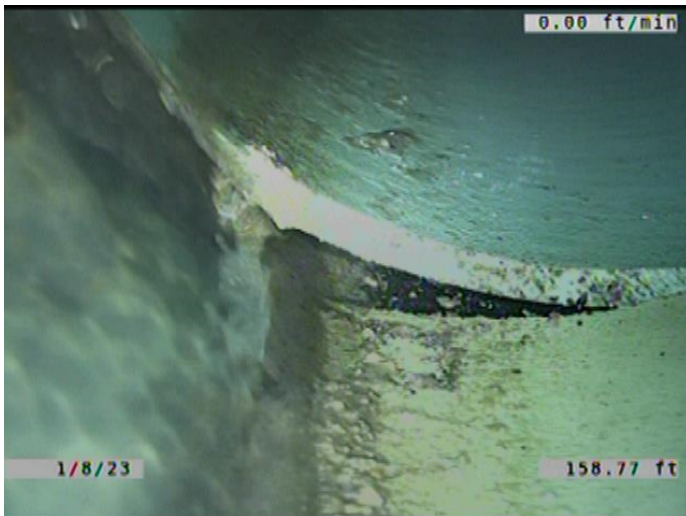
Code: **JOMD**
 Description: **Joint Offset Medium Defective**

Distance (ft): **158.8**
 Structural Grade: **3**
 O&M Grade: **0**
 Clock Start/From:
 Clock To:
 1st Value:
 2nd Value:
 Value Percent:
 Continuous Index:
 Within 8" of Joint: **NO**
 Remarks:
