Profile/Photo Observation Report

Street:	TULIP LN	Flow Control:	Not Controlled
City:	Hobart, IN	Year Renewed:	
Location:	Other	Tape/Media #:	
Purpose:	Not Known	Dia/Height:	8"
Use:	Sanitary	Material:	PVC
Drain Area:	NA	Lining:	
Category:	NA		
Comment:

Location Details:		Direction of Survey:	Downstream
US MH:	M-1004-080	DS MH:	M-1004-081
		Total Length Surveyed (ft):	45.5

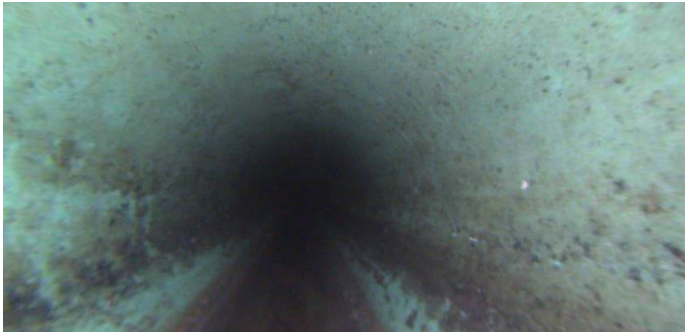
Code:	MWL
Description:	Water Level

Distance (ft):	.0
Structural Grade:	0
O&M Grade:	0
Clock Start/From:	
Clock To:	
1st Value:	
2nd Value:	
Value Percent:	5.000
Continuous Index:	
Within 8" of Joint:	NO
Remarks:

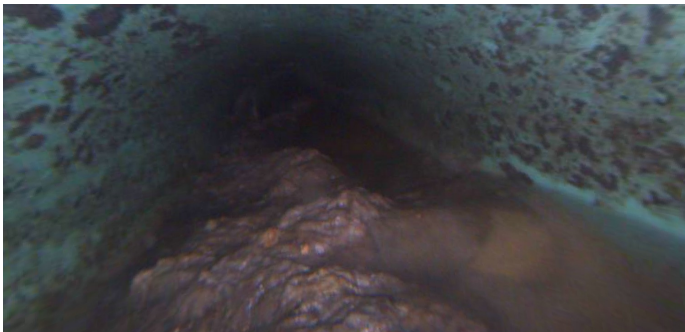
Code:	DSZ
Description:	Deposits Settled Other

Distance (ft):	44.8
Structural Grade:	0
O&M Grade:	3
Clock Start/From:	4
Clock To:	8
1st Value:	
2nd Value:	
Value Percent:	20.000
Continuous Index:	
Within 8" of Joint:	NO
Remarks:	misc

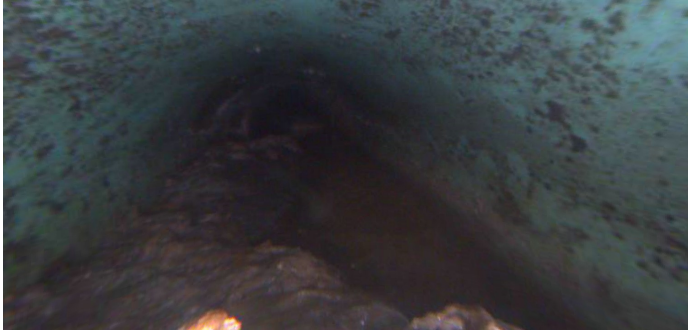
Code:	MSA
Description:	Abandoned Survey
Distance (ft):	45.5
Structural Grade:	0
O&M Grade:	0
Clock Start/From:	
Clock To:	
1st Value:	
2nd Value:	
Value Percent:	
Continuous Index:	
Within 8" of Joint:	NO
Remarks:	dsz
