Profile/Photo Observation Report

Street:	Tulip Ln.	Flow Control:	Not Controlled
City:	Hobart, IN	Year Renewed:	
Location:	Other	Tape/Media #:	
Purpose:	Not Known	Dia/Height:	8"
Use:	Sanitary	Material:	PVC
Drain Area:	NA	Lining:	
Category:	NA		
Comment:

Location Details:		Direction of Survey:	Downstream
US MH:	M-1004-080	DS MH:	M-1004-081
		Total Length Surveyed (ft):	45.5

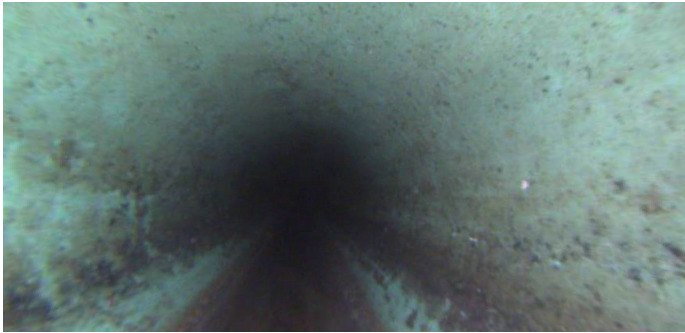
Code:	MWL
Description:	Water Level

Distance (ft):	.0
Structural Grade:	0
O&M Grade:	0
Clock Start/From:	
Clock To:	
1st Value:	
2nd Value:	
Value Percent:	5.000
Continuous Index:	
Within 8" of Joint:	NO
Remarks:

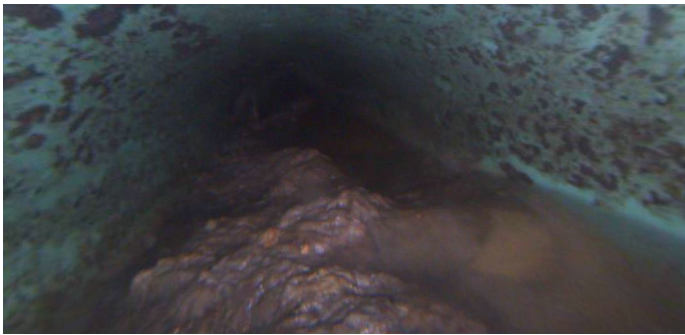
Code:	DSZ
Description:	Deposits Settled Other

Distance (ft):	44.8
Structural Grade:	0
O&M Grade:	3
Clock Start/From:	4
Clock To:	8
1st Value:	
2nd Value:	
Value Percent:	20.000
Continuous Index:	
Within 8" of Joint:	NO
Remarks:	misc

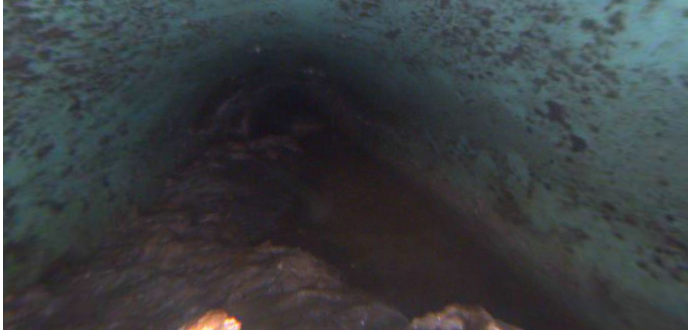
Code:	MSA
Description:	Abandoned Survey
Distance (ft):	45.5
Structural Grade:	0
O&M Grade:	0
Clock Start/From:	
Clock To:	
1st Value:	
2nd Value:	
Value Percent:	
Continuous Index:	
Within 8" of Joint:	NO
Remarks:	dsz
