## Profile/Photo Observation Report

Date:	<b>01/14/2023</b>	Weather:		Coding:	<b>PACP 7.0</b>
Pipe Length (ft):	<b>89.0</b>	Owner:	<b>City of Hobart</b>	Pre Clean:	<b>Heavy Cleaning</b>
P.O.#:	<b>YES502259</b>	Surveyor:	<b>S. Bucklin</b>	PSR:	<b>P-1004-081-080</b>
Customer:	<b>City of Hobart</b>	Clean Date:	<b>10/29/2022</b>	Shape:	<b>C</b>

Street:	<b>McAfee Drive</b>	Flow Control:	<b>Not Controlled</b>
City:	<b>Hobart, IN</b>	Year Renewed:	
Location:	<b>Easement/Right of Way</b>	Tape/Media #:	
Purpose:	<b>Routine Assessment</b>	Dia/Height:	<b>8"</b>
Use:	<b>Sanitary Sewage Pipe</b>	Material:	<b>PVC</b>
Drain Area:		Lining:	<b>None</b>
Category:	<b>NA</b>

US MH: **M-1004-080** DS MH: **M-1004-081** Total Length Surveyed (ft): **88.8**

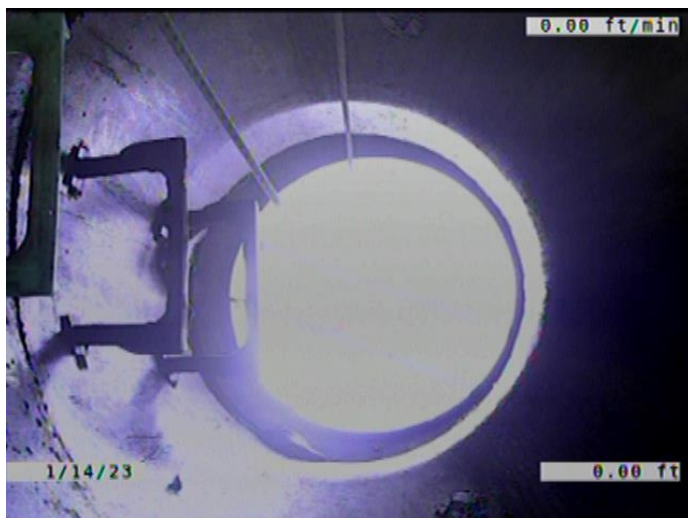
Code: **AMH**  
 Description: **Manhole**

Distance (ft): **.0**  
 Structural Grade: **0**  
 O&M Grade: **0**  
 Clock Start/From:  
 Clock To:  
 1st Value:  
 2nd Value:  
 Value Percent:  
 Continuous Index:  
 Within 8" of Joint: **NO**  
 Remarks: **M-1004-080**

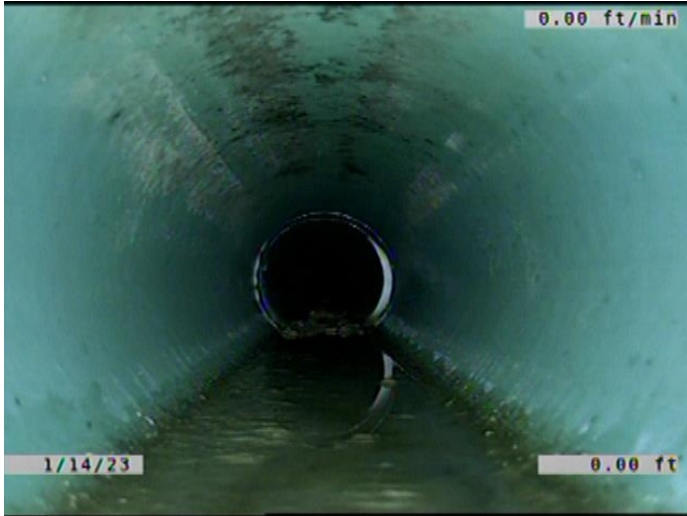
Code:	<b>MWL</b>
Description:	<b>Miscellaneous Water Level</b>
Distance (ft):	<b>.0</b>
Structural Grade:	<b>0</b>
O&M Grade:	<b>0</b>
Clock Start/From:	
Clock To:	
1st Value:	
2nd Value:	
Value Percent:	<b>5.000</b>
Continuous Index:	
Within 8" of Joint:	<b>NO</b>
Remarks:

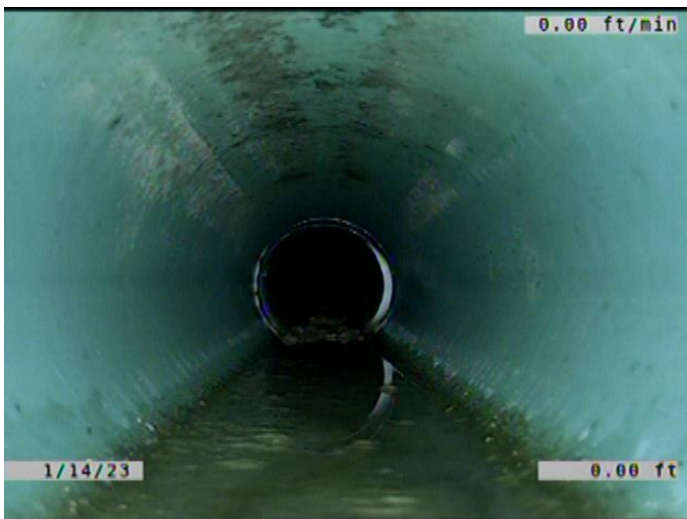
Code:	<b>DSF</b>
Description:	<b>Deposits Settled Fine</b>
Distance (ft):	<b>.0</b>
Structural Grade:	<b>0</b>
O&M Grade:	<b>2</b>
Clock Start/From:	<b>5</b>
Clock To:	<b>7</b>
1st Value:	
2nd Value:	
Value Percent:	<b>5.000</b>
Continuous Index:	<b>S01</b>
Within 8" of Joint:	<b>YES</b>
Remarks:

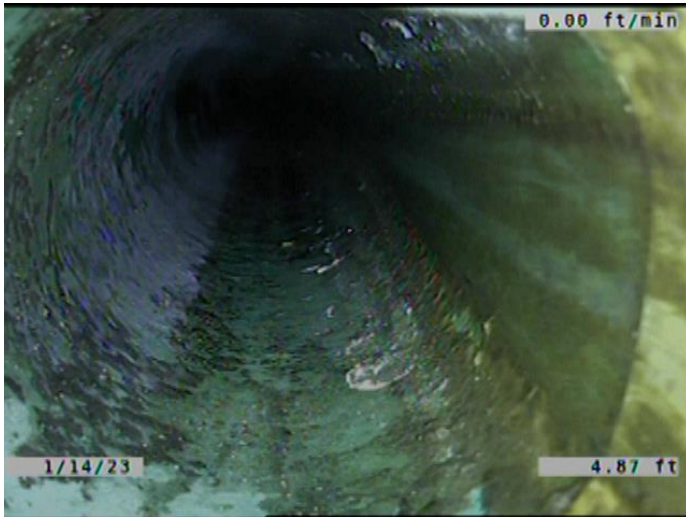
Code: **TF**  
Description: **Tap Factory**

Distance (ft): **4.9**  
Structural Grade: **0**  
O&M Grade: **0**  
Clock Start/From: **3**  
Clock To:  
1st Value: **6.000**  
2nd Value:  
Value Percent:  
Continuous Index:  
Within 8" of Joint: **YES**  
Remarks:

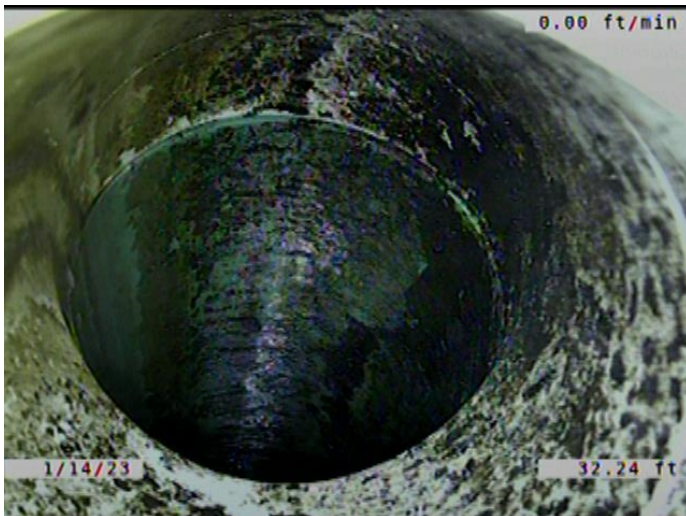
Code: **TF**  
Description: **Tap Factory**

Distance (ft): **32.2**  
Structural Grade: **0**  
O&M Grade: **0**  
Clock Start/From: **9**  
Clock To:  
1st Value: **6.000**  
2nd Value:  
Value Percent:  
Continuous Index:  
Within 8" of Joint: **YES**  
Remarks:

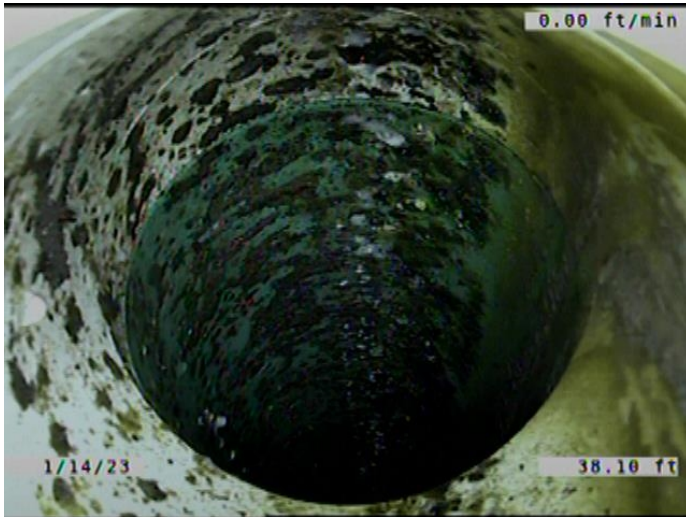
Code: **TF**  
 Description: **Tap Factory**

Distance (ft): **38.1**  
 Structural Grade: **0**  
 O&M Grade: **0**  
 Clock Start/From: **3**  
 Clock To:  
 1st Value: **6.000**  
 2nd Value:  
 Value Percent:  
 Continuous Index:  
 Within 8" of Joint: **YES**  
 Remarks:

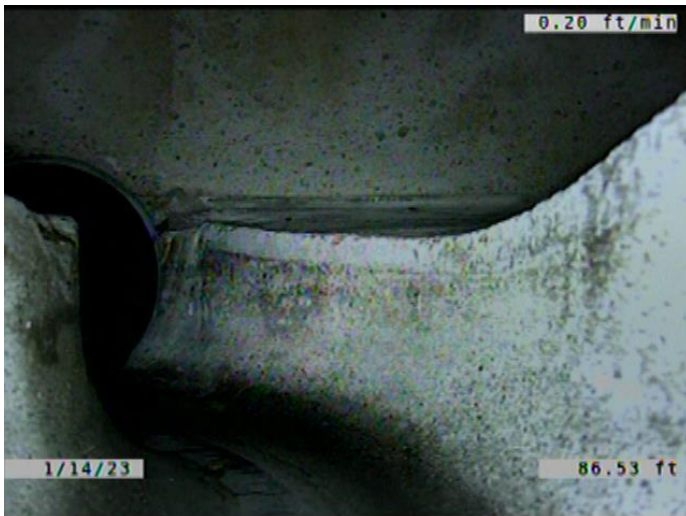
Code: **DSF**  
 Description: **Deposits Settled Fine**

Distance (ft): **86.5**  
 Structural Grade: **0**  
 O&M Grade: **2**  
 Clock Start/From: **5**  
 Clock To: **7**  
 1st Value:  
 2nd Value:  
 Value Percent: **5.000**  
 Continuous Index: **F01**  
 Within 8" of Joint: **YES**  
 Remarks:

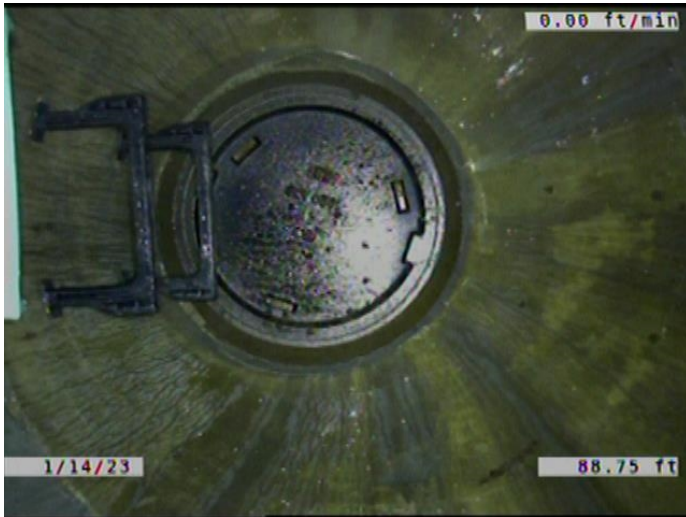
Code:	AMH
Description:	Manhole
Distance (ft):	88.7
Structural Grade:	0
O&M Grade:	0
Clock Start/From:	
Clock To:	
1st Value:	
2nd Value:	
Value Percent:	
Continuous Index:	
Within 8" of Joint:	NO
Remarks:	M-1004-081
