## Profile/Photo Observation Report

Date:	11/03/2022	Weather:		Coding:	PACP 7.0
Pipe Length (ft):	196.0	Owner:	City of Hobart	Pre Clean:	No Pre-Cleaning
P.O.#:	YES502259	Surveyor:	S. Bucklin	PSR:	P-1004-082-047
Customer:	City of Hobart, IN (Red	Clean Date:		Shape:	C

Street:	McAfee Drive	Flow Control:	Not Controlled
City:	Hobart, IN	Year Renewed:	
Location:	Easement/Right of Way	Tape/Media #:	
Purpose:	Routine Assessment	Dia/Height:	8"
Use:	Sanitary Sewage Pipe	Material:	PVC
Drain Area:		Lining:	None
Category:	NA		
Comment:			
Location Details:		Direction of Survey:	Upstream
US MH:	M-1004-082	DS MH:	M-1004-047
		Total Length Surveyed (ft):	185.4

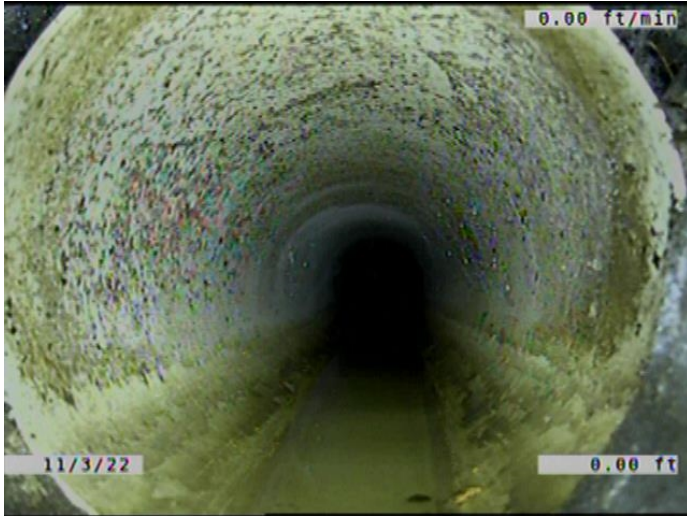
Code: **MWL**  
Description: **Miscellaneous Water Level**

Distance (ft): **.0**  
Structural Grade: **0**  
O&M Grade: **0**  
Clock Start/From:  
Clock To:  
1st Value:  
2nd Value:  
Value Percent: **5.000**  
Continuous Index:  
Within 8" of Joint: **NO**  
Remarks:

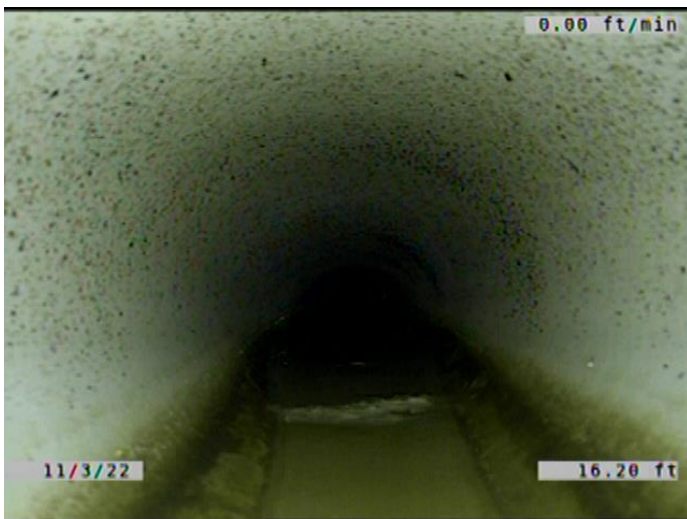
Code: **MWLS**  
Description: **Miscellaneous Water Level Sag**

Distance (ft): **16.2**  
Structural Grade: **4**  
O&M Grade: **0**  
Clock Start/From:  
Clock To:  
1st Value:  
2nd Value:  
Value Percent: **55.000**  
Continuous Index: **S01**  
Within 8" of Joint: **NO**  
Remarks:

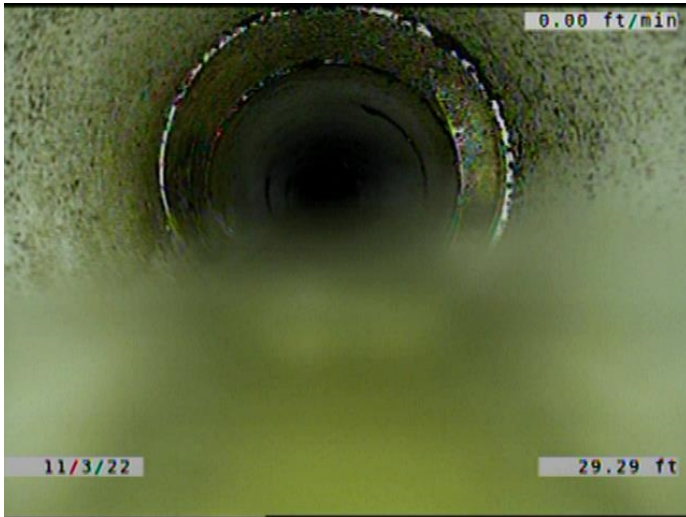
Code: **MWLS**  
Description: **Miscellaneous Water Level Sag**

Distance (ft): **29.3**  
Structural Grade: **4**  
O&M Grade: **0**  
Clock Start/From:  
Clock To:  
1st Value:  
2nd Value:  
Value Percent: **55.000**  
Continuous Index: **F01**  
Within 8" of Joint: **NO**  
Remarks:

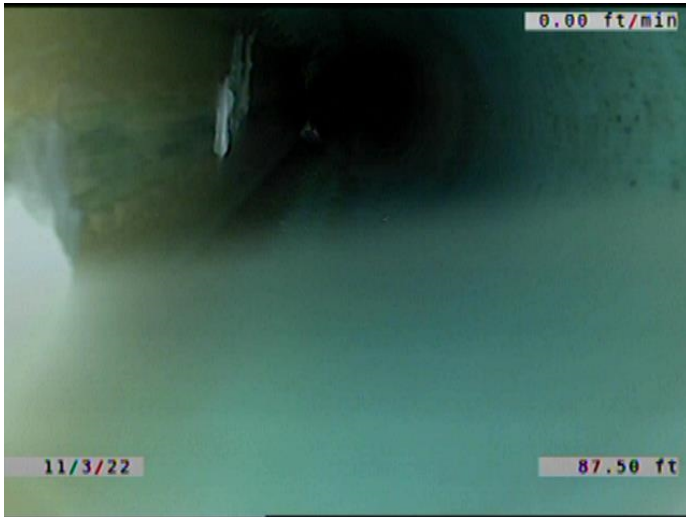
Code: **TF**  
 Description: **Tap Factory**

Distance (ft): **87.5**  
 Structural Grade: **0**  
 O&M Grade: **0**  
 Clock Start/From: **9**  
 Clock To:  
 1st Value: **4.000**  
 2nd Value:  
 Value Percent:  
 Continuous Index:  
 Within 8" of Joint: **YES**  
 Remarks:

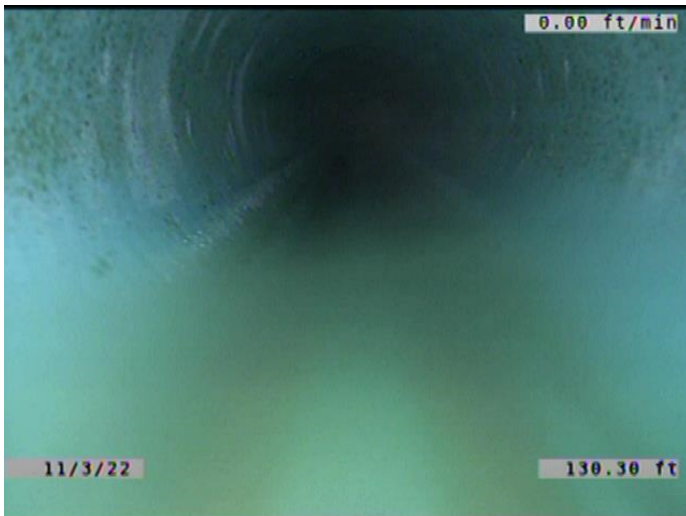
Code: **MWLS**  
 Description: **Miscellaneous Water Level Sag**

Distance (ft): **130.3**  
 Structural Grade: **2**  
 O&M Grade: **0**  
 Clock Start/From:  
 Clock To:  
 1st Value:  
 2nd Value:  
 Value Percent: **10.000**  
 Continuous Index: **F02**  
 Within 8" of Joint: **NO**  
 Remarks:

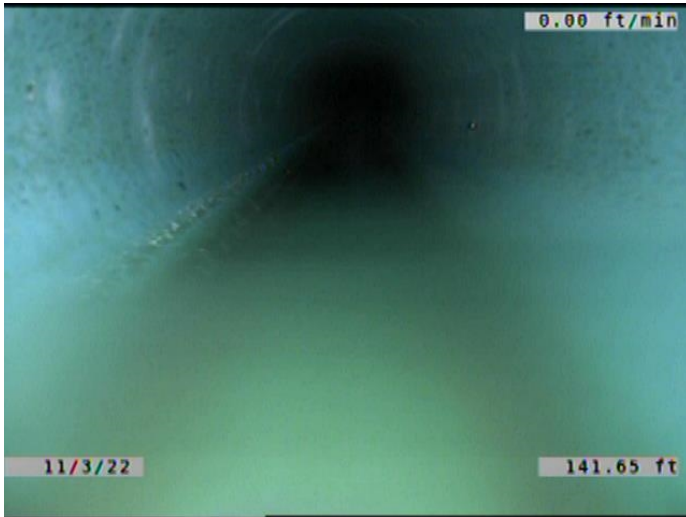
Code: **MWLS**  
Description: **Miscellaneous Water Level Sag**

Distance (ft): **141.6**  
Structural Grade: **2**  
O&M Grade: **0**  
Clock Start/From:  
Clock To:  
1st Value:  
2nd Value:  
Value Percent: **5.000**  
Continuous Index: **S03**  
Within 8" of Joint: **NO**  
Remarks:

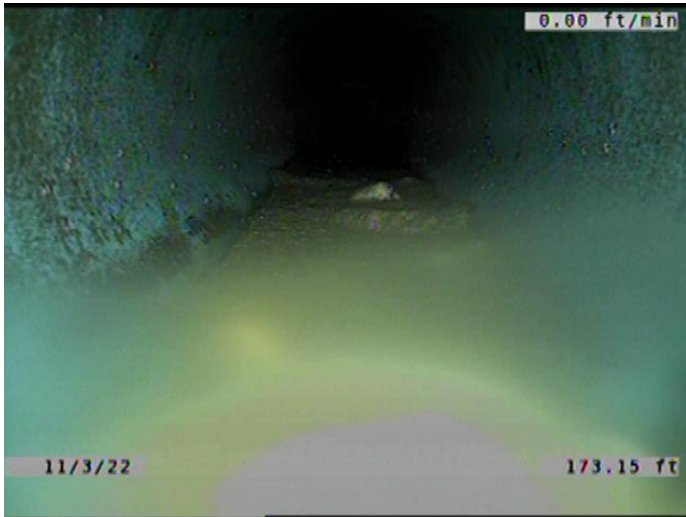
Code: **DSF**  
Description: **Deposits Settled Fine**

Distance (ft): **173.2**  
Structural Grade: **0**  
O&M Grade: **2**  
Clock Start/From: **5**  
Clock To: **7**  
1st Value:  
2nd Value:  
Value Percent: **10.000**  
Continuous Index: **S04**  
Within 8" of Joint: **YES**  
Remarks:

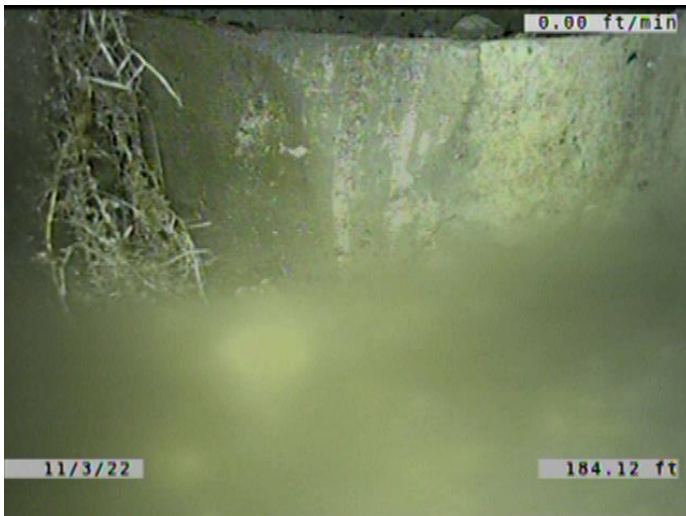
Code: **MWLS**  
Description: **Miscellaneous Water Level Sag**

Distance (ft): **184.1**  
Structural Grade: **2**  
O&M Grade: **0**  
Clock Start/From:  
Clock To:  
1st Value:  
2nd Value:  
Value Percent: **5.000**  
Continuous Index: **F03**  
Within 8" of Joint: **NO**  
Remarks:

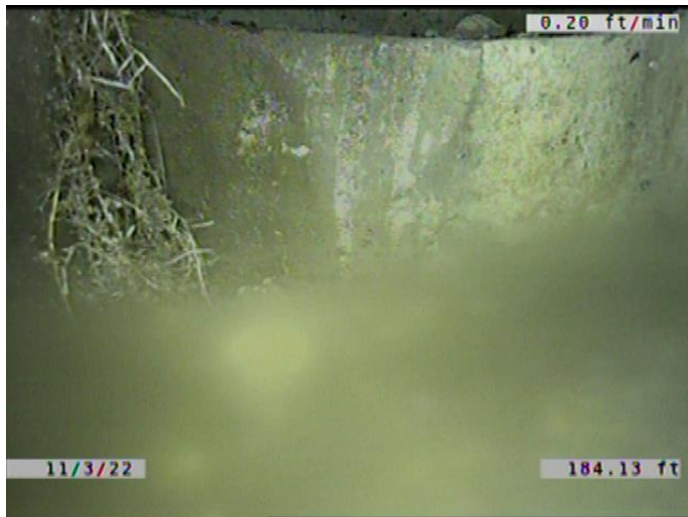
Code:	<b>DSF</b>
Description:	<b>Deposits Settled Fine</b>
Distance (ft):	<b>184.1</b>
Structural Grade:	<b>0</b>
O&M Grade:	<b>2</b>
Clock Start/From:	<b>5</b>
Clock To:	<b>7</b>
1st Value:	
2nd Value:	
Value Percent:	<b>10.000</b>
Continuous Index:	<b>F04</b>
Within 8" of Joint:	<b>YES</b>
Remarks:

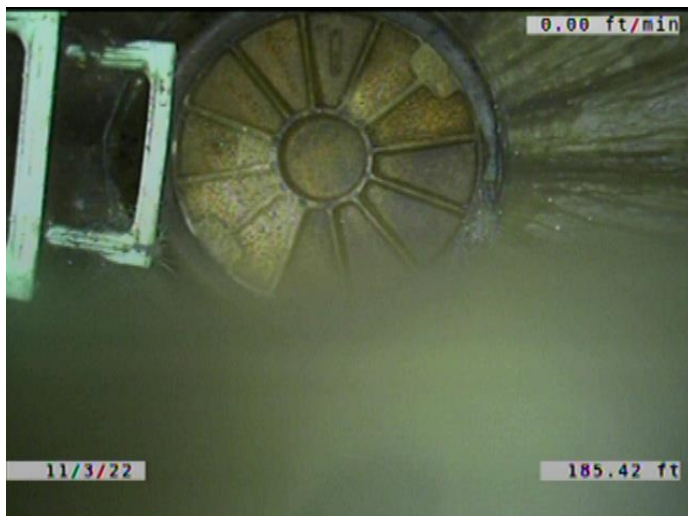
Code:	<b>AMH</b>
Description:	<b>Manhole</b>
Distance (ft):	<b>185.4</b>
Structural Grade:	<b>0</b>
O&M Grade:	<b>0</b>
Clock Start/From:	
Clock To:	
1st Value:	
2nd Value:	
Value Percent:	
Continuous Index:	
Within 8" of Joint:	<b>NO</b>
Remarks:	<b>M-1004-082</b>
