Profile/Photo Observation Report

Street:	CYPRESS LN	Flow Control:	Not Controlled
City:	Hobart, IN	Year Renewed:	
Location:	Other	Tape/Media #:	
Purpose:	Not Known	Dia/Height:	8"
Use:	Sanitary	Material:	PVC
Drain Area:	NA	Lining:	
Category:	NA		
Comment:

Location Details:		Direction of Survey:	Upstream
US MH:	M-1004-084	DS MH:	M-1004-083
		Total Length Surveyed (ft):	253.5

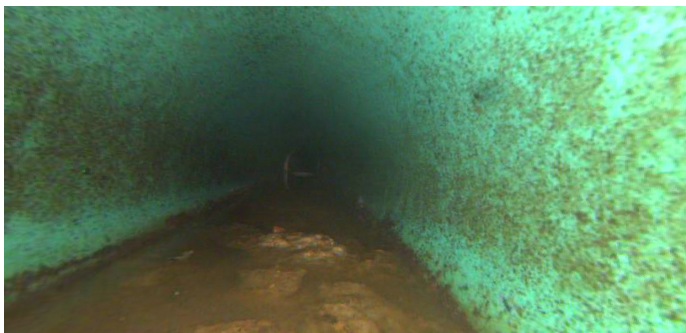
Code: **AMH**
Description: **Manhole**

Distance (ft): **.0**
Structural Grade: **0**
O&M Grade: **0**
Clock Start/From:
Clock To:
1st Value:
2nd Value:
Value Percent:
Continuous Index:
Within 8" of Joint: **NO**
Remarks: **M-1004-083**

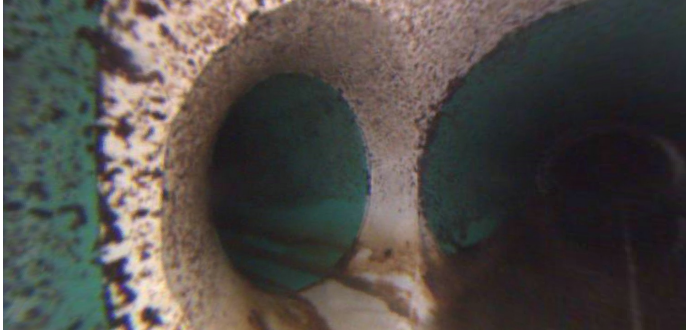
Code: **TFA**
Description: **Tap Factory Active**

Distance (ft): **8.8**
Structural Grade: **0**
O&M Grade: **0**
Clock Start/From: **3**
Clock To:
1st Value: **4.000**
2nd Value:
Value Percent:
Continuous Index:
Within 8" of Joint:
Remarks:

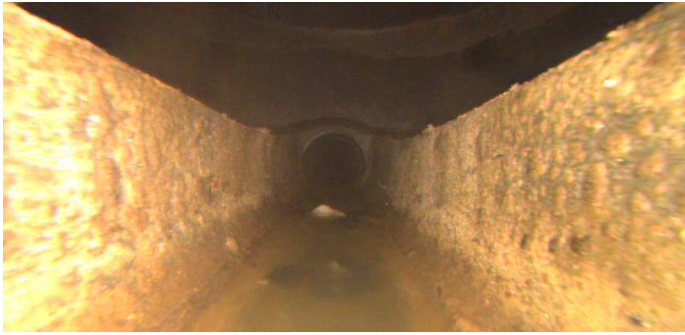
Code: **DAGS**
Description: **Deposits Attached Grease**

Distance (ft): **251.8**
Structural Grade: **0**
O&M Grade: **2**
Clock Start/From: **4**
Clock To: **8**
1st Value:
2nd Value:
Value Percent: **5.000**
Continuous Index: **F01**
Within 8" of Joint: **NO**
Remarks:

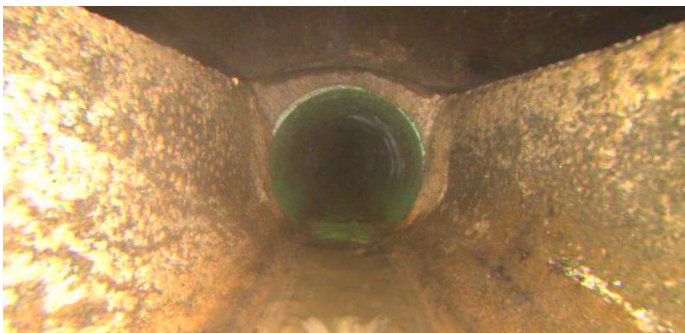
Code: **AMH**
Description: **Manhole**

Distance (ft): **253.5**
Structural Grade: **0**
O&M Grade: **0**
Clock Start/From:
Clock To:
1st Value:
2nd Value:
Value Percent:
Continuous Index:
Within 8" of Joint: **NO**
Remarks: **M-1004-084**
