Profile/Photo Observation Report

Date:	04/12/2018	Weather:		Coding:	PACP 6.0
Pipe Length (ft):	255.9	Owner:	NA	Pre Clean:	Not Known
P.O.#:		Surveyor:	Jen Costello	PSR:	P-1004-083-084
Customer:		Clean Date:	01/01/1900	Shape:	C

Street:	Cypress Ln.	Flow Control:	Not Controlled
City:	Hobart, IN	Year Renewed:	
Location:	Other	Tape/Media #:	
Purpose:	Not Known	Dia/Height:	8"
Use:	Sanitary	Material:	PVC
Drain Area:	NA	Lining:	
Category:	NA		
Comment:

Location Details:		Direction of Survey:	Upstream
US MH:	M-1004-084	DS MH:	M-1004-083
		Total Length Surveyed (ft):	253.5

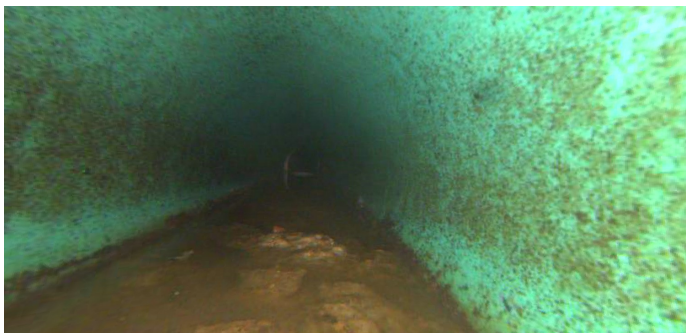
Code: **AMH**
Description: **Manhole**

Distance (ft): **.0**
Structural Grade: **0**
O&M Grade: **0**
Clock Start/From:
Clock To:
1st Value:
2nd Value:
Value Percent:
Continuous Index:
Within 8" of Joint: **NO**
Remarks: **M-1004-083**

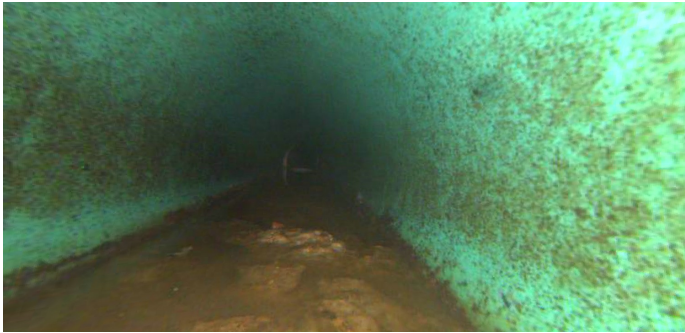
Code:	MWL
Description:	Water Level

Distance (ft):	.0
Structural Grade:	0
O&M Grade:	0
Clock Start/From:	
Clock To:	
1st Value:	
2nd Value:	
Value Percent:	10.000
Continuous Index:	
Within 8" of Joint:	NO
Remarks:

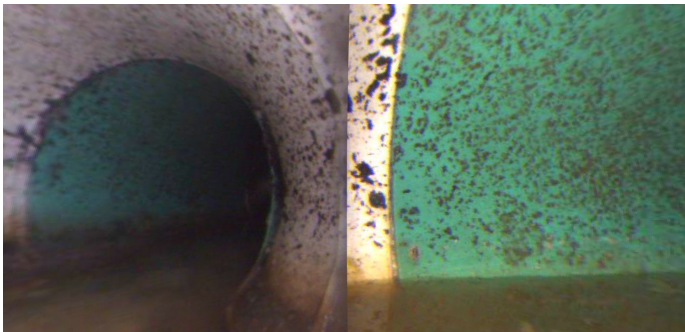
Code:	TFA
Description:	Tap Factory Active

Distance (ft):	6.3
Structural Grade:	0
O&M Grade:	0
Clock Start/From:	9
Clock To:	
1st Value:	4.000
2nd Value:	
Value Percent:	
Continuous Index:	
Within 8" of Joint:	
Remarks:

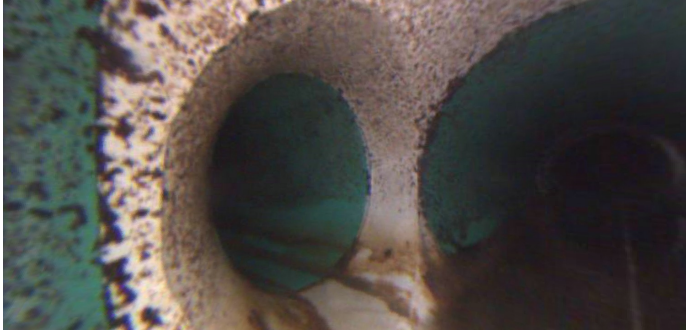
Code: **TFA**
Description: **Tap Factory Active**

Distance (ft): **8.8**
Structural Grade: **0**
O&M Grade: **0**
Clock Start/From: **3**
Clock To:
1st Value: **4.000**
2nd Value:
Value Percent:
Continuous Index:
Within 8" of Joint:
Remarks:

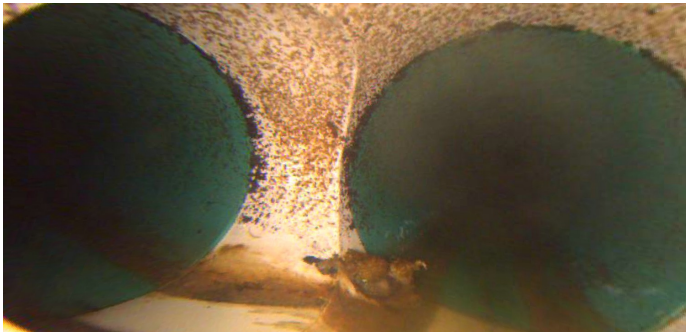
Code: **TFA**
Description: **Tap Factory Active**

Distance (ft): **40.4**
Structural Grade: **0**
O&M Grade: **0**
Clock Start/From: **9**
Clock To:
1st Value: **4.000**
2nd Value:
Value Percent:
Continuous Index:
Within 8" of Joint:
Remarks:

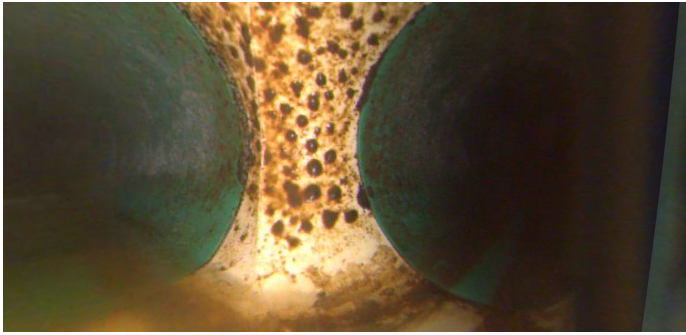
Code: **TF**
Description: **Tap Factory**

Distance (ft): **53.3**
Structural Grade: **0**
O&M Grade: **0**
Clock Start/From: **9**
Clock To:
1st Value: **4.000**
2nd Value:
Value Percent:
Continuous Index:
Within 8" of Joint:
Remarks:

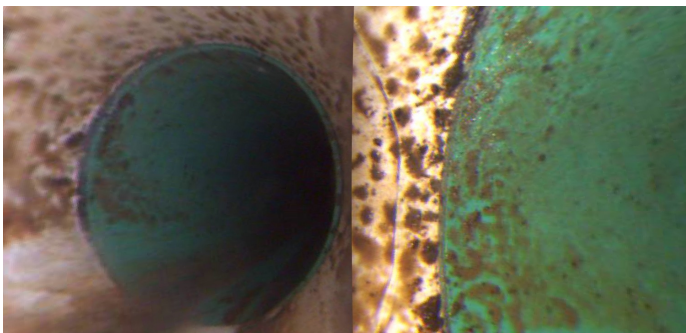
Code: **TFA**
Description: **Tap Factory Active**

Distance (ft): **110.8**
Structural Grade: **0**
O&M Grade: **0**
Clock Start/From: **9**
Clock To:
1st Value: **4.000**
2nd Value:
Value Percent:
Continuous Index:
Within 8" of Joint:
Remarks:

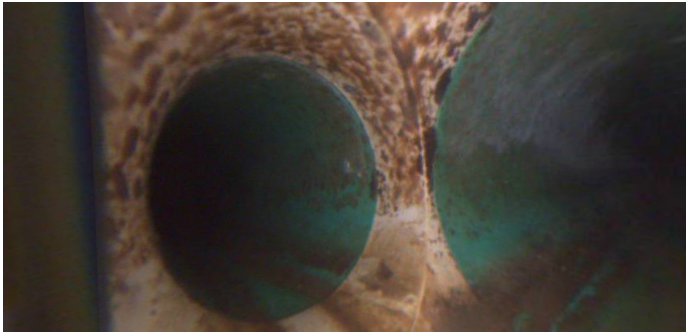
Code: **TF**
Description: **Tap Factory**

Distance (ft): **122.0**
Structural Grade: **0**
O&M Grade: **0**
Clock Start/From: **3**
Clock To:
1st Value: **4.000**
2nd Value:
Value Percent:
Continuous Index:
Within 8" of Joint:
Remarks:

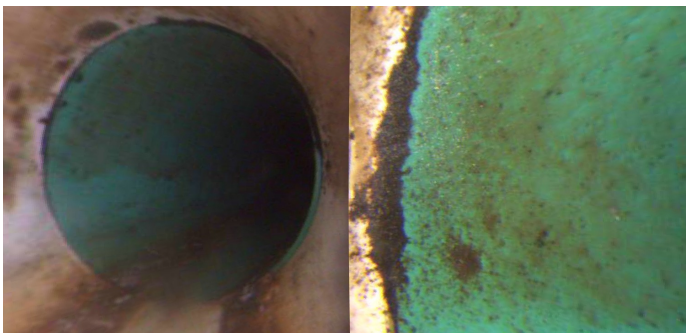
Code: **TF**
Description: **Tap Factory**

Distance (ft): **190.3**
Structural Grade: **0**
O&M Grade: **0**
Clock Start/From: **9**
Clock To:
1st Value: **4.000**
2nd Value:
Value Percent:
Continuous Index:
Within 8" of Joint:
Remarks:

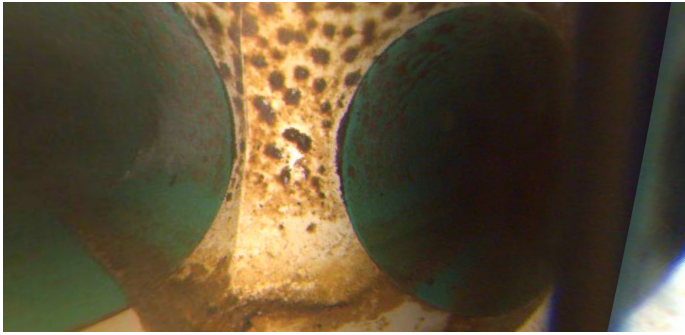
Code: **TF**
Description: **Tap Factory**

Distance (ft): **194.6**
Structural Grade: **0**
O&M Grade: **0**
Clock Start/From: **3**
Clock To:
1st Value: **4.000**
2nd Value:
Value Percent:
Continuous Index:
Within 8" of Joint:
Remarks:

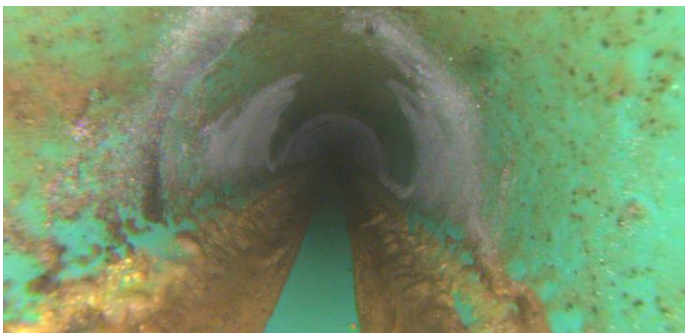
Code: **DAGS**
Description: **Deposits Attached Grease**

Distance (ft): **228.8**
Structural Grade: **0**
O&M Grade: **2**
Clock Start/From: **4**
Clock To: **8**
1st Value:
2nd Value:
Value Percent: **5.000**
Continuous Index: **S01**
Within 8" of Joint: **NO**
Remarks:

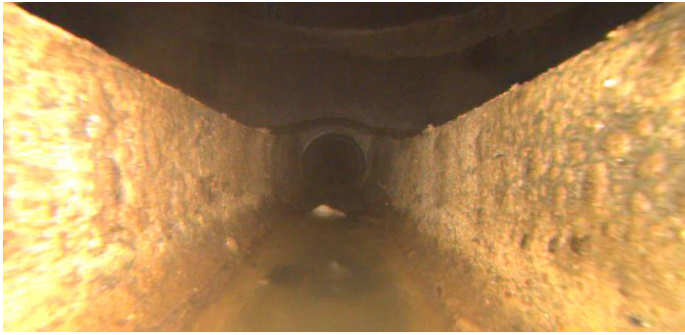
Code: **DAGS**
Description: **Deposits Attached Grease**

Distance (ft): **251.8**
Structural Grade: **0**
O&M Grade: **2**
Clock Start/From: **4**
Clock To: **8**
1st Value:
2nd Value:
Value Percent: **5.000**
Continuous Index: **F01**
Within 8" of Joint: **NO**
Remarks:

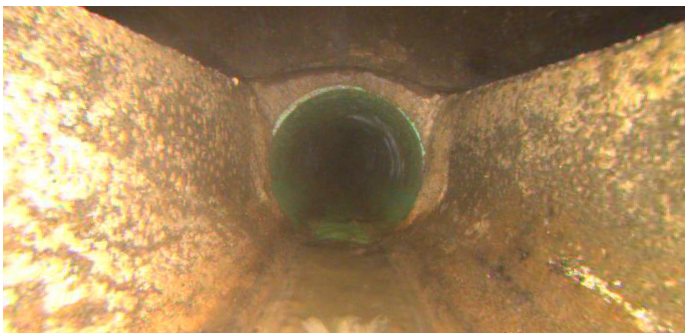
Code: **AMH**
Description: **Manhole**

Distance (ft): **253.5**
Structural Grade: **0**
O&M Grade: **0**
Clock Start/From:
Clock To:
1st Value:
2nd Value:
Value Percent:
Continuous Index:
Within 8" of Joint: **NO**
Remarks: **M-1004-084**
