Profile/Photo Observation Report

Date:	01/14/2023	Weather:		Coding:	PACP 7.0
Pipe Length (ft):	131.0	Owner:	City of Hobart	Pre Clean:	Heavy Cleaning
P.O.#:	YES502259	Surveyor:	S. Bucklin	PSR:	P-1004-084-085
Customer:	City of Hobart	Clean Date:	10/29/2022	Shape:	C

Street:	Cypress Lane	Flow Control:	Not Controlled
City:	Hobart, IN	Year Renewed:	
Location:	Easement/Right of Way	Tape/Media #:	
Purpose:	Routine Assessment	Dia/Height:	8"
Use:	Sanitary Sewage Pipe	Material:	PVC
Drain Area:		Lining:	None
Category:	NA

US MH:	M-1004-084	DS MH:	M-1004-085	Total Length Surveyed (ft):	135.8
--------	-------------------	--------	-------------------	-----------------------------	--------------

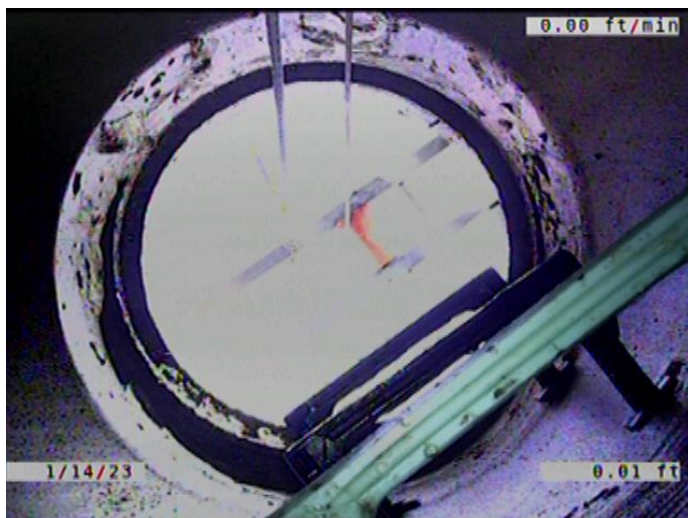
Code: **AMH**
Description: **Manhole**

Distance (ft): **.0**
Structural Grade: **0**
O&M Grade: **0**
Clock Start/From:
Clock To:
1st Value:
2nd Value:
Value Percent:
Continuous Index:
Within 8" of Joint: **NO**
Remarks: **M-1004-085**

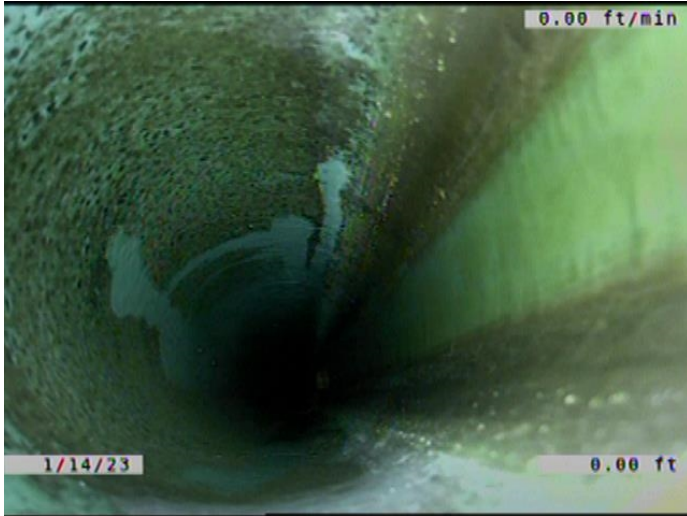
Code:	MWL
Description:	Miscellaneous Water Level
Distance (ft):	.0
Structural Grade:	0
O&M Grade:	0
Clock Start/From:	
Clock To:	
1st Value:	
2nd Value:	
Value Percent:	5.000
Continuous Index:	
Within 8" of Joint:	NO
Remarks:

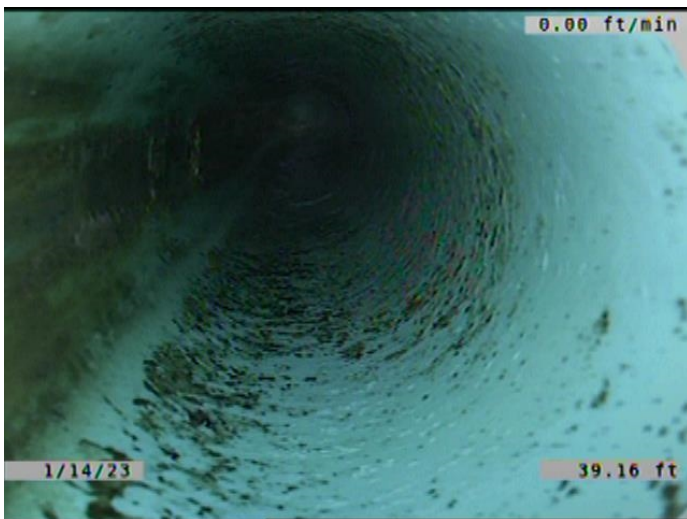
Code:	TF
Description:	Tap Factory
Distance (ft):	39.2
Structural Grade:	0
O&M Grade:	0
Clock Start/From:	9
Clock To:	
1st Value:	6.000
2nd Value:	
Value Percent:	
Continuous Index:	
Within 8" of Joint:	YES
Remarks:

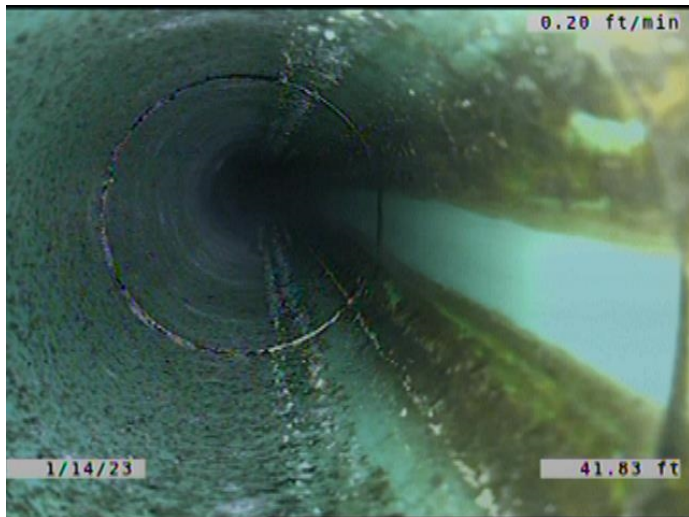
Code: **TF**
 Description: **Tap Factory**

Distance (ft): **41.8**
 Structural Grade: **0**
 O&M Grade: **0**
 Clock Start/From: **3**
 Clock To:
 1st Value: **6.000**
 2nd Value:
 Value Percent:
 Continuous Index:
 Within 8" of Joint: **YES**
 Remarks:

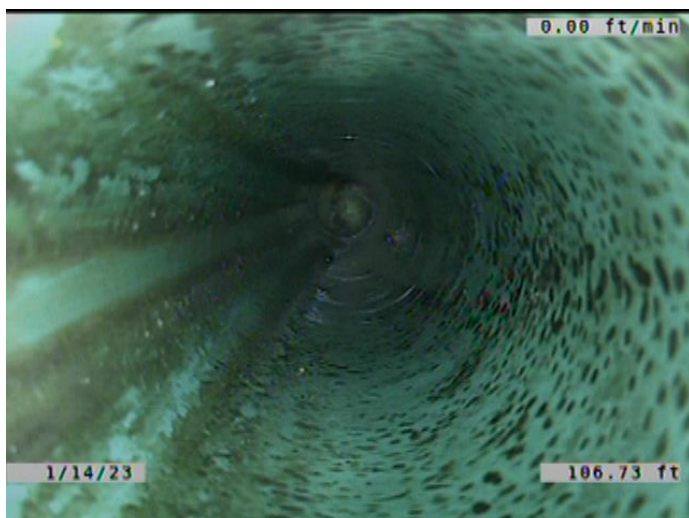
Code: **TF**
 Description: **Tap Factory**

Distance (ft): **106.7**
 Structural Grade: **0**
 O&M Grade: **0**
 Clock Start/From: **9**
 Clock To:
 1st Value: **6.000**
 2nd Value:
 Value Percent:
 Continuous Index:
 Within 8" of Joint: **YES**
 Remarks:

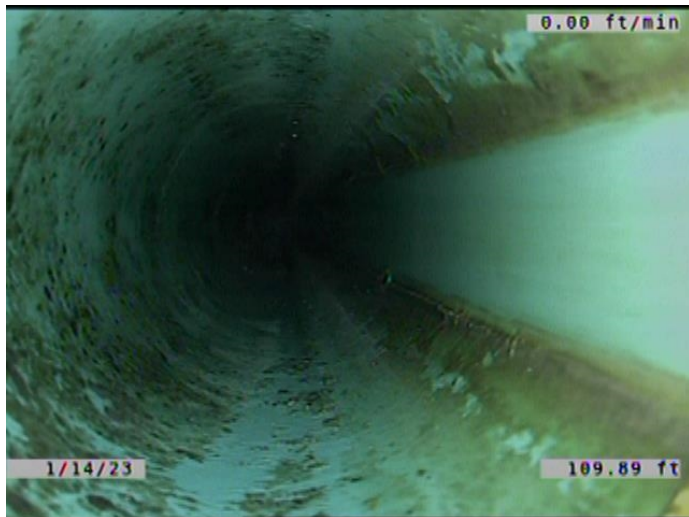
Code: **TF**
 Description: **Tap Factory**

Distance (ft): **109.9**
 Structural Grade: **0**
 O&M Grade: **0**
 Clock Start/From: **3**
 Clock To:
 1st Value: **6.000**
 2nd Value:
 Value Percent:
 Continuous Index:
 Within 8" of Joint: **YES**
 Remarks:

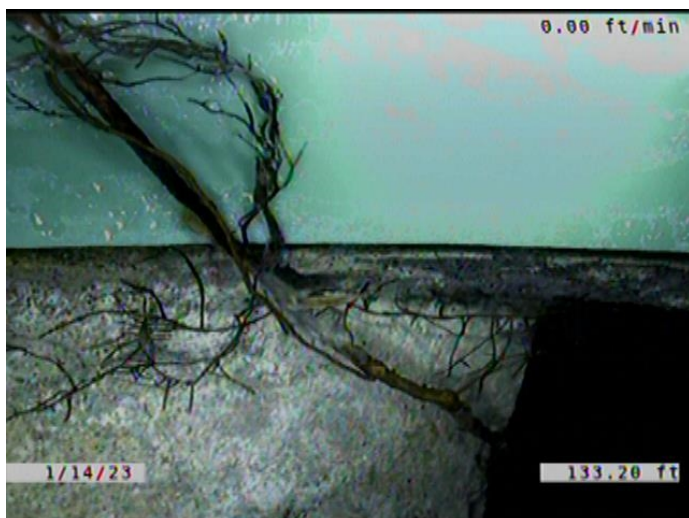
Code: **RFJ**
 Description: **Roots Fine Joint**

Distance (ft): **133.2**
 Structural Grade: **0**
 O&M Grade: **1**
 Clock Start/From: **8**
 Clock To: **10**
 1st Value:
 2nd Value:
 Value Percent:
 Continuous Index:
 Within 8" of Joint: **YES**
 Remarks:

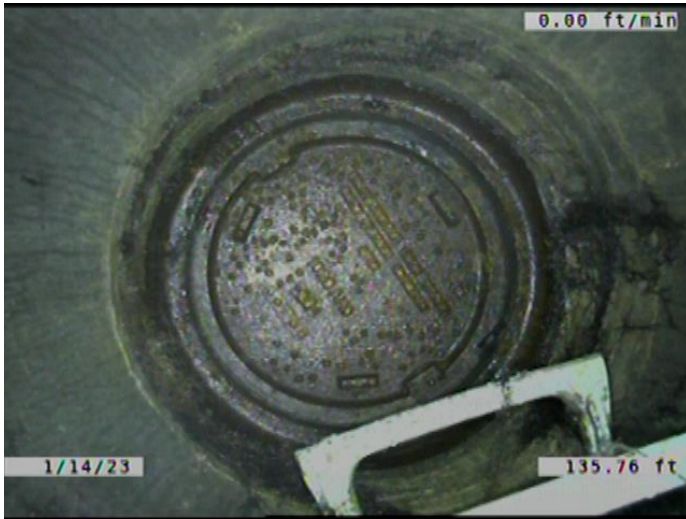
Code:	AMH
Description:	Manhole
Distance (ft):	135.8
Structural Grade:	0
O&M Grade:	0
Clock Start/From:	
Clock To:	
1st Value:	
2nd Value:	
Value Percent:	
Continuous Index:	
Within 8" of Joint:	NO
Remarks:	M-1004-084
