Profile/Photo Observation Report

Date:	01/08/2023	Weather:		Coding:	PACP 7.0
Pipe Length (ft):	302.1	Owner:	City of Hobart	Pre Clean:	Heavy Cleaning
P.O.#:	YES502259	Surveyor:	S. Bucklin	PSR:	P-1004-078-085
Customer:	City of Hobart	Clean Date:	10/29/2022	Shape:	C

Street:	Hemlock Drive	Flow Control:	Not Controlled
City:	Hobart, IN	Year Renewed:	
Location:	Easement/Right of Way	Tape/Media #:	
Purpose:	Routine Assessment	Dia/Height:	10"
Use:	Sanitary Sewage Pipe	Material:	PVC
Drain Area:		Lining:	None
Category:	NA

US MH:	M-1004-078	DS MH:	M-1004-085	Total Length Surveyed (ft):	299.2
--------	-------------------	--------	-------------------	-----------------------------	--------------

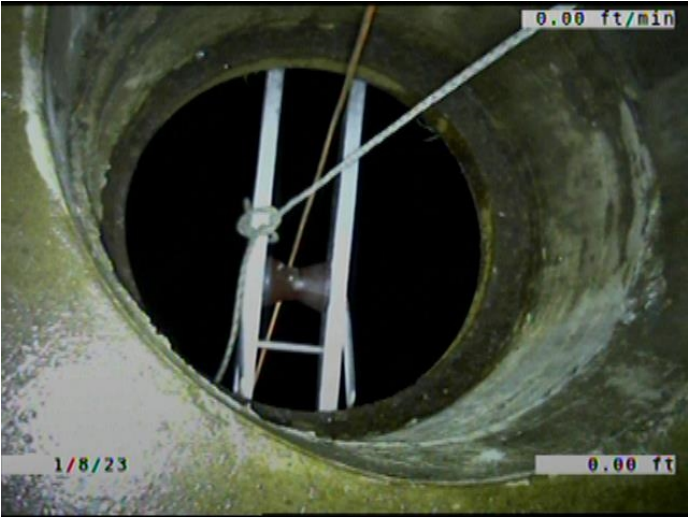
AMH

Manhole

.0

M-1004-078

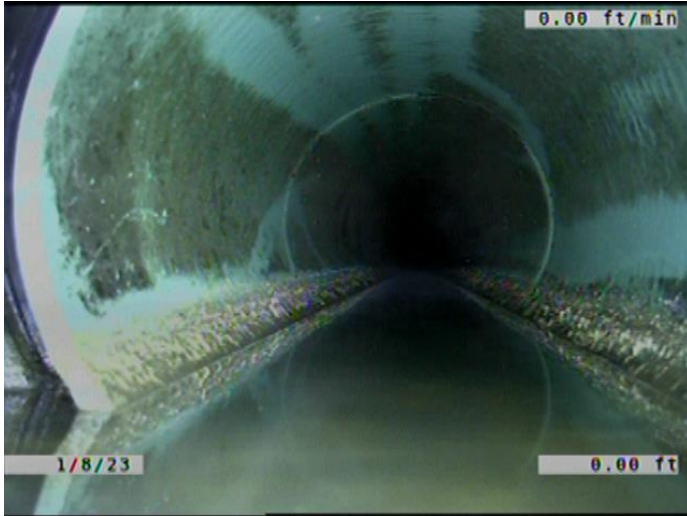
Code:	MWL
Description:	Miscellaneous Water Level
Distance (ft):	.0
Structural Grade:	0
O&M Grade:	0
Clock Start/From:	
Clock To:	
1st Value:	
2nd Value:	
Value Percent:	10.000
Continuous Index:	
Within 8" of Joint:	NO
Remarks:

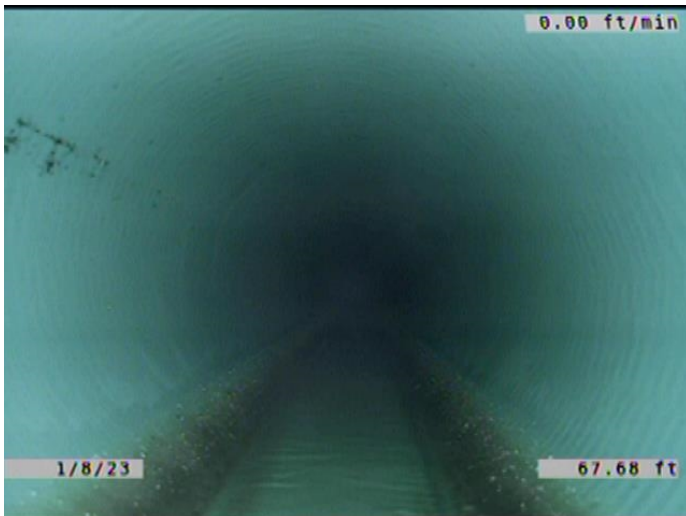
Code: **MWLS**
 Description: **Miscellaneous Water Level Sag**

Distance (ft): **67.7**
 Structural Grade: **2**
 O&M Grade: **0**
 Clock Start/From:
 Clock To:
 1st Value:
 2nd Value:
 Value Percent: **10.000**
 Continuous Index: **F01**
 Within 8" of Joint: **NO**
 Remarks:

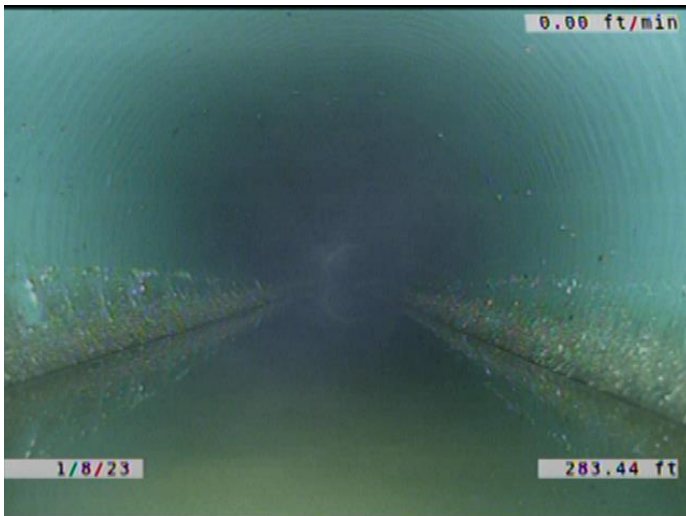
Code: **MWLS**
 Description: **Miscellaneous Water Level Sag**

Distance (ft): **283.4**
 Structural Grade: **2**
 O&M Grade: **0**
 Clock Start/From:
 Clock To:
 1st Value:
 2nd Value:
 Value Percent: **20.000**
 Continuous Index: **S02**
 Within 8" of Joint: **NO**
 Remarks:
