Profile/Photo Observation Report

Street:	CYPRESS LN	Flow Control:	Not Controlled
City:	Hobart, IN	Year Renewed:	
Location:	Other	Tape/Media #:	
Purpose:	Not Known	Dia/Height:	8"
Use:	Sanitary	Material:	PVC
Drain Area:	NA	Lining:	
Category:	NA		
Comment:

Location Details:		Direction of Survey:	Upstream
US MH:	M-1004-087	DS MH:	M-1004-086
		Total Length Surveyed (ft):	184.7

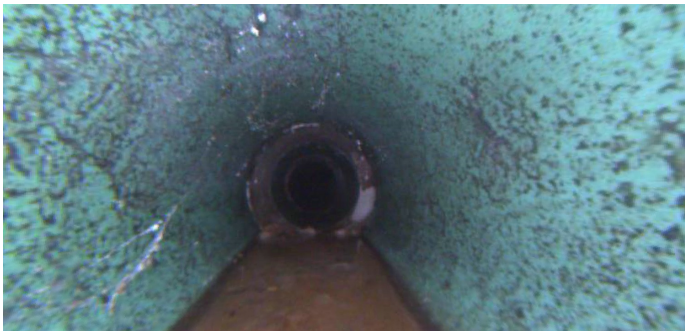
Code:	AMH
Description:	Manhole
Distance (ft):	.0
Structural Grade:	0
O&M Grade:	0
Clock Start/From:	
Clock To:	
1st Value:	
2nd Value:	
Value Percent:	
Continuous Index:	
Within 8" of Joint:	NO
Remarks:	M-1004-086

Manhole

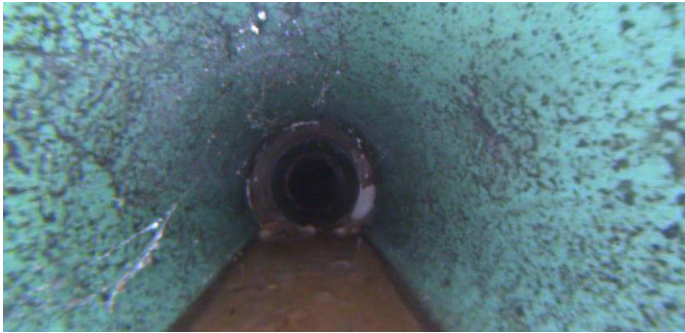
Code:	MWL
Description:	Water Level

Distance (ft):	.0
Structural Grade:	0
O&M Grade:	0
Clock Start/From:	
Clock To:	
1st Value:	
2nd Value:	
Value Percent:	10.000
Continuous Index:	
Within 8" of Joint:	NO
Remarks:

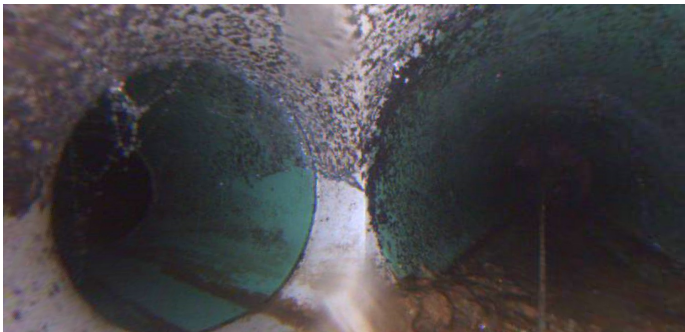
Code:	TF
Description:	Tap Factory

Distance (ft):	3.1
Structural Grade:	0
O&M Grade:	0
Clock Start/From:	3
Clock To:	
1st Value:	4.000
2nd Value:	
Value Percent:	
Continuous Index:	
Within 8" of Joint:	
Remarks:

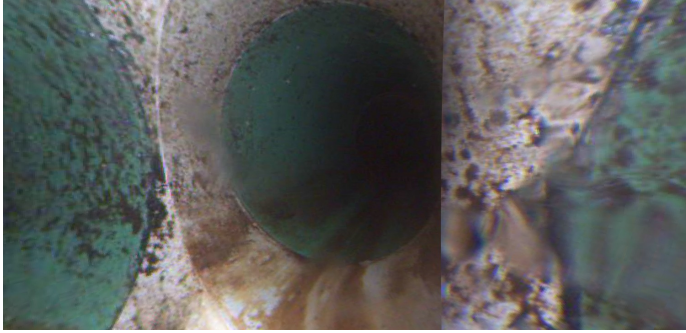
Code: **TF**
Description: **Tap Factory**

Distance (ft): **4.7**
Structural Grade: **0**
O&M Grade: **0**
Clock Start/From: **9**
Clock To:
1st Value: **4.000**
2nd Value:
Value Percent:
Continuous Index:
Within 8" of Joint:
Remarks:

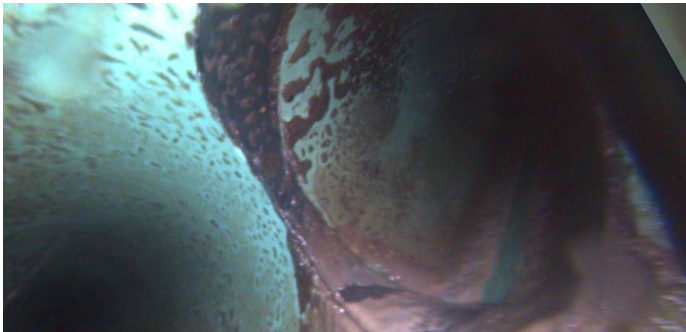
Code: **TBA**
Description: **Tap Break-in Active**

Distance (ft): **8.1**
Structural Grade: **0**
O&M Grade: **0**
Clock Start/From: **2**
Clock To:
1st Value: **4.000**
2nd Value:
Value Percent:
Continuous Index:
Within 8" of Joint:
Remarks:

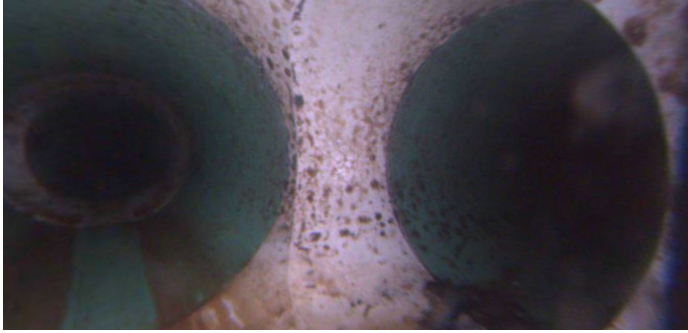
Code: **TF**
Description: **Tap Factory**

Distance (ft): **53.9**
Structural Grade: **0**
O&M Grade: **0**
Clock Start/From: **3**
Clock To:
1st Value: **4.000**
2nd Value:
Value Percent:
Continuous Index:
Within 8" of Joint:
Remarks:

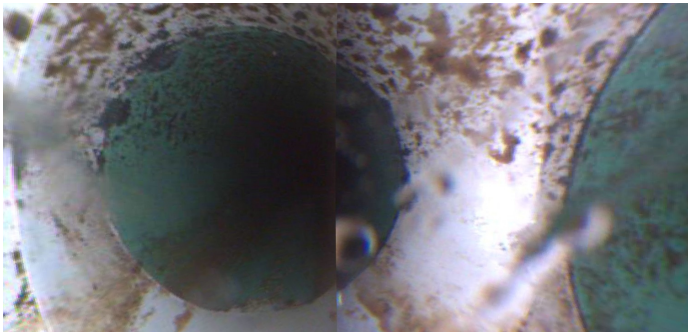
Code: **TF**
Description: **Tap Factory**

Distance (ft): **55.8**
Structural Grade: **0**
O&M Grade: **0**
Clock Start/From: **9**
Clock To:
1st Value: **4.000**
2nd Value:
Value Percent:
Continuous Index:
Within 8" of Joint:
Remarks:

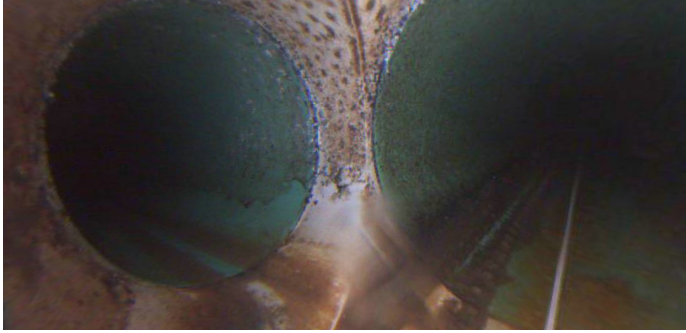
Code: **TF**
Description: **Tap Factory**

Distance (ft): **111.2**
Structural Grade: **0**
O&M Grade: **0**
Clock Start/From: **3**
Clock To:
1st Value: **4.000**
2nd Value:
Value Percent:
Continuous Index:
Within 8" of Joint:
Remarks:

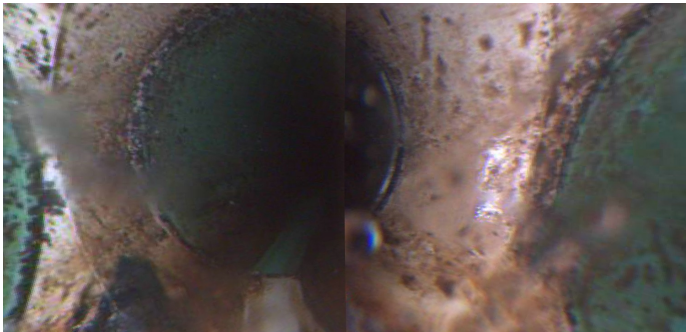
Code: **TFA**
Description: **Tap Factory Active**

Distance (ft): **115.5**
Structural Grade: **0**
O&M Grade: **0**
Clock Start/From: **9**
Clock To:
1st Value: **4.000**
2nd Value:
Value Percent:
Continuous Index:
Within 8" of Joint:
Remarks:

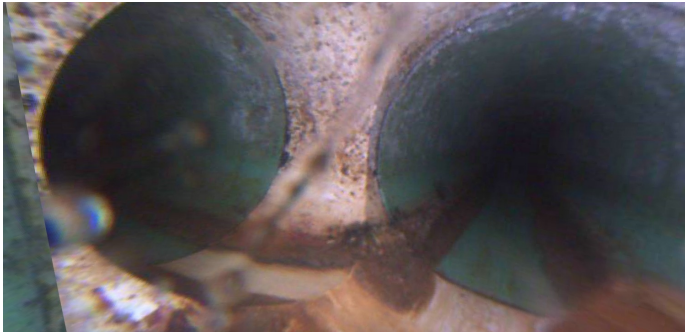
Code: **TFA**
Description: **Tap Factory Active**

Distance (ft): **163.0**
Structural Grade: **0**
O&M Grade: **0**
Clock Start/From: **9**
Clock To:
1st Value: **4.000**
2nd Value:
Value Percent:
Continuous Index:
Within 8" of Joint:
Remarks:

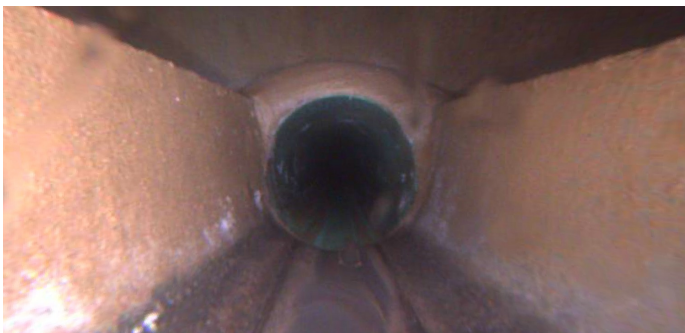
Code: **AMH**
Description: **Manhole**

Distance (ft): **184.7**
Structural Grade: **0**
O&M Grade: **0**
Clock Start/From:
Clock To:
1st Value:
2nd Value:
Value Percent:
Continuous Index:
Within 8" of Joint: **NO**
Remarks: **M-1004-087**
