Profile/Photo Observation Report

Street:	Cypress Ln.	Flow Control:	Not Controlled
City:	Hobart, IN	Year Renewed:	
Location:	Other	Tape/Media #:	
Purpose:	Not Known	Dia/Height:	8"
Use:	Sanitary	Material:	PVC
Drain Area:	NA	Lining:	
Category:	NA		
Comment:

Location Details:		Direction of Survey:	Upstream
US MH:	M-1004-087	DS MH:	M-1004-086
		Total Length Surveyed (ft):	184.7

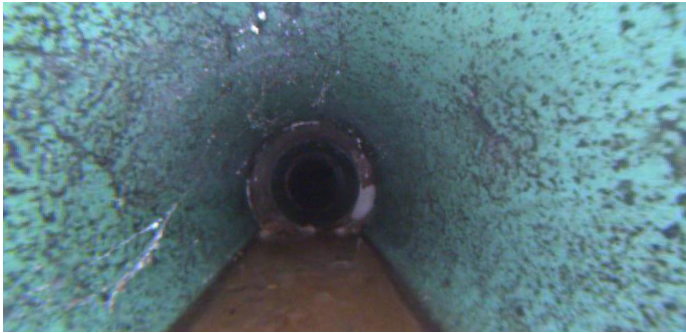
Code:	MWL
Description:	Water Level

Distance (ft):	.0
Structural Grade:	0
O&M Grade:	0
Clock Start/From:	
Clock To:	
1st Value:	
2nd Value:	
Value Percent:	10.000
Continuous Index:	
Within 8" of Joint:	NO
Remarks:

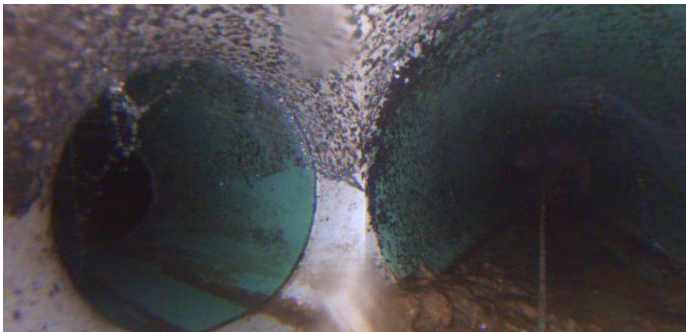
Code:	TF
Description:	Tap Factory

Distance (ft):	3.1
Structural Grade:	0
O&M Grade:	0
Clock Start/From:	3
Clock To:	
1st Value:	4.000
2nd Value:	
Value Percent:	
Continuous Index:	
Within 8" of Joint:	
Remarks:

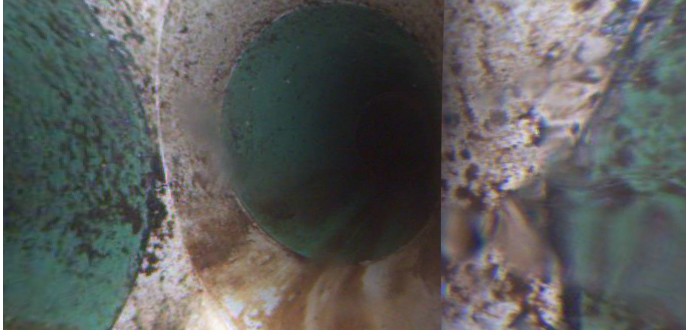
Code: **TF**
Description: **Tap Factory**

Distance (ft): **4.7**
Structural Grade: **0**
O&M Grade: **0**
Clock Start/From: **9**
Clock To:
1st Value: **4.000**
2nd Value:
Value Percent:
Continuous Index:
Within 8" of Joint:
Remarks:

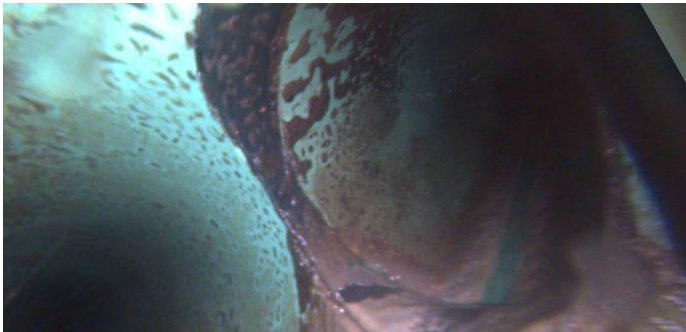
Code: **TBA**
Description: **Tap Break-in Active**

Distance (ft): **8.1**
Structural Grade: **0**
O&M Grade: **0**
Clock Start/From: **2**
Clock To:
1st Value: **4.000**
2nd Value:
Value Percent:
Continuous Index:
Within 8" of Joint:
Remarks:

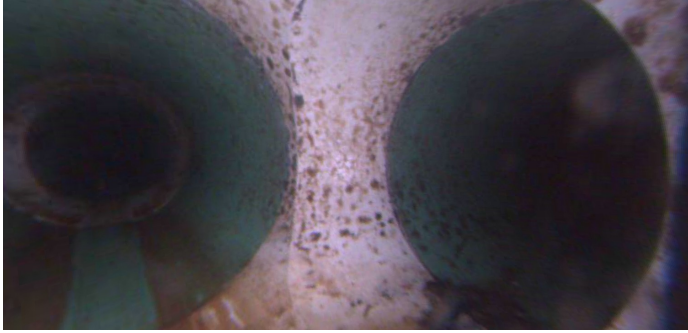
Code: **TF**
Description: **Tap Factory**

Distance (ft): **53.9**
Structural Grade: **0**
O&M Grade: **0**
Clock Start/From: **3**
Clock To:
1st Value: **4.000**
2nd Value:
Value Percent:
Continuous Index:
Within 8" of Joint:
Remarks:

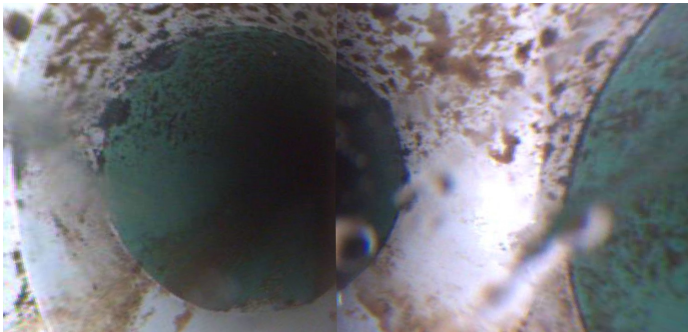
Code: **TF**
Description: **Tap Factory**

Distance (ft): **55.8**
Structural Grade: **0**
O&M Grade: **0**
Clock Start/From: **9**
Clock To:
1st Value: **4.000**
2nd Value:
Value Percent:
Continuous Index:
Within 8" of Joint:
Remarks:

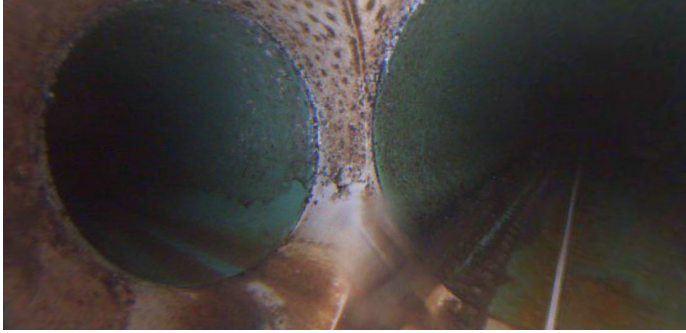
Code: **TF**
Description: **Tap Factory**

Distance (ft): **111.2**
Structural Grade: **0**
O&M Grade: **0**
Clock Start/From: **3**
Clock To:
1st Value: **4.000**
2nd Value:
Value Percent:
Continuous Index:
Within 8" of Joint:
Remarks:

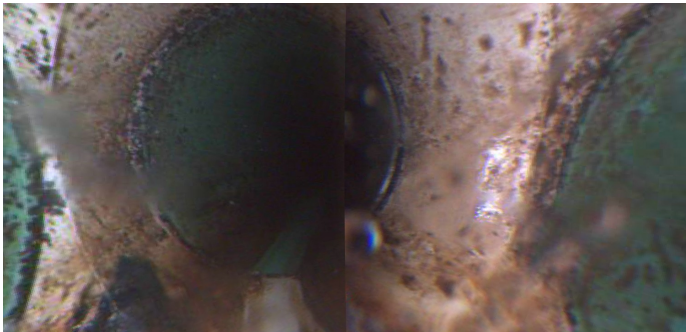
Code: **TFA**
Description: **Tap Factory Active**

Distance (ft): **115.5**
Structural Grade: **0**
O&M Grade: **0**
Clock Start/From: **9**
Clock To:
1st Value: **4.000**
2nd Value:
Value Percent:
Continuous Index:
Within 8" of Joint:
Remarks:

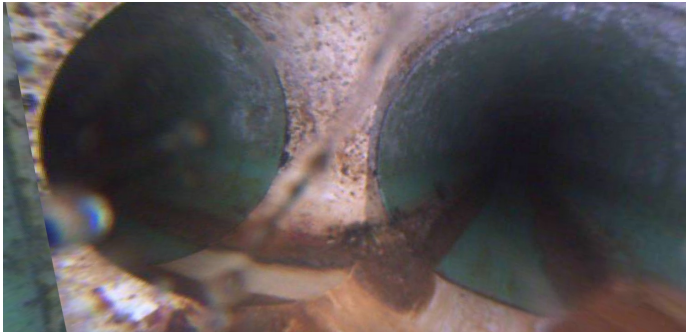
Code: **TFA**
Description: **Tap Factory Active**

Distance (ft): **163.0**
Structural Grade: **0**
O&M Grade: **0**
Clock Start/From: **9**
Clock To:
1st Value: **4.000**
2nd Value:
Value Percent:
Continuous Index:
Within 8" of Joint:
Remarks:

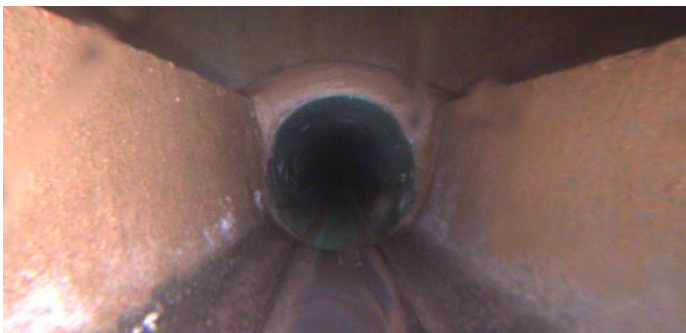
Code: **AMH**
Description: **Manhole**

Distance (ft): **184.7**
Structural Grade: **0**
O&M Grade: **0**
Clock Start/From:
Clock To:
1st Value:
2nd Value:
Value Percent:
Continuous Index:
Within 8" of Joint: **NO**
Remarks: **M-1004-087**
