## Profile/Photo Observation Report

Date:	10/15/2021	Weather:		Coding:	PACP 6.0
Pipe Length (ft):		Owner:	Hobart, IN	Pre Clean:	Not Known
P.O.#:	806_1	Surveyor:	M. Pielacha	PSR:	P-902-024-023
Customer:	Hobart, IN	Clean Date:		Shape:	C

Street:	Off East 33rd Lane	Flow Control:	
City:	Hobart, IN	Year Renewed:	
Location:	Yard	Tape/Media #:	806
Purpose:	Routine Assessment	Dia/Height:	8"
Use:	Sanitary	Material:	VCP
Drain Area:		Lining:	
Category:	NA		
Comment:

Location Details:		Direction of Survey:	Upstream
US MH:	M-902-24	DS MH:	M-902-23
		Total Length Surveyed (ft):	61.5

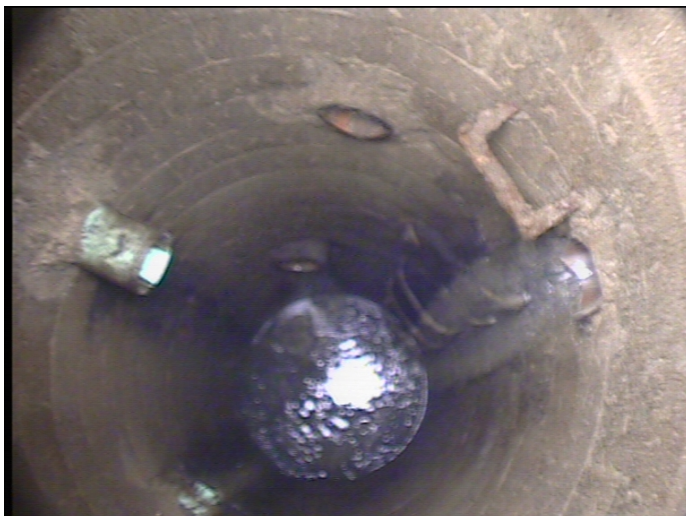
Code: **AMH**  
Description: **Manhole**

Distance (ft): **.0**  
Structural Grade: **0**  
O&M Grade: **0**  
Clock Start/From:  
Clock To:  
1st Value:  
2nd Value:  
Value Percent:  
Continuous Index:  
Within 8" of Joint: **NO**  
Remarks: **M-902-23**

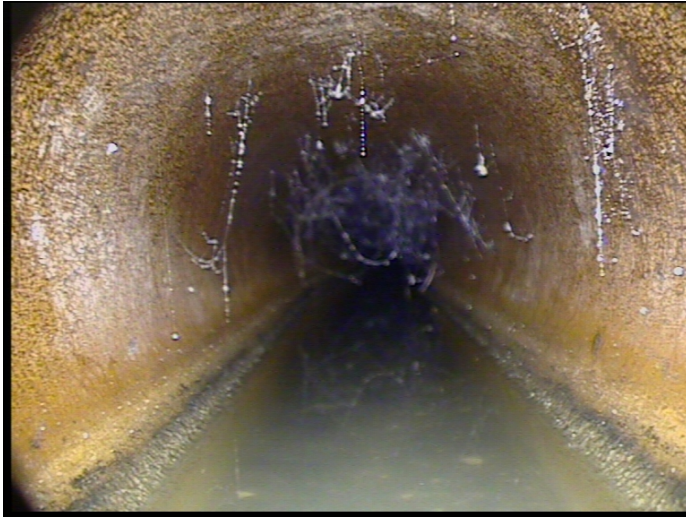
Code: **MWL**  
Description: **Water Level**

Distance (ft): **.0**  
Structural Grade: **0**  
O&M Grade: **0**  
Clock Start/From:  
Clock To:  
1st Value:  
2nd Value:  
Value Percent: **5.000**  
Continuous Index:  
Within 8" of Joint: **NO**  
Remarks:

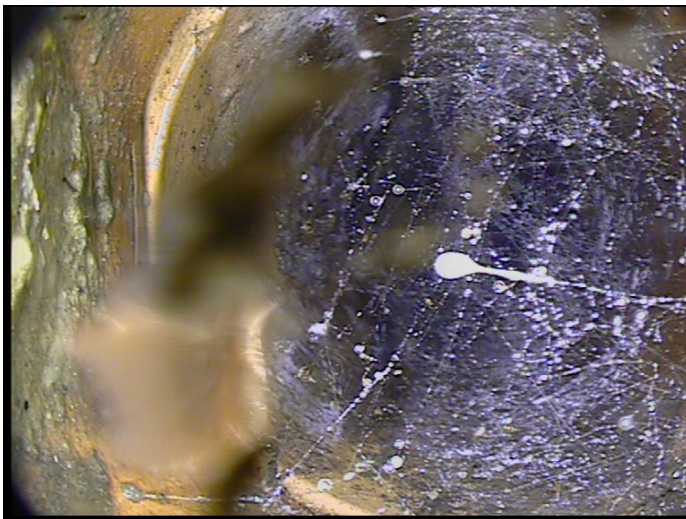
Code: **TF**  
Description: **Tap Factory**

Distance (ft): **36.3**  
Structural Grade: **0**  
O&M Grade: **0**  
Clock Start/From: **9**  
Clock To:  
1st Value: **4.000**  
2nd Value:  
Value Percent:  
Continuous Index:  
Within 8" of Joint: **NO**  
Remarks:

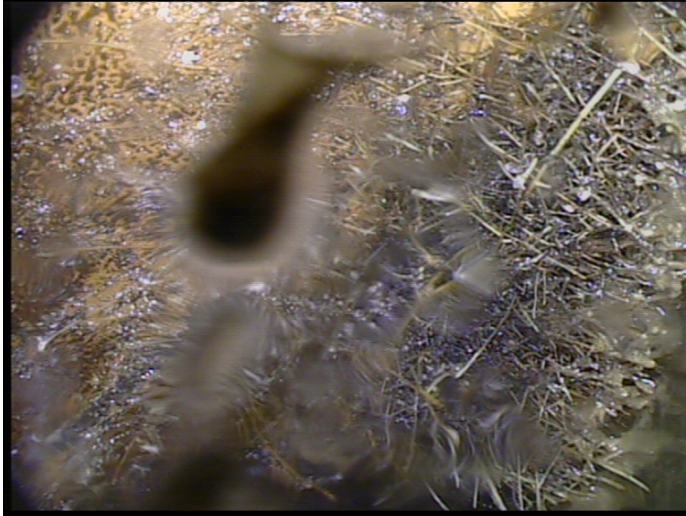
Code: **RMJ**  
Description: **Roots Medium Joint**

Distance (ft): **42.4**  
Structural Grade: **0**  
O&M Grade: **3**  
Clock Start/From: **1**  
Clock To: **5**  
1st Value:  
2nd Value:  
Value Percent: **10.000**  
Continuous Index: **S01**  
Within 8" of Joint: **YES**  
Remarks:

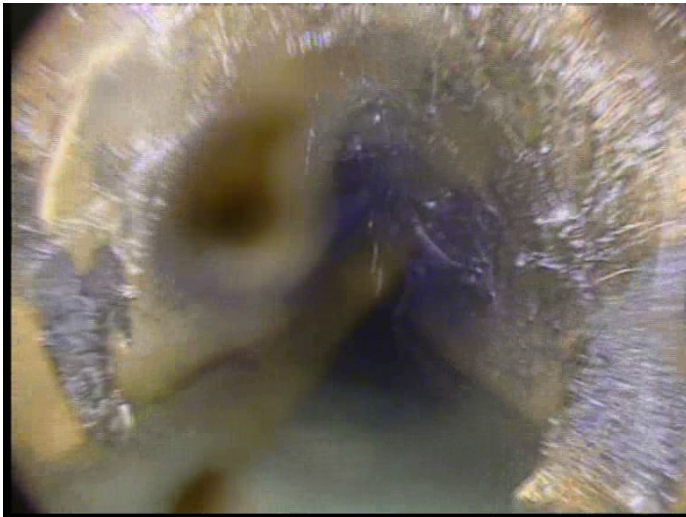
Code: **RFJ**  
Description: **Roots Fine Joint**

Distance (ft): **46.9**  
Structural Grade: **0**  
O&M Grade: **1**  
Clock Start/From: **8**  
Clock To: **10**  
1st Value:  
2nd Value:  
Value Percent:  
Continuous Index:  
Within 8" of Joint: **YES**  
Remarks:

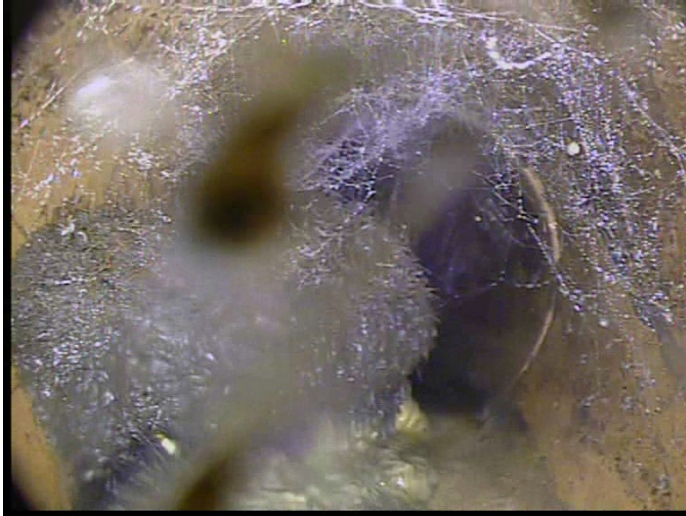
Code:	<b>RMJ</b>
Description:	<b>Roots Medium Joint</b>
Distance (ft):	<b>61.5</b>
Structural Grade:	<b>0</b>
O&M Grade:	<b>3</b>
Clock Start/From:	<b>1</b>
Clock To:	<b>5</b>
1st Value:	
2nd Value:	
Value Percent:	<b>10.000</b>
Continuous Index:	<b>F01</b>
Within 8" of Joint:	<b>YES</b>
Remarks:

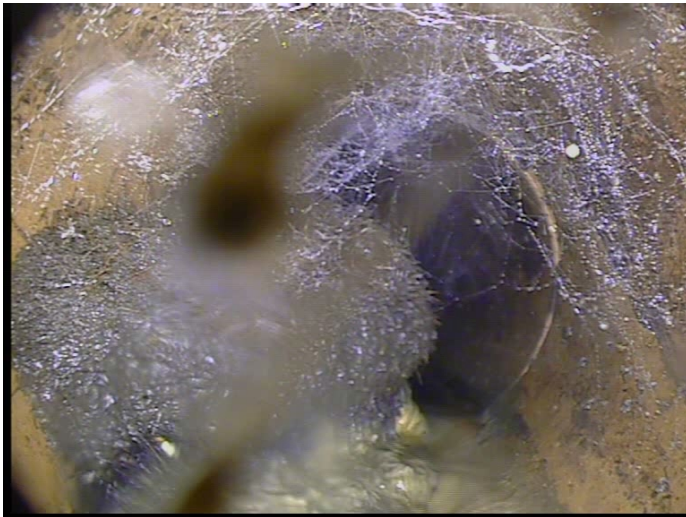
Code:	<b>RMJ</b>
Description:	<b>Roots Medium Joint</b>
Distance (ft):	<b>61.5</b>
Structural Grade:	<b>0</b>
O&M Grade:	<b>3</b>
Clock Start/From:	<b>6</b>
Clock To:	<b>11</b>
1st Value:	
2nd Value:	
Value Percent:	<b>45.000</b>
Continuous Index:	
Within 8" of Joint:	<b>YES</b>
Remarks:

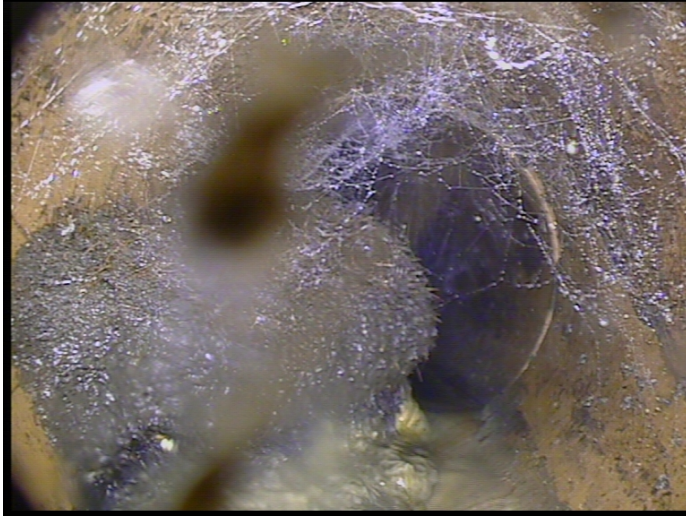
Code:	<b>MSA</b>
Description:	<b>Abandoned Survey</b>
Distance (ft):	<b>61.5</b>
Structural Grade:	<b>0</b>
O&M Grade:	<b>0</b>
Clock Start/From:	
Clock To:	
1st Value:	
2nd Value:	
Value Percent:	
Continuous Index:	
Within 8" of Joint:	<b>NO</b>
Remarks:	<b>Large Roots</b>
