Profile/Photo Observation Report

Street:	Off Shelby Lane	Flow Control:	
City:	Hobart, IN	Year Renewed:	
Location:	Yard	Tape/Media #:	807
Purpose:	Routine Assessment	Dia/Height:	10"
Use:	Sanitary	Material:	VCP
Drain Area:		Lining:	
Category:	NA		
Comment:

Location Details:		Direction of Survey:	Upstream
US MH:	M-902-28	DS MH:	M-902-27
		Total Length Surveyed (ft):	220.7

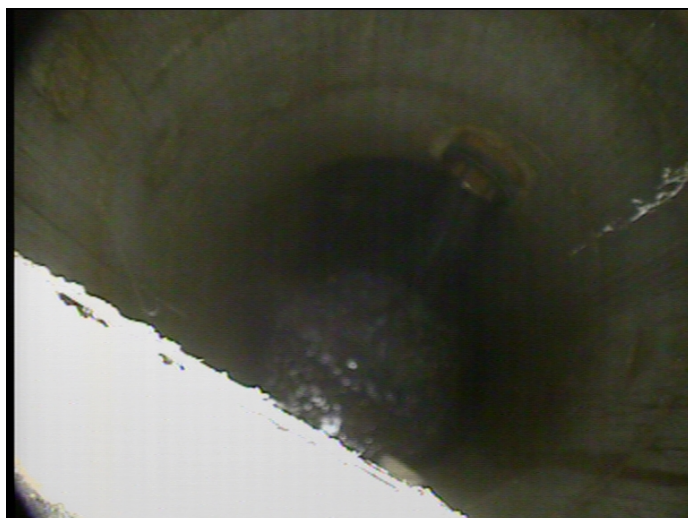
Code: **AMH**
 Description: **Manhole**

Distance (ft): **.0**
 Structural Grade: **0**
 O&M Grade: **0**
 Clock Start/From:
 Clock To:
 1st Value:
 2nd Value:
 Value Percent:
 Continuous Index:
 Within 8" of Joint: **NO**
 Remarks: **M-902-27**

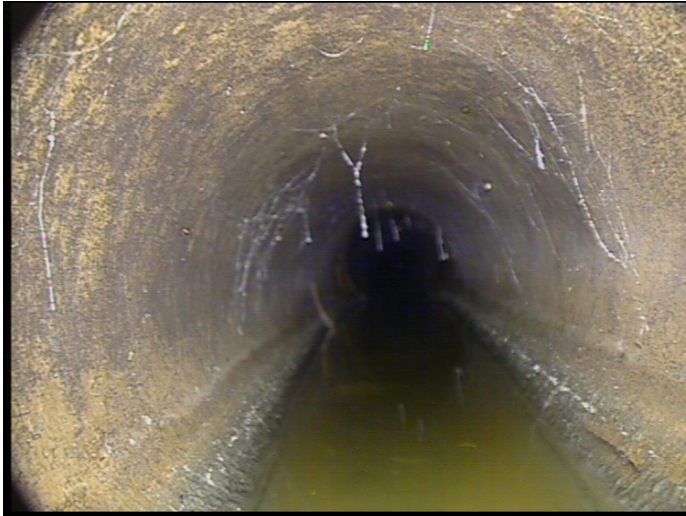
Code:	MWL
Description:	Water Level
Distance (ft):	.0
Structural Grade:	0
O&M Grade:	0
Clock Start/From:	
Clock To:	
1st Value:	
2nd Value:	
Value Percent:	5.000
Continuous Index:	
Within 8" of Joint:	NO
Remarks:

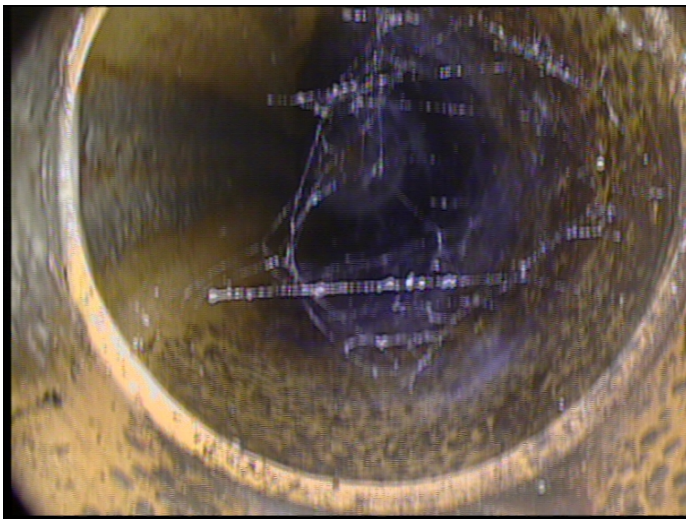
Code:	TF
Description:	Tap Factory
Distance (ft):	10.6
Structural Grade:	0
O&M Grade:	0
Clock Start/From:	10
Clock To:	
1st Value:	4.000
2nd Value:	
Value Percent:	
Continuous Index:	
Within 8" of Joint:	NO
Remarks:

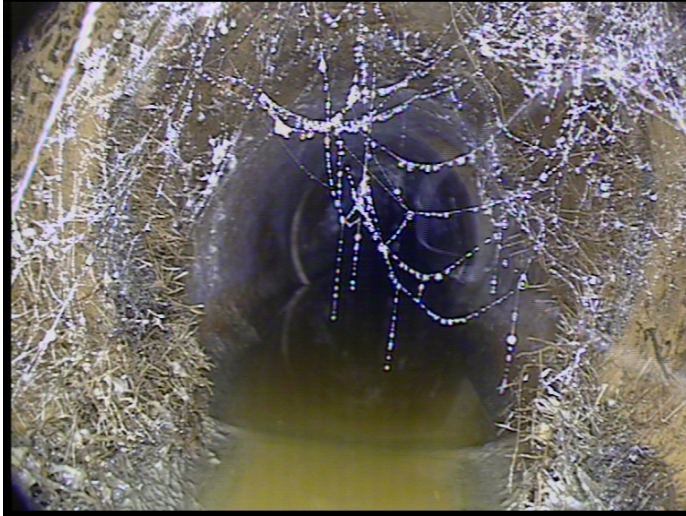
Code:	RMJ
Description:	Roots Medium Joint
Distance (ft):	24.4
Structural Grade:	0
O&M Grade:	3
Clock Start/From:	7
Clock To:	5
1st Value:	
2nd Value:	
Value Percent:	5.000
Continuous Index:	
Within 8" of Joint:	YES
Remarks:

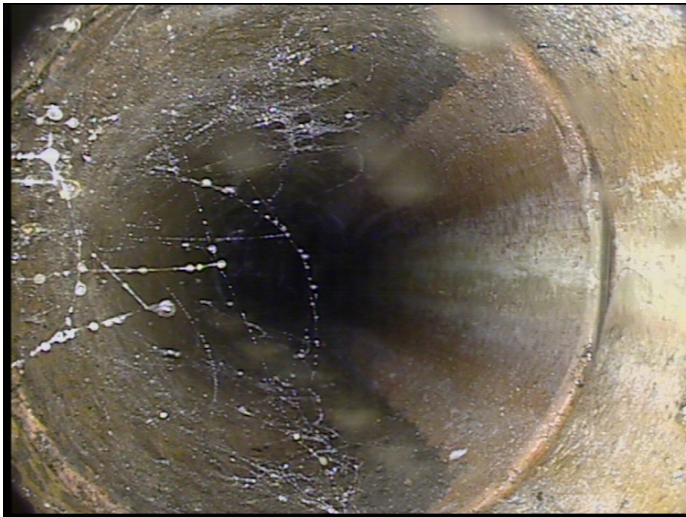
Code:	TF
Description:	Tap Factory
Distance (ft):	25.8
Structural Grade:	0
O&M Grade:	0
Clock Start/From:	3
Clock To:	
1st Value:	4.000
2nd Value:	
Value Percent:	
Continuous Index:	
Within 8" of Joint:	NO
Remarks:

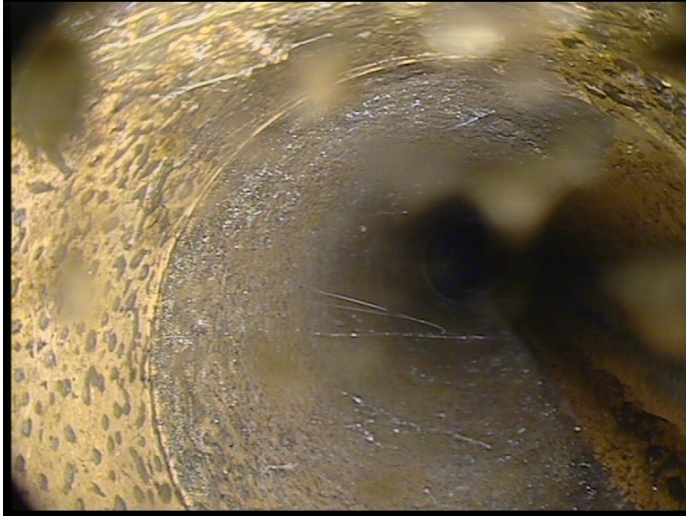
Code: **TF**
Description: **Tap Factory**

Distance (ft): **104.7**
Structural Grade: **0**
O&M Grade: **0**
Clock Start/From: **3**
Clock To:
1st Value: **4.000**
2nd Value:
Value Percent:
Continuous Index:
Within 8" of Joint: **NO**
Remarks:

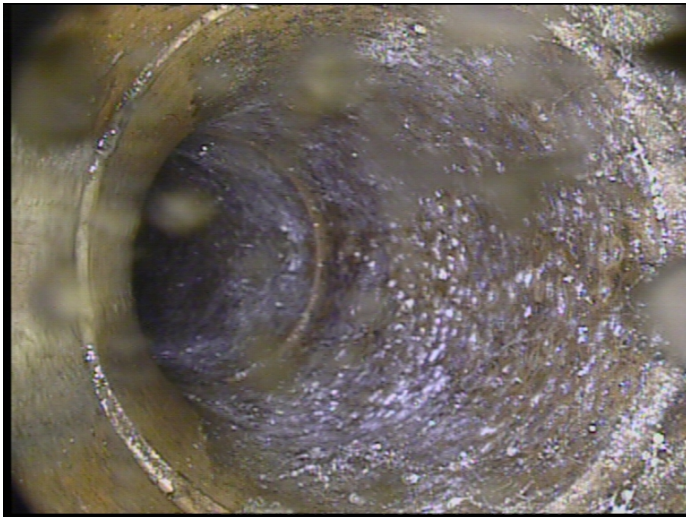
Code: **TF**
Description: **Tap Factory**

Distance (ft): **112.8**
Structural Grade: **0**
O&M Grade: **0**
Clock Start/From: **10**
Clock To:
1st Value: **4.000**
2nd Value:
Value Percent:
Continuous Index:
Within 8" of Joint: **NO**
Remarks:

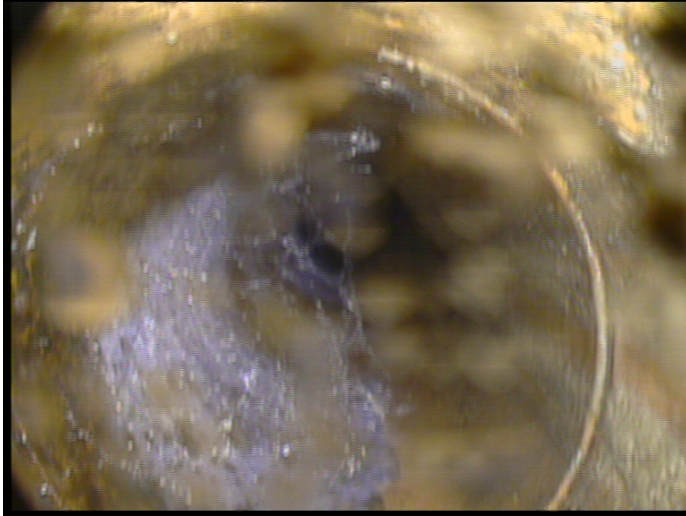
Code: **TF**
Description: **Tap Factory**

Distance (ft): **185.1**
Structural Grade: **0**
O&M Grade: **0**
Clock Start/From: **3**
Clock To:
1st Value: **4.000**
2nd Value:
Value Percent:
Continuous Index:
Within 8" of Joint: **NO**
Remarks:

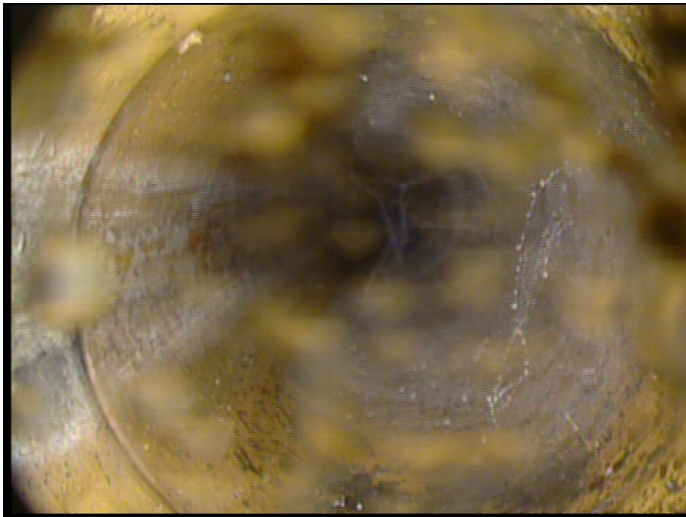
Code: **TF**
Description: **Tap Factory**

Distance (ft): **192.6**
Structural Grade: **0**
O&M Grade: **0**
Clock Start/From: **9**
Clock To:
1st Value: **4.000**
2nd Value:
Value Percent:
Continuous Index:
Within 8" of Joint: **NO**
Remarks:

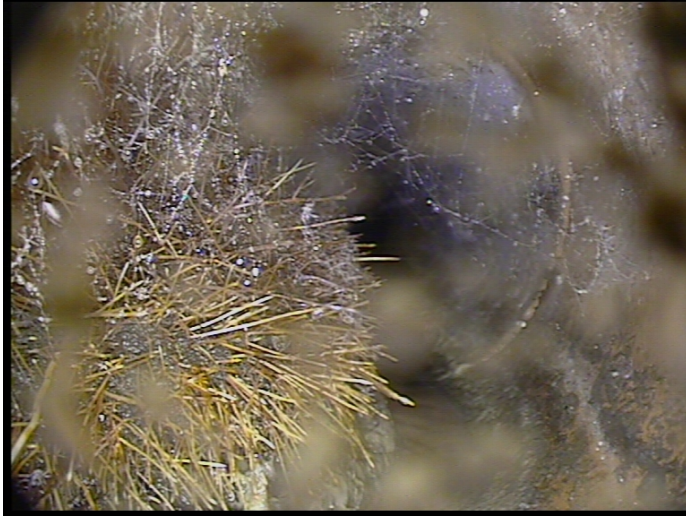
Code: **RMJ**
Description: **Roots Medium Joint**

Distance (ft): **216.7**
Structural Grade: **0**
O&M Grade: **3**
Clock Start/From: **7**
Clock To: **9**
1st Value:
2nd Value:
Value Percent: **20.000**
Continuous Index:
Within 8" of Joint: **YES**
Remarks:

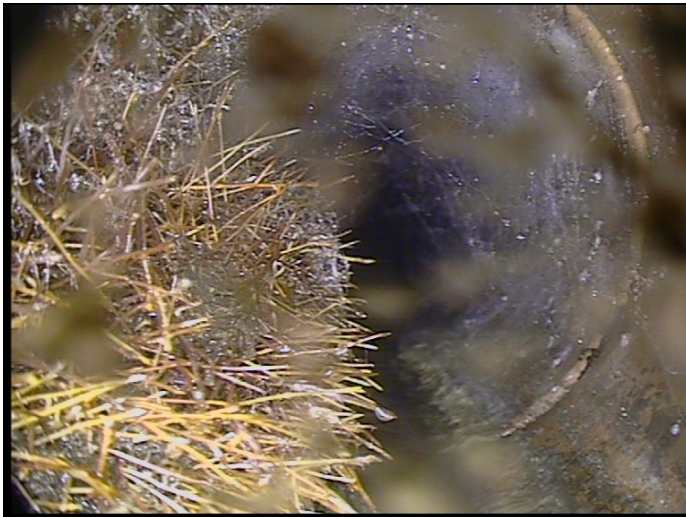
Code: **MSA**
Description: **Abandoned Survey**

Distance (ft): **220.7**
Structural Grade: **0**
O&M Grade: **0**
Clock Start/From:
Clock To:
1st Value:
2nd Value:
Value Percent:
Continuous Index:
Within 8" of Joint: **NO**
Remarks: **Large roots**
