## Profile/Photo Observation Report

Street:	<b>CYPRESS LN</b>	Flow Control:	<b>Not Controlled</b>
City:	<b>Hobart, IN</b>	Year Renewed:	
Location:	<b>Other</b>	Tape/Media #:	
Purpose:	<b>Not Known</b>	Dia/Height:	<b>8"</b>
Use:	<b>Sanitary</b>	Material:	<b>PVC</b>
Drain Area:	<b>NA</b>	Lining:	
Category:	<b>NA</b>		
Comment:

Location Details:		Direction of Survey:	<b>Downstream</b>
US MH:	<b>M-1004-088</b>	DS MH:	<b>M-1004-087</b>
		Total Length Surveyed (ft):	<b>175.8</b>

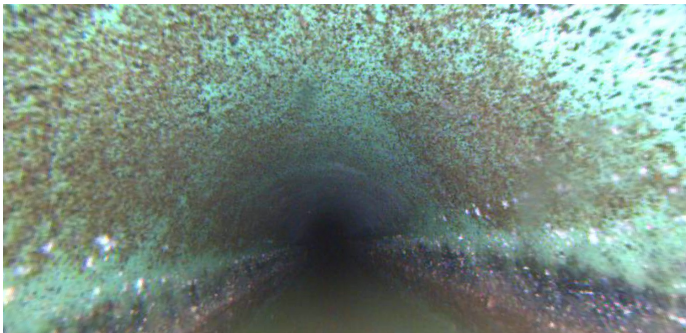
Code:	AMH
Description:	Manhole
Distance (ft):	.0
Structural Grade:	0
O&M Grade:	0
Clock Start/From:	
Clock To:	
1st Value:	
2nd Value:	
Value Percent:	
Continuous Index:	
Within 8" of Joint:	NO
Remarks:	M-1004-088

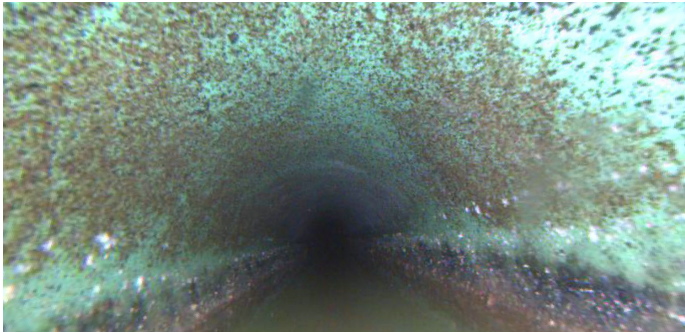
Code:	<b>MWL</b>
Description:	<b>Water Level</b>

Distance (ft):	<b>.0</b>
Structural Grade:	<b>0</b>
O&M Grade:	<b>0</b>
Clock Start/From:	
Clock To:	
1st Value:	
2nd Value:	
Value Percent:	<b>10.000</b>
Continuous Index:	
Within 8" of Joint:	<b>NO</b>
Remarks:

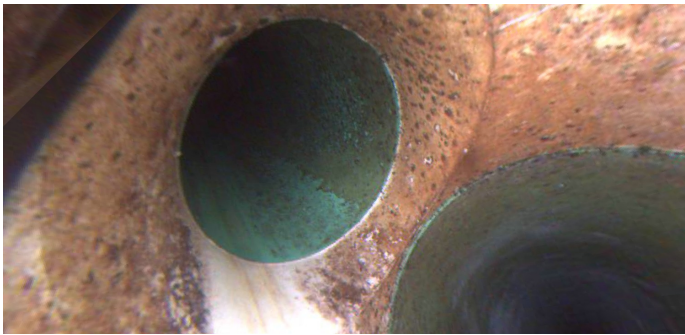
Code:	<b>TF</b>
Description:	<b>Tap Factory</b>

Distance (ft):	<b>21.4</b>
Structural Grade:	<b>0</b>
O&M Grade:	<b>0</b>
Clock Start/From:	<b>10</b>
Clock To:	
1st Value:	<b>4.000</b>
2nd Value:	
Value Percent:	
Continuous Index:	
Within 8" of Joint:	
Remarks:

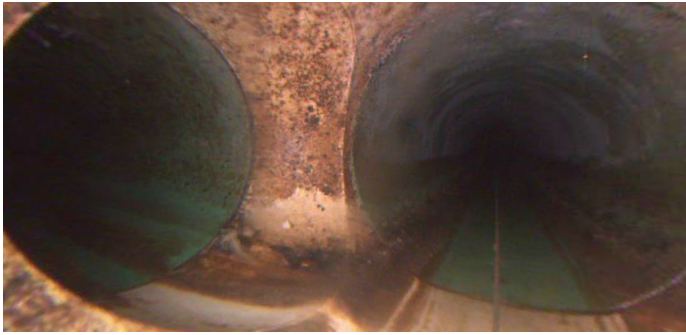
Code: **TF**  
Description: **Tap Factory**

Distance (ft): **28.2**  
Structural Grade: **0**  
O&M Grade: **0**  
Clock Start/From: **3**  
Clock To:  
1st Value: **4.000**  
2nd Value:  
Value Percent:  
Continuous Index:  
Within 8" of Joint:  
Remarks:

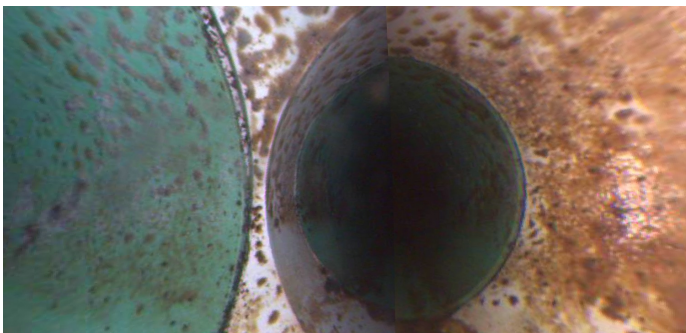
Code: **TF**  
Description: **Tap Factory**

Distance (ft): **70.0**  
Structural Grade: **0**  
O&M Grade: **0**  
Clock Start/From: **3**  
Clock To:  
1st Value: **4.000**  
2nd Value:  
Value Percent:  
Continuous Index:  
Within 8" of Joint:  
Remarks:

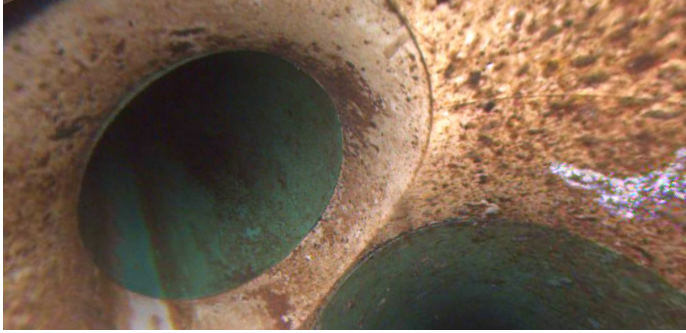
Code: **TF**  
Description: **Tap Factory**

Distance (ft): **90.7**  
Structural Grade: **0**  
O&M Grade: **0**  
Clock Start/From: **11**  
Clock To:  
1st Value: **4.000**  
2nd Value:  
Value Percent:  
Continuous Index:  
Within 8" of Joint:  
Remarks:

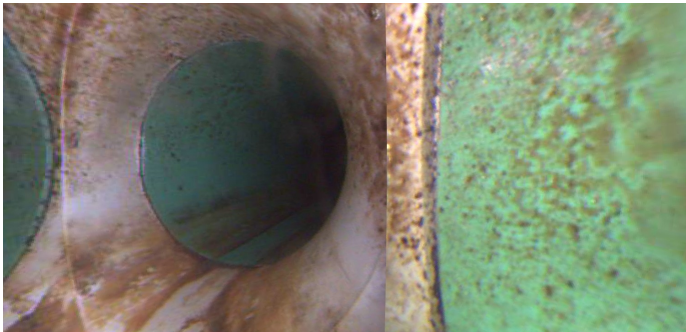
Code: **TF**  
Description: **Tap Factory**

Distance (ft): **138.5**  
Structural Grade: **0**  
O&M Grade: **0**  
Clock Start/From: **3**  
Clock To:  
1st Value: **4.000**  
2nd Value:  
Value Percent:  
Continuous Index:  
Within 8" of Joint:  
Remarks:

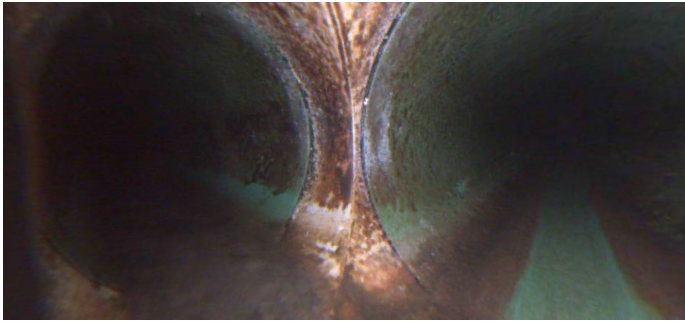
Code: **TFA**  
Description: **Tap Factory Active**

Distance (ft): **162.0**  
Structural Grade: **0**  
O&M Grade: **0**  
Clock Start/From: **9**  
Clock To:  
1st Value: **4.000**  
2nd Value:  
Value Percent:  
Continuous Index:  
Within 8" of Joint:  
Remarks:

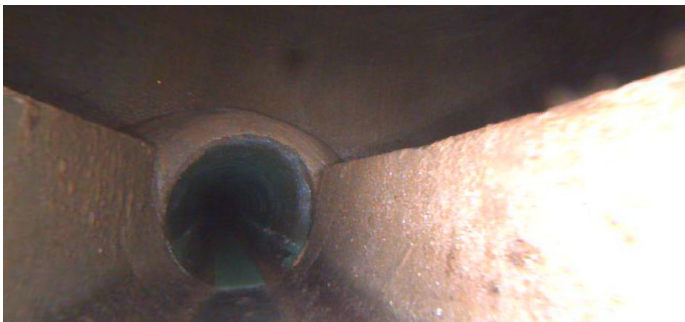
Code: **AMH**  
Description: **Manhole**

Distance (ft): **175.8**  
Structural Grade: **0**  
O&M Grade: **0**  
Clock Start/From:  
Clock To:  
1st Value:  
2nd Value:  
Value Percent:  
Continuous Index:  
Within 8" of Joint: **NO**  
Remarks: **M-1004-087**
