Profile/Photo Observation Report

Street:	Cypress Ln.	Flow Control:	Not Controlled
City:	Hobart, IN	Year Renewed:	
Location:	Other	Tape/Media #:	
Purpose:	Not Known	Dia/Height:	8"
Use:	Sanitary	Material:	PVC
Drain Area:	NA	Lining:	
Category:	NA		
Comment:

Location Details:		Direction of Survey:	Downstream
US MH:	M-1004-088	DS MH:	M-1004-087
		Total Length Surveyed (ft):	175.8

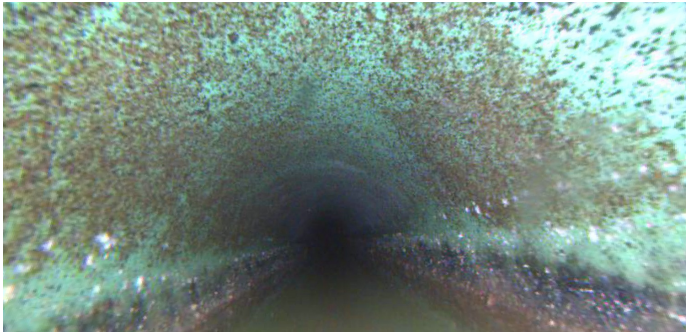
Code: **MWL**
Description: **Water Level**

Distance (ft): **.0**
Structural Grade: **0**
O&M Grade: **0**
Clock Start/From:
Clock To:
1st Value:
2nd Value:
Value Percent: **10.000**
Continuous Index:
Within 8" of Joint: **NO**
Remarks:

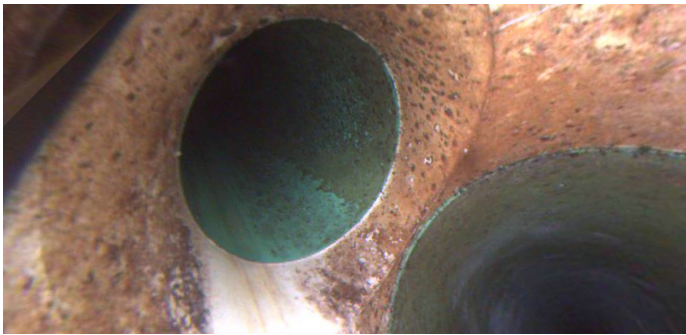
Code: **TF**
Description: **Tap Factory**

Distance (ft): **21.4**
Structural Grade: **0**
O&M Grade: **0**
Clock Start/From: **10**
Clock To:
1st Value: **4.000**
2nd Value:
Value Percent:
Continuous Index:
Within 8" of Joint:
Remarks:

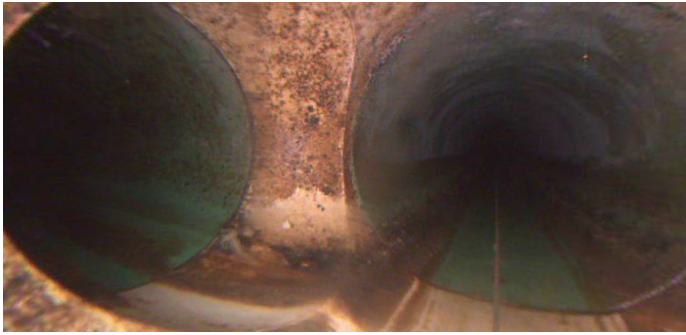
Code: **TF**
Description: **Tap Factory**

Distance (ft): **28.2**
Structural Grade: **0**
O&M Grade: **0**
Clock Start/From: **3**
Clock To:
1st Value: **4.000**
2nd Value:
Value Percent:
Continuous Index:
Within 8" of Joint:
Remarks:

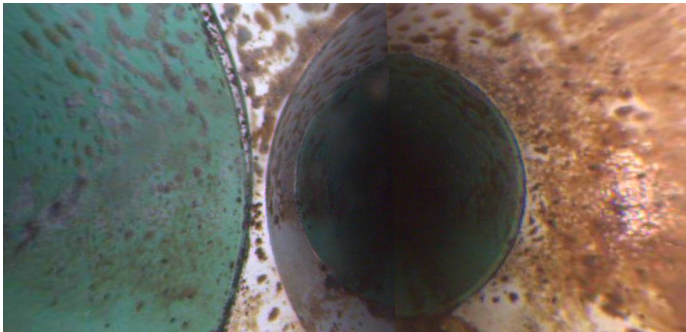
Code: **TF**
Description: **Tap Factory**

Distance (ft): **70.0**
Structural Grade: **0**
O&M Grade: **0**
Clock Start/From: **3**
Clock To:
1st Value: **4.000**
2nd Value:
Value Percent:
Continuous Index:
Within 8" of Joint:
Remarks:

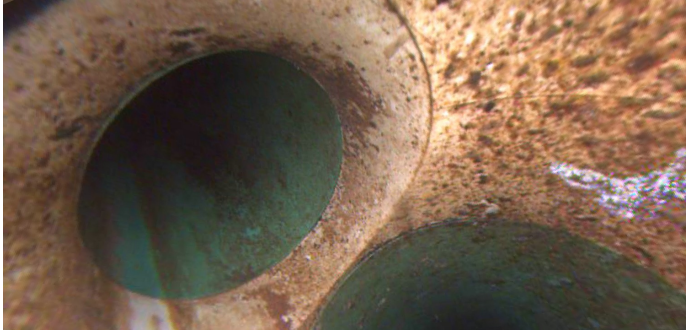
Code: **TF**
Description: **Tap Factory**

Distance (ft): **90.7**
Structural Grade: **0**
O&M Grade: **0**
Clock Start/From: **11**
Clock To:
1st Value: **4.000**
2nd Value:
Value Percent:
Continuous Index:
Within 8" of Joint:
Remarks:

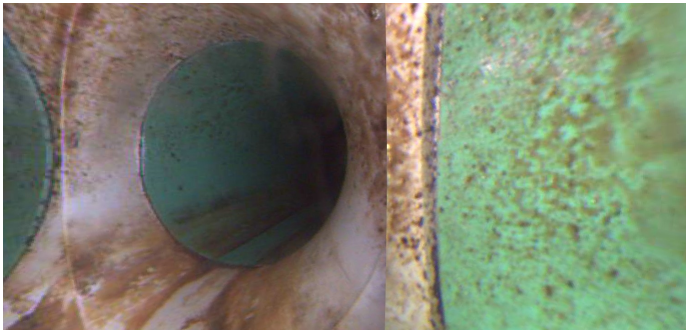
Code: **TF**
Description: **Tap Factory**

Distance (ft): **138.5**
Structural Grade: **0**
O&M Grade: **0**
Clock Start/From: **3**
Clock To:
1st Value: **4.000**
2nd Value:
Value Percent:
Continuous Index:
Within 8" of Joint:
Remarks:

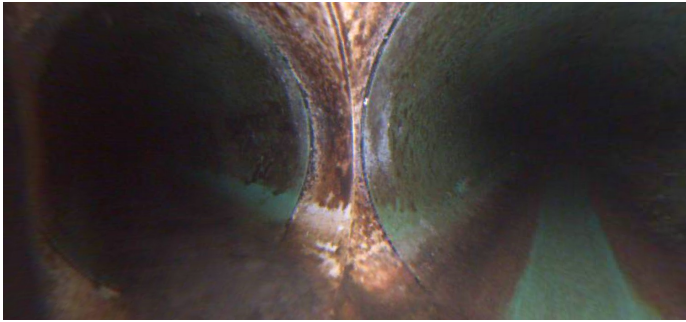
Code: **TFA**
Description: **Tap Factory Active**

Distance (ft): **162.0**
Structural Grade: **0**
O&M Grade: **0**
Clock Start/From: **9**
Clock To:
1st Value: **4.000**
2nd Value:
Value Percent:
Continuous Index:
Within 8" of Joint:
Remarks:

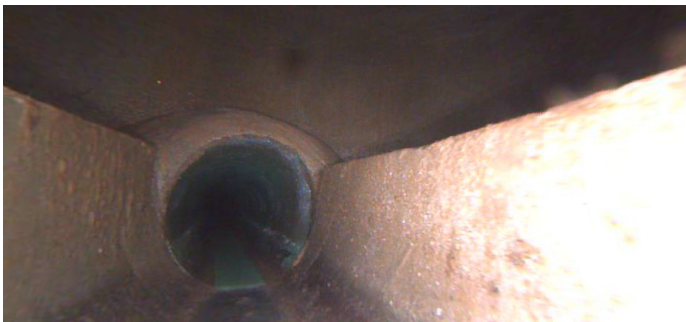
Code: **AMH**
Description: **Manhole**

Distance (ft): **175.8**
Structural Grade: **0**
O&M Grade: **0**
Clock Start/From:
Clock To:
1st Value:
2nd Value:
Value Percent:
Continuous Index:
Within 8" of Joint: **NO**
Remarks: **M-1004-087**
