## Profile/Photo Observation Report

Street:	<b>CYPRESS LN</b>	Flow Control:	<b>Not Controlled</b>
City:	<b>Hobart, IN</b>	Year Renewed:	
Location:	<b>Other</b>	Tape/Media #:	
Purpose:	<b>Not Known</b>	Dia/Height:	<b>8"</b>
Use:	<b>Sanitary</b>	Material:	<b>PVC</b>
Drain Area:	<b>NA</b>	Lining:	
Category:	<b>NA</b>		
Comment:

Location Details:		Direction of Survey:	<b>Upstream</b>
US MH:	<b>M-1004-089</b>	DS MH:	<b>M-1004-088</b>
		Total Length Surveyed (ft):	<b>175.9</b>

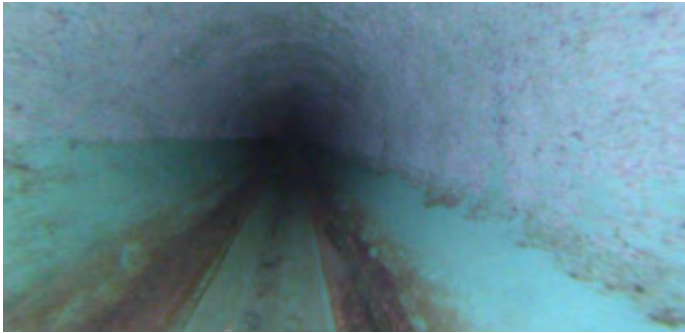
Code:	<b>MWL</b>
Description:	<b>Water Level</b>

Distance (ft):	<b>.0</b>
Structural Grade:	<b>0</b>
O&M Grade:	<b>0</b>
Clock Start/From:	
Clock To:	
1st Value:	
2nd Value:	
Value Percent:	<b>5.000</b>
Continuous Index:	
Within 8" of Joint:	<b>NO</b>
Remarks:

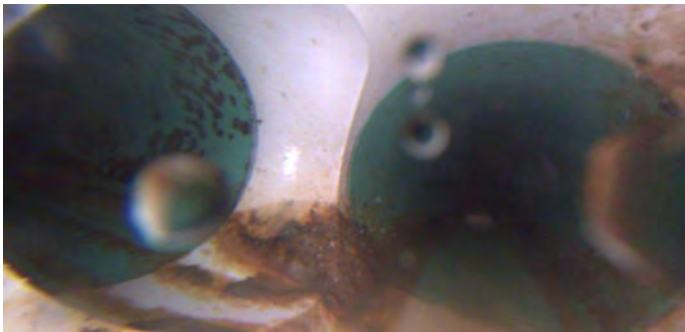
Code:	<b>TFA</b>
Description:	<b>Tap Factory Active</b>

Distance (ft):	<b>29.9</b>
Structural Grade:	<b>0</b>
O&M Grade:	<b>0</b>
Clock Start/From:	<b>9</b>
Clock To:	
1st Value:	<b>4.000</b>
2nd Value:	
Value Percent:	
Continuous Index:	
Within 8" of Joint:	
Remarks:

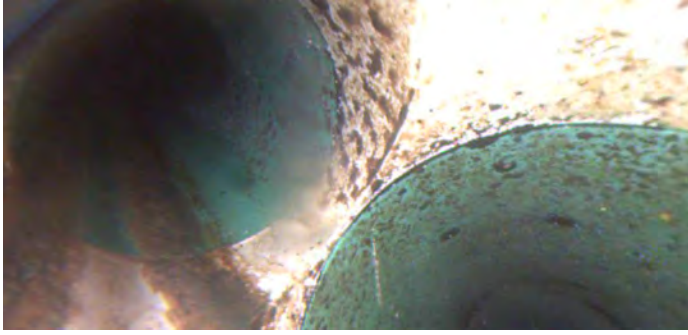
Code: **TF**  
Description: **Tap Factory**

Distance (ft): **62.1**  
Structural Grade: **0**  
O&M Grade: **0**  
Clock Start/From: **2**  
Clock To:  
1st Value: **4.000**  
2nd Value:  
Value Percent:  
Continuous Index:  
Within 8" of Joint:  
Remarks:

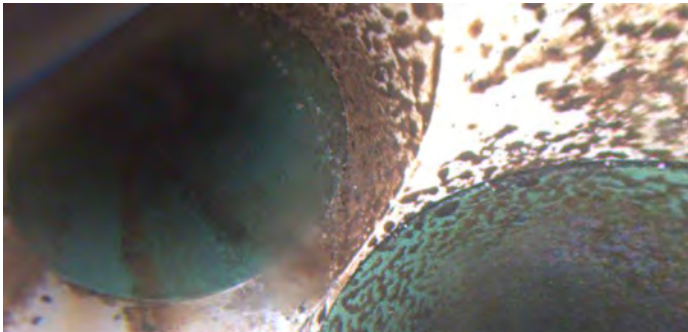
Code: **TF**  
Description: **Tap Factory**

Distance (ft): **146.9**  
Structural Grade: **0**  
O&M Grade: **0**  
Clock Start/From: **2**  
Clock To:  
1st Value: **4.000**  
2nd Value:  
Value Percent:  
Continuous Index:  
Within 8" of Joint:  
Remarks:

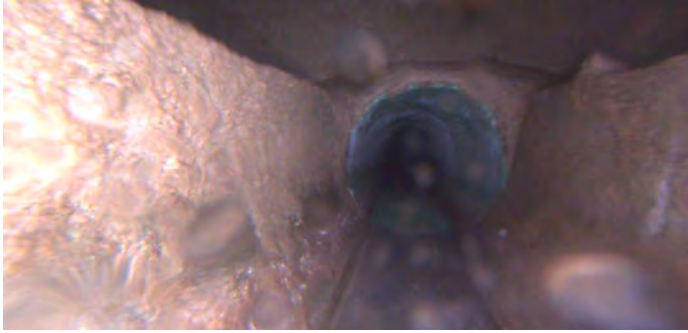
Code:	<b>AMH</b>
Description:	<b>Manhole</b>
Distance (ft):	<b>175.9</b>
Structural Grade:	<b>0</b>
O&M Grade:	<b>0</b>
Clock Start/From:	
Clock To:	
1st Value:	
2nd Value:	
Value Percent:	
Continuous Index:	
Within 8" of Joint:	<b>NO</b>
Remarks:	<b>M-1004-089</b>
