Profile/Photo Observation Report

Street:	Cypress Ln.	Flow Control:	Not Controlled
City:	Hobart, IN	Year Renewed:	
Location:	Other	Tape/Media #:	
Purpose:	Not Known	Dia/Height:	8"
Use:	Sanitary	Material:	PVC
Drain Area:	NA	Lining:	
Category:	NA		
Comment:

Location Details:		Direction of Survey:	Upstream
US MH:	M-1004-089	DS MH:	M-1004-088
		Total Length Surveyed (ft):	175.9

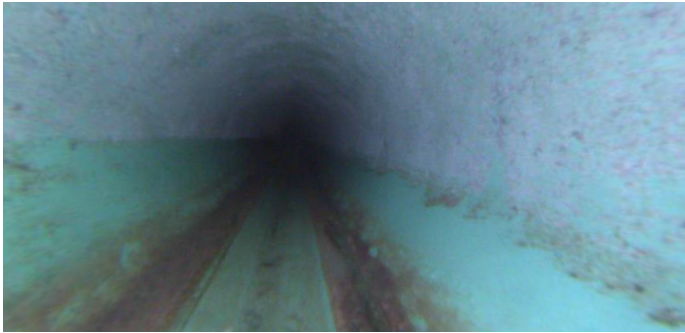
Code:	MWL
Description:	Water Level

Distance (ft):	.0
Structural Grade:	0
O&M Grade:	0
Clock Start/From:	
Clock To:	
1st Value:	
2nd Value:	
Value Percent:	5.000
Continuous Index:	
Within 8" of Joint:	NO
Remarks:

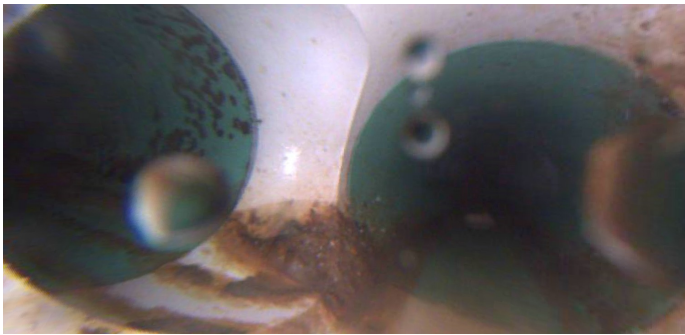
Code:	TFA
Description:	Tap Factory Active

Distance (ft):	29.9
Structural Grade:	0
O&M Grade:	0
Clock Start/From:	9
Clock To:	
1st Value:	4.000
2nd Value:	
Value Percent:	
Continuous Index:	
Within 8" of Joint:	
Remarks:

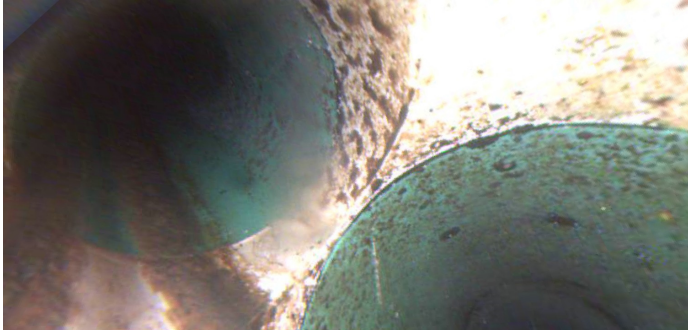
Code: **TF**
Description: **Tap Factory**

Distance (ft): **62.1**
Structural Grade: **0**
O&M Grade: **0**
Clock Start/From: **2**
Clock To:
1st Value: **4.000**
2nd Value:
Value Percent:
Continuous Index:
Within 8" of Joint:
Remarks:

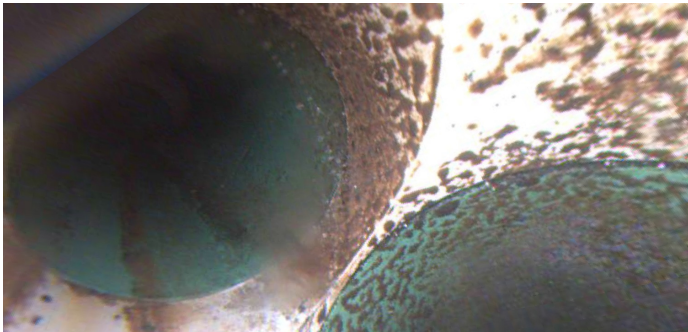
Code: **TF**
Description: **Tap Factory**

Distance (ft): **146.9**
Structural Grade: **0**
O&M Grade: **0**
Clock Start/From: **2**
Clock To:
1st Value: **4.000**
2nd Value:
Value Percent:
Continuous Index:
Within 8" of Joint:
Remarks:

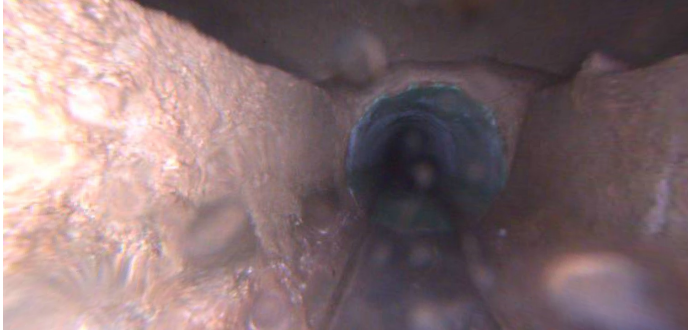
Code:	AMH
Description:	Manhole
Distance (ft):	175.9
Structural Grade:	0
O&M Grade:	0
Clock Start/From:	
Clock To:	
1st Value:	
2nd Value:	
Value Percent:	
Continuous Index:	
Within 8" of Joint:	NO
Remarks:	M-1004-089
