## Profile/Photo Observation Report

Street:	<b>CYPRESS LN</b>	Flow Control:	<b>Not Controlled</b>
City:	<b>Hobart, IN</b>	Year Renewed:	
Location:	<b>Other</b>	Tape/Media #:	
Purpose:	<b>Not Known</b>	Dia/Height:	<b>8"</b>
Use:	<b>Sanitary</b>	Material:	<b>PVC</b>
Drain Area:	<b>NA</b>	Lining:	
Category:	<b>NA</b>		
Comment:

Location Details:		Direction of Survey:	<b>Downstream</b>
US MH:	<b>M-1004-090</b>	DS MH:	<b>M-1004-089</b>
		Total Length Surveyed (ft):	<b>67.2</b>

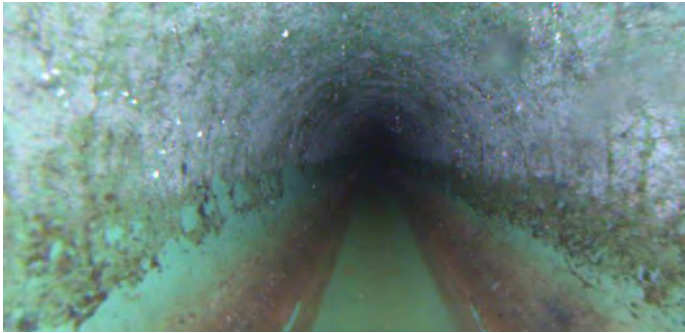
Code:	<b>MWL</b>
Description:	<b>Water Level</b>

Distance (ft):	<b>.0</b>
Structural Grade:	<b>0</b>
O&M Grade:	<b>0</b>
Clock Start/From:	
Clock To:	
1st Value:	
2nd Value:	
Value Percent:	<b>5.000</b>
Continuous Index:	
Within 8" of Joint:	<b>NO</b>
Remarks:

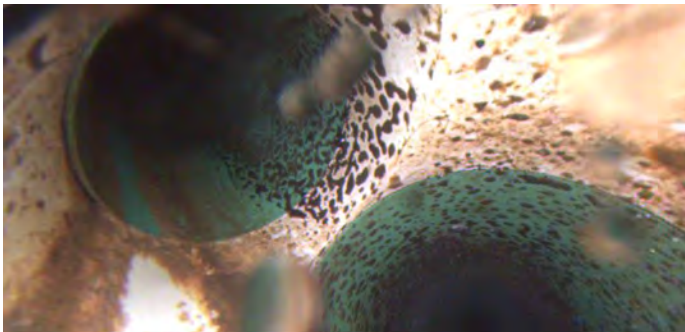
Code:	<b>TF</b>
Description:	<b>Tap Factory</b>

Distance (ft):	<b>22.0</b>
Structural Grade:	<b>0</b>
O&M Grade:	<b>0</b>
Clock Start/From:	<b>10</b>
Clock To:	
1st Value:	<b>4.000</b>
2nd Value:	
Value Percent:	
Continuous Index:	
Within 8" of Joint:	
Remarks:

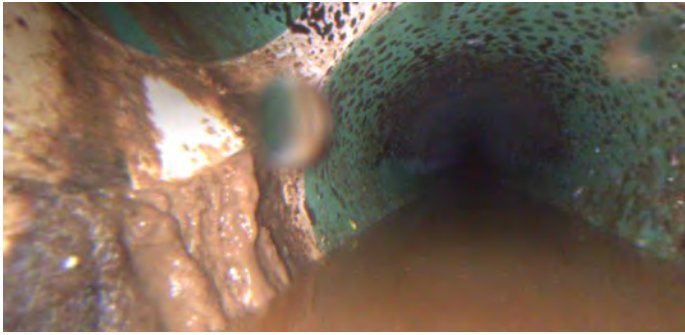
Code: **DAGS**  
Description: **Deposits Attached Grease**

Distance (ft): **22.0**  
Structural Grade: **0**  
O&M Grade: **2**  
Clock Start/From: **9**  
Clock To:  
1st Value:  
2nd Value:  
Value Percent: **5.000**  
Continuous Index:  
Within 8" of Joint: **NO**  
Remarks:

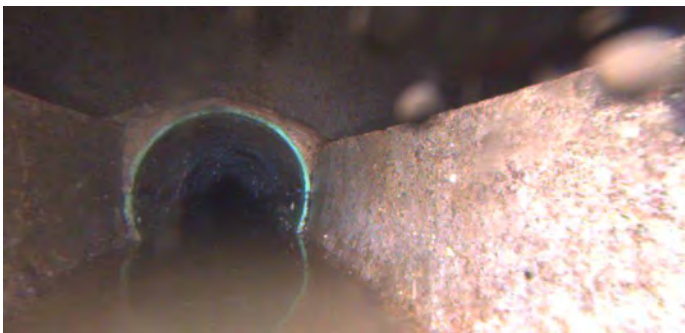
Code: **AMH**  
Description: **Manhole**

Distance (ft): **67.2**  
Structural Grade: **0**  
O&M Grade: **0**  
Clock Start/From:  
Clock To:  
1st Value:  
2nd Value:  
Value Percent:  
Continuous Index:  
Within 8" of Joint: **NO**  
Remarks: **M-1004-089**
