Profile/Photo Observation Report

Street:	Cypress Ln.	Flow Control:	Not Controlled
City:	Hobart, IN	Year Renewed:	
Location:	Other	Tape/Media #:	
Purpose:	Not Known	Dia/Height:	8"
Use:	Sanitary	Material:	PVC
Drain Area:	NA	Lining:	
Category:	NA		
Comment:

Location Details:		Direction of Survey:	Downstream
US MH:	M-1004-090	DS MH:	M-1004-089
		Total Length Surveyed (ft):	67.2

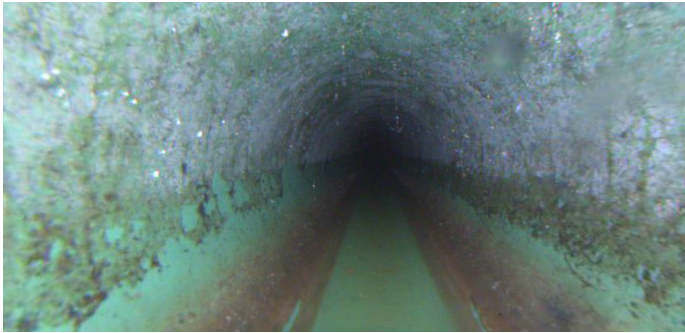
Code:	MWL
Description:	Water Level

Distance (ft):	.0
Structural Grade:	0
O&M Grade:	0
Clock Start/From:	
Clock To:	
1st Value:	
2nd Value:	
Value Percent:	5.000
Continuous Index:	
Within 8" of Joint:	NO
Remarks:

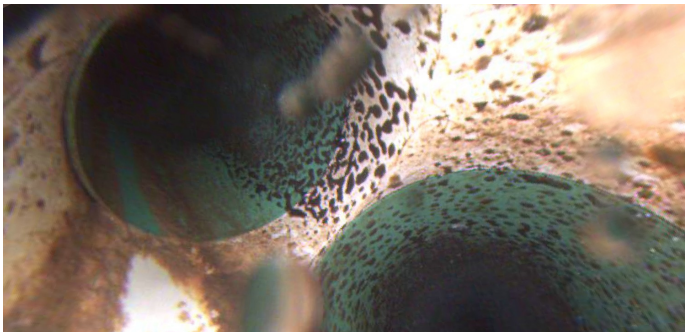
Code:	TF
Description:	Tap Factory

Distance (ft):	22.0
Structural Grade:	0
O&M Grade:	0
Clock Start/From:	10
Clock To:	
1st Value:	4.000
2nd Value:	
Value Percent:	
Continuous Index:	
Within 8" of Joint:	
Remarks:

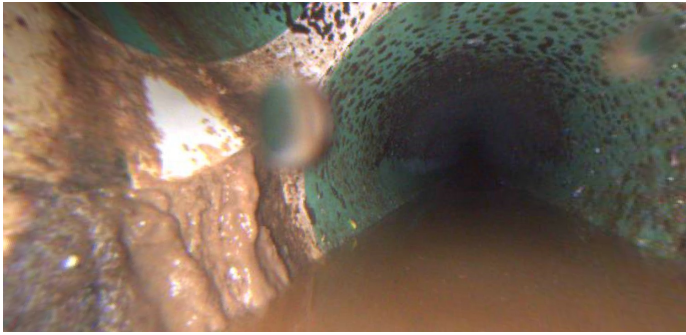
Code: **DAGS**
Description: **Deposits Attached Grease**

Distance (ft): **22.0**
Structural Grade: **0**
O&M Grade: **2**
Clock Start/From: **9**
Clock To:
1st Value:
2nd Value:
Value Percent: **5.000**
Continuous Index:
Within 8" of Joint: **NO**
Remarks:

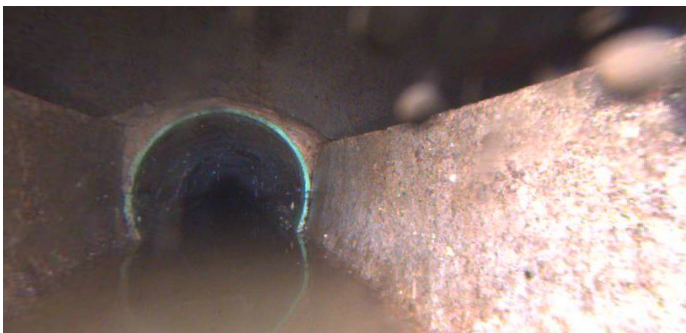
Code: **AMH**
Description: **Manhole**

Distance (ft): **67.2**
Structural Grade: **0**
O&M Grade: **0**
Clock Start/From:
Clock To:
1st Value:
2nd Value:
Value Percent:
Continuous Index:
Within 8" of Joint: **NO**
Remarks: **M-1004-089**
