Profile/Photo Observation Report

Street:	CYPRESS LN	Flow Control:	Not Controlled
City:	Hobart, IN	Year Renewed:	
Location:	Other	Tape/Media #:	
Purpose:	Not Known	Dia/Height:	8"
Use:	Sanitary	Material:	PVC
Drain Area:	NA	Lining:	
Category:	NA		
Comment:

Location Details:		Direction of Survey:	Upstream
US MH:	M-1004-092	DS MH:	M-1004-091
		Total Length Surveyed (ft):	209.5

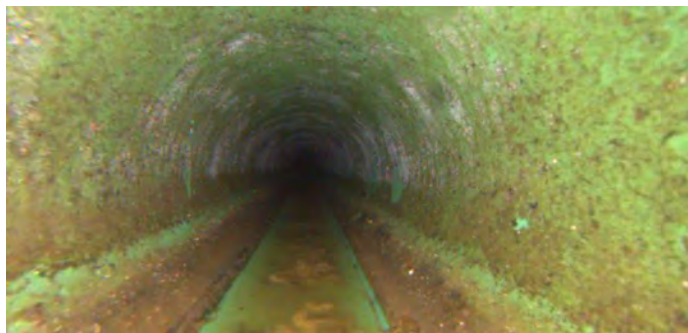
Code: **AMH**
Description: **Manhole**

Distance (ft): **.0**
Structural Grade: **0**
O&M Grade: **0**
Clock Start/From:
Clock To:
1st Value:
2nd Value:
Value Percent:
Continuous Index:
Within 8" of Joint: **NO**
Remarks: **M-1004-091**

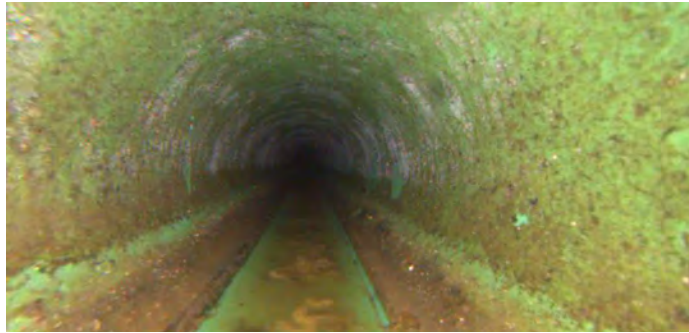
Code:	MWL
Description:	Water Level
Distance (ft):	.0
Structural Grade:	0
O&M Grade:	0
Clock Start/From:	
Clock To:	
1st Value:	
2nd Value:	
Value Percent:	5.000
Continuous Index:	
Within 8" of Joint:	NO
Remarks:

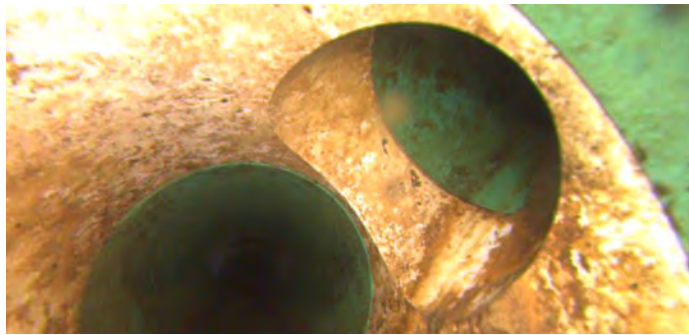
Code:	TF
Description:	Tap Factory
Distance (ft):	11.1
Structural Grade:	0
O&M Grade:	0
Clock Start/From:	2
Clock To:	
1st Value:	4.000
2nd Value:	
Value Percent:	
Continuous Index:	
Within 8" of Joint:	
Remarks:

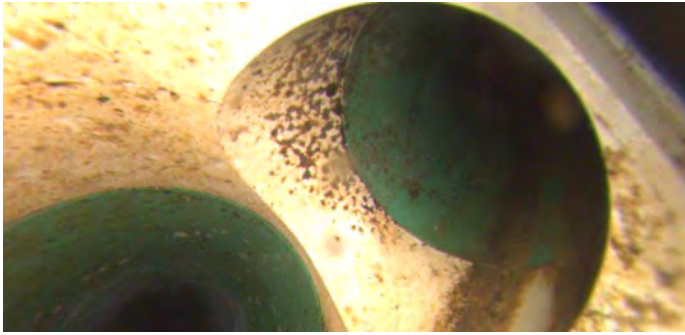
Code: **TF**
Description: **Tap Factory**

Distance (ft): **73.9**
Structural Grade: **0**
O&M Grade: **0**
Clock Start/From: **2**
Clock To:
1st Value: **4.000**
2nd Value:
Value Percent:
Continuous Index:
Within 8" of Joint:
Remarks:

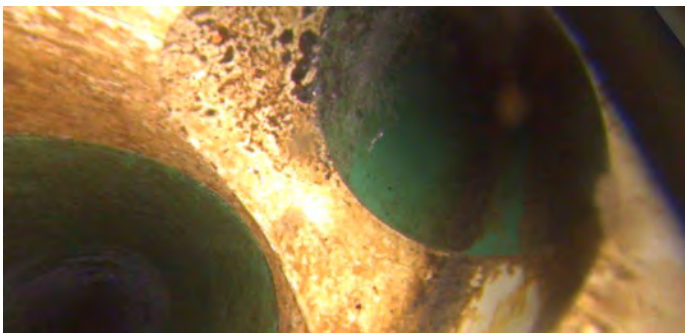
Code: **TF**
Description: **Tap Factory**

Distance (ft): **143.0**
Structural Grade: **0**
O&M Grade: **0**
Clock Start/From: **2**
Clock To:
1st Value: **4.000**
2nd Value:
Value Percent:
Continuous Index:
Within 8" of Joint:
Remarks:

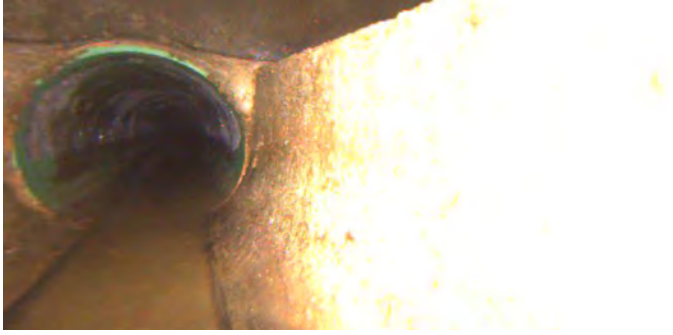
Code:	AMH
Description:	Manhole
Distance (ft):	209.5
Structural Grade:	0
O&M Grade:	0
Clock Start/From:	
Clock To:	
1st Value:	
2nd Value:	
Value Percent:	
Continuous Index:	
Within 8" of Joint:	NO
Remarks:	M-1004-092
