## Profile/Photo Observation Report

Street:	<b>Cypress Ln.</b>	Flow Control:	<b>Not Controlled</b>
City:	<b>Hobart, IN</b>	Year Renewed:	
Location:	<b>Other</b>	Tape/Media #:	
Purpose:	<b>Not Known</b>	Dia/Height:	<b>8"</b>
Use:	<b>Sanitary</b>	Material:	<b>PVC</b>
Drain Area:	<b>NA</b>	Lining:	
Category:	<b>NA</b>		
Comment:

Location Details:		Direction of Survey:	<b>Upstream</b>
US MH:	<b>M-1004-092</b>	DS MH:	<b>M-1004-091</b>
		Total Length Surveyed (ft):	<b>209.5</b>

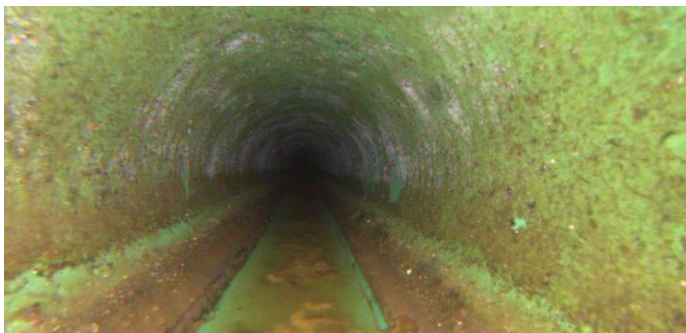
Code: **AMH**  
Description: **Manhole**

Distance (ft): **.0**  
Structural Grade: **0**  
O&M Grade: **0**  
Clock Start/From:  
Clock To:  
1st Value:  
2nd Value:  
Value Percent:  
Continuous Index:  
Within 8" of Joint: **NO**  
Remarks: **M-1004-091**

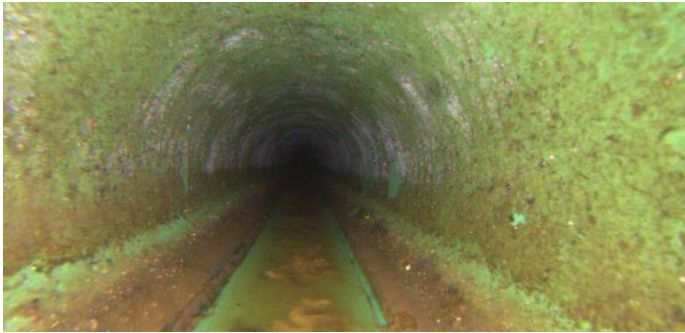
Code:	<b>MWL</b>
Description:	<b>Water Level</b>

Distance (ft):	<b>.0</b>
Structural Grade:	<b>0</b>
O&M Grade:	<b>0</b>
Clock Start/From:	
Clock To:	
1st Value:	
2nd Value:	
Value Percent:	<b>5.000</b>
Continuous Index:	
Within 8" of Joint:	<b>NO</b>
Remarks:

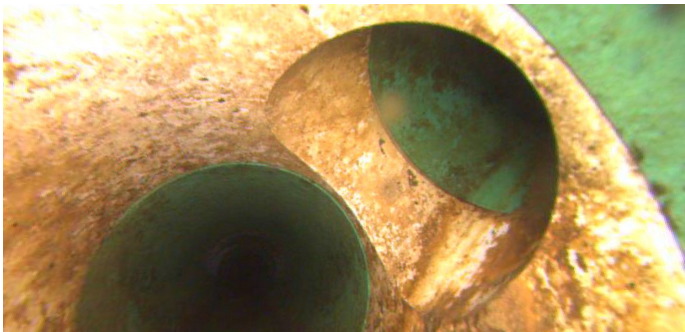
Code:	<b>TF</b>
Description:	<b>Tap Factory</b>

Distance (ft):	<b>11.1</b>
Structural Grade:	<b>0</b>
O&M Grade:	<b>0</b>
Clock Start/From:	<b>2</b>
Clock To:	
1st Value:	<b>4.000</b>
2nd Value:	
Value Percent:	
Continuous Index:	
Within 8" of Joint:	
Remarks:

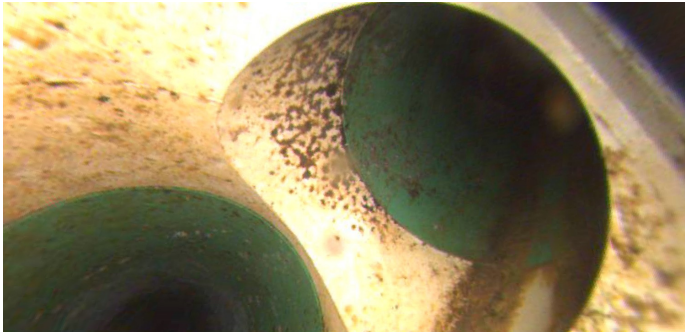
Code: **TF**  
Description: **Tap Factory**

Distance (ft): **73.9**  
Structural Grade: **0**  
O&M Grade: **0**  
Clock Start/From: **2**  
Clock To:  
1st Value: **4.000**  
2nd Value:  
Value Percent:  
Continuous Index:  
Within 8" of Joint:  
Remarks:

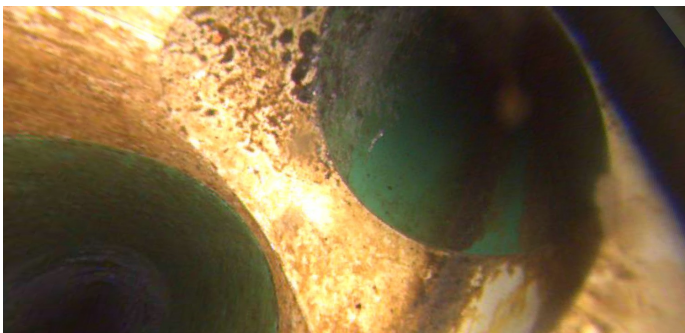
Code: **TF**  
Description: **Tap Factory**

Distance (ft): **143.0**  
Structural Grade: **0**  
O&M Grade: **0**  
Clock Start/From: **2**  
Clock To:  
1st Value: **4.000**  
2nd Value:  
Value Percent:  
Continuous Index:  
Within 8" of Joint:  
Remarks:

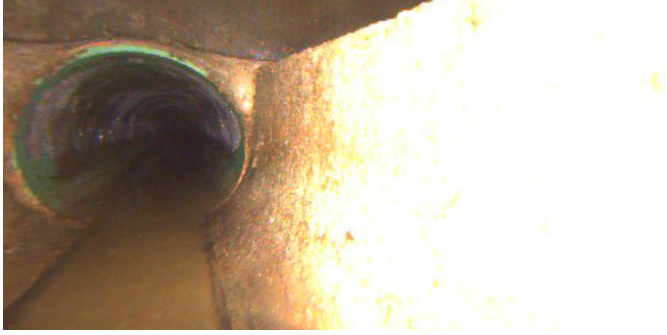
Code:	AMH
Description:	Manhole
Distance (ft):	209.5
Structural Grade:	0
O&M Grade:	0
Clock Start/From:	
Clock To:	
1st Value:	
2nd Value:	
Value Percent:	
Continuous Index:	
Within 8" of Joint:	NO
Remarks:	M-1004-092
