Profile/Photo Observation Report

Street:	HILLCREST AVE & CYPRESS LN	Flow Control:	Not Controlled
City:	Hobart, IN	Year Renewed:	
Location:	Other	Tape/Media #:	
Purpose:	Not Known	Dia/Height:	8"
Use:	Sanitary	Material:	PVC
Drain Area:	NA	Lining:	
Category:	NA		
Comment:

Location Details:		Direction of Survey:	Downstream
US MH:	M-1004-093	DS MH:	M-1004-092
		Total Length Surveyed (ft):	69.3

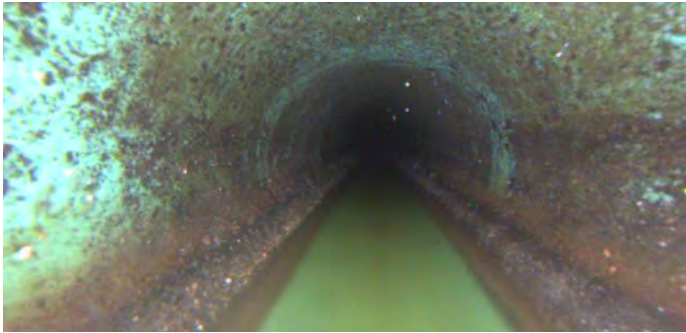
Code: **MWL**
Description: **Water Level**

Distance (ft): **.0**
Structural Grade: **0**
O&M Grade: **0**
Clock Start/From:
Clock To:
1st Value:
2nd Value:
Value Percent: **10.000**
Continuous Index:
Within 8" of Joint: **NO**
Remarks:

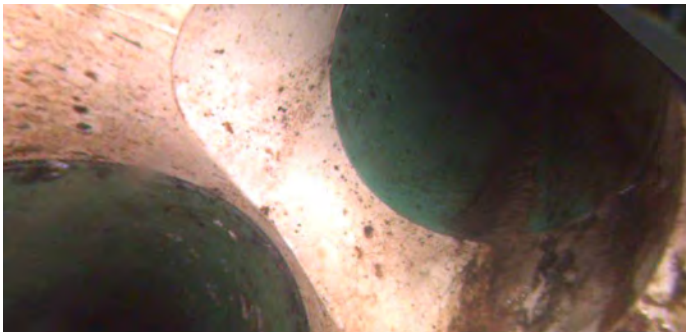
Code: **TF**
Description: **Tap Factory**

Distance (ft): **12.3**
Structural Grade: **0**
O&M Grade: **0**
Clock Start/From: **10**
Clock To:
1st Value: **4.000**
2nd Value:
Value Percent:
Continuous Index:
Within 8" of Joint:
Remarks:

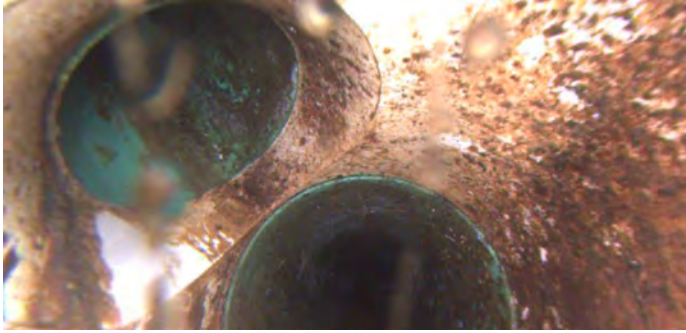
Code: **TF**
Description: **Tap Factory**

Distance (ft): **56.7**
Structural Grade: **0**
O&M Grade: **0**
Clock Start/From: **10**
Clock To:
1st Value: **4.000**
2nd Value:
Value Percent:
Continuous Index:
Within 8" of Joint:
Remarks:

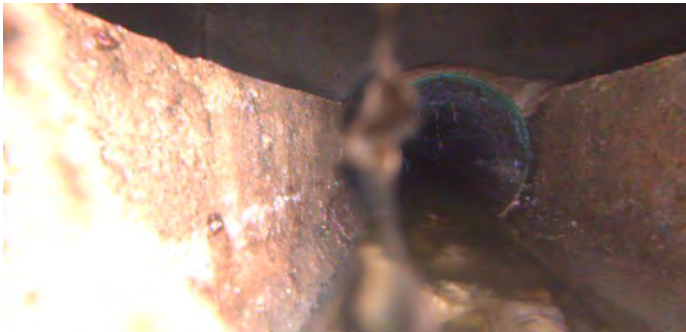
Code: **AMH**
Description: **Manhole**

Distance (ft): **69.3**
Structural Grade: **0**
O&M Grade: **0**
Clock Start/From:
Clock To:
1st Value:
2nd Value:
Value Percent:
Continuous Index:
Within 8" of Joint: **NO**
Remarks: **M-1004-092**
