Profile/Photo Observation Report

Street:	Cypress Ln.	Flow Control:	Not Controlled
City:	Hobart, IN	Year Renewed:	
Location:	Other	Tape/Media #:	
Purpose:	Not Known	Dia/Height:	8"
Use:	Sanitary	Material:	PVC
Drain Area:	NA	Lining:	
Category:	NA		
Comment:

Location Details:		Direction of Survey:	Downstream
US MH:	M-1004-093	DS MH:	M-1004-092
		Total Length Surveyed (ft):	69.3

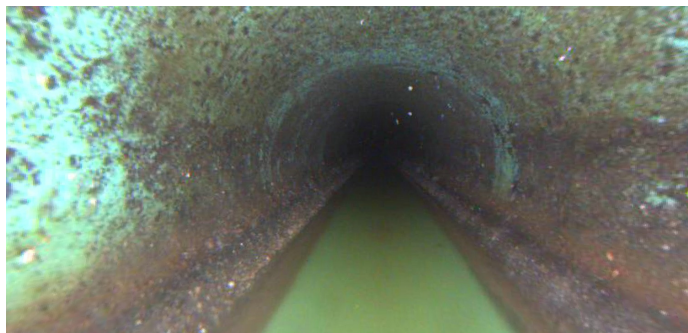
Code: **AMH**
 Description: **Manhole**

Distance (ft): **.0**
 Structural Grade: **0**
 O&M Grade: **0**
 Clock Start/From:
 Clock To:
 1st Value:
 2nd Value:
 Value Percent:
 Continuous Index:
 Within 8" of Joint: **NO**
 Remarks: **M-1004-093**

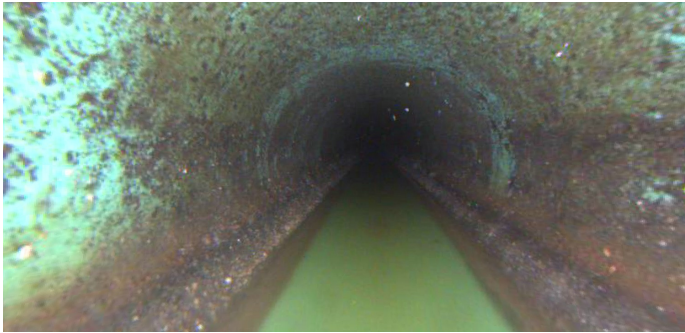
Code: **MWL**
Description: **Water Level**

Distance (ft): **.0**
Structural Grade: **0**
O&M Grade: **0**
Clock Start/From:
Clock To:
1st Value:
2nd Value:
Value Percent: **10.000**
Continuous Index:
Within 8" of Joint: **NO**
Remarks:

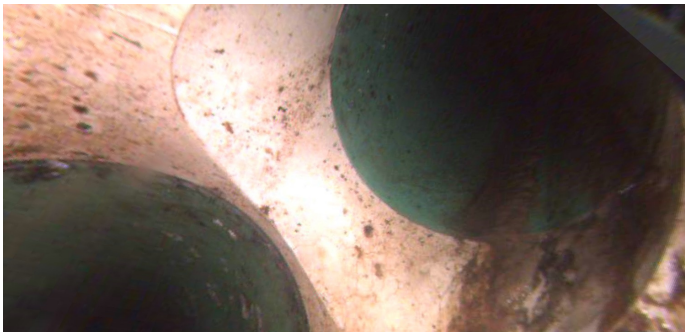
Code: **TF**
Description: **Tap Factory**

Distance (ft): **12.3**
Structural Grade: **0**
O&M Grade: **0**
Clock Start/From: **10**
Clock To:
1st Value: **4.000**
2nd Value:
Value Percent:
Continuous Index:
Within 8" of Joint:
Remarks:

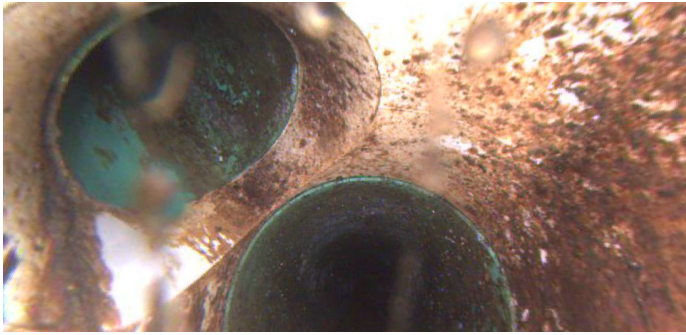
Code: **TF**
Description: **Tap Factory**

Distance (ft): **56.7**
Structural Grade: **0**
O&M Grade: **0**
Clock Start/From: **10**
Clock To:
1st Value: **4.000**
2nd Value:
Value Percent:
Continuous Index:
Within 8" of Joint:
Remarks:

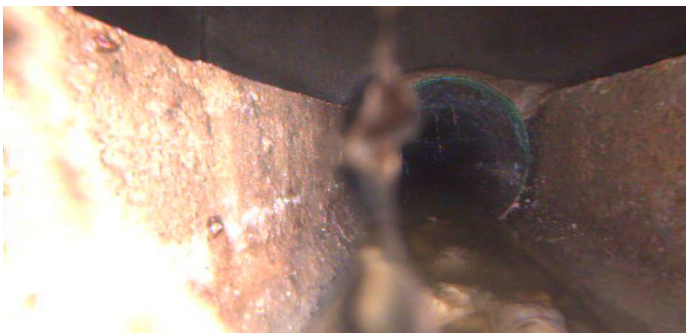
Code: **AMH**
Description: **Manhole**

Distance (ft): **69.3**
Structural Grade: **0**
O&M Grade: **0**
Clock Start/From:
Clock To:
1st Value:
2nd Value:
Value Percent:
Continuous Index:
Within 8" of Joint: **NO**
Remarks: **M-1004-092**
