Profile/Photo Observation Report

Street:	HILLCREST AVE	Flow Control:	Not Controlled
City:	Hobart, IN	Year Renewed:	
Location:	Other	Tape/Media #:	
Purpose:	Not Known	Dia/Height:	8"
Use:	Sanitary	Material:	PVC
Drain Area:	NA	Lining:	
Category:	NA		
Comment:

Location Details:		Direction of Survey:	Upstream
US MH:	M-1004-094	DS MH:	M-1004-093
		Total Length Surveyed (ft):	67.5

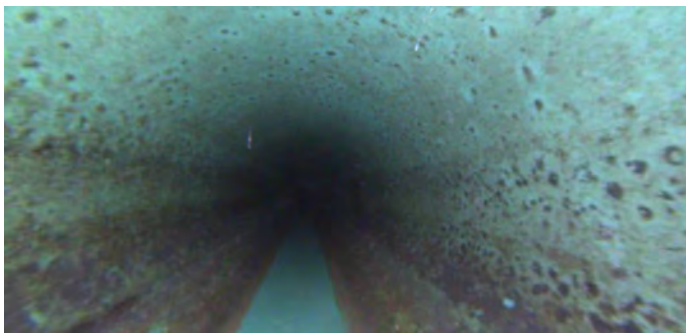
Code: **AMH**
Description: **Manhole**

Distance (ft):	.0
Structural Grade:	0
O&M Grade:	0
Clock Start/From:	
Clock To:	
1st Value:	
2nd Value:	
Value Percent:	
Continuous Index:	
Within 8" of Joint:	NO
Remarks:	M-1004-093

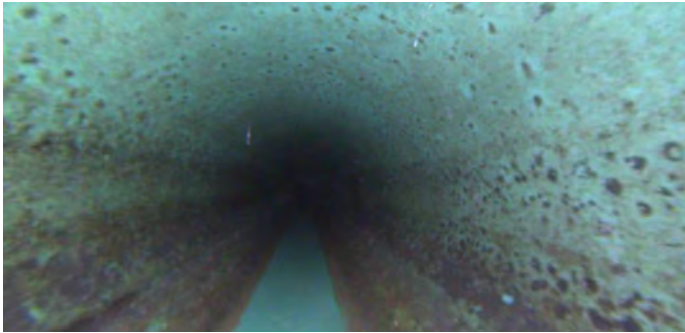
Code:	MWL
Description:	Water Level

Distance (ft):	.0
Structural Grade:	0
O&M Grade:	0
Clock Start/From:	
Clock To:	
1st Value:	
2nd Value:	
Value Percent:	5.000
Continuous Index:	
Within 8" of Joint:	NO
Remarks:

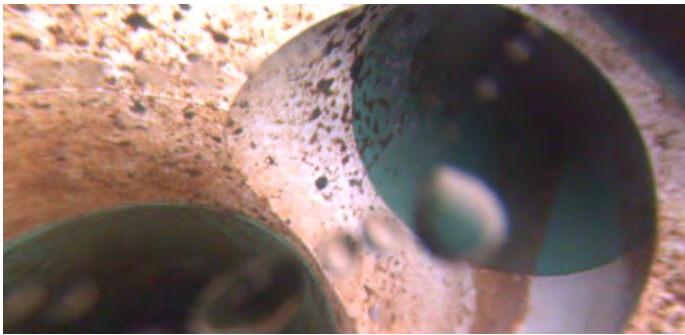
Code:	TF
Description:	Tap Factory

Distance (ft):	34.3
Structural Grade:	0
O&M Grade:	0
Clock Start/From:	2
Clock To:	
1st Value:	4.000
2nd Value:	
Value Percent:	
Continuous Index:	
Within 8" of Joint:	
Remarks:

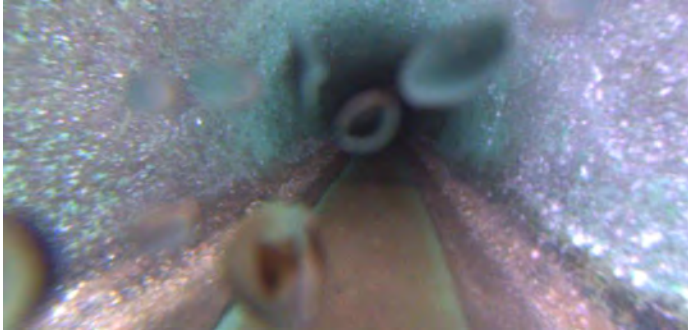
Code:	AMH
Description:	Manhole
Distance (ft):	67.5
Structural Grade:	0
O&M Grade:	0
Clock Start/From:	
Clock To:	
1st Value:	
2nd Value:	
Value Percent:	
Continuous Index:	
Within 8" of Joint:	NO
Remarks:	M-1004-094
