Profile/Photo Observation Report

Street:	Cypress Ln.	Flow Control:	Not Controlled
City:	Hobart, IN	Year Renewed:	
Location:	Other	Tape/Media #:	
Purpose:	Not Known	Dia/Height:	8"
Use:	Sanitary	Material:	PVC
Drain Area:	NA	Lining:	
Category:	NA		
Comment:

Location Details:		Direction of Survey:	Upstream
US MH:	M-1004-094	DS MH:	M-1004-093
		Total Length Surveyed (ft):	67.5

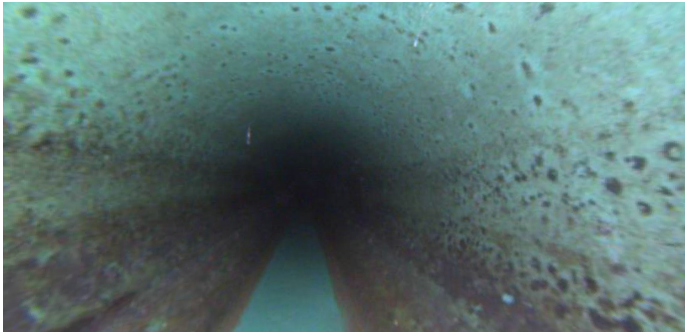
Code:	MWL
Description:	Water Level

Distance (ft):	.0
Structural Grade:	0
O&M Grade:	0
Clock Start/From:	
Clock To:	
1st Value:	
2nd Value:	
Value Percent:	5.000
Continuous Index:	
Within 8" of Joint:	NO
Remarks:

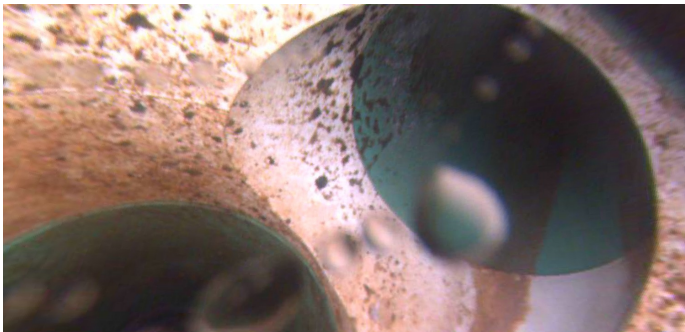
Code:	TF
Description:	Tap Factory

Distance (ft):	34.3
Structural Grade:	0
O&M Grade:	0
Clock Start/From:	2
Clock To:	
1st Value:	4.000
2nd Value:	
Value Percent:	
Continuous Index:	
Within 8" of Joint:	
Remarks:

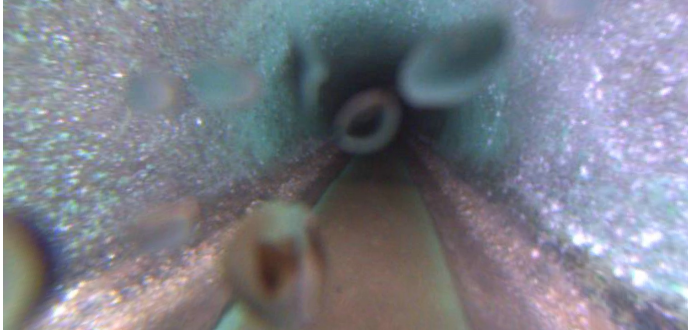
Code:	AMH
Description:	Manhole
Distance (ft):	67.5
Structural Grade:	0
O&M Grade:	0
Clock Start/From:	
Clock To:	
1st Value:	
2nd Value:	
Value Percent:	
Continuous Index:	
Within 8" of Joint:	NO
Remarks:	M-1004-094
