## Profile/Photo Observation Report

Street:	<b>LAUREL CT</b>	Flow Control:	<b>Not Controlled</b>
City:	<b>Hobart, IN</b>	Year Renewed:	
Location:	<b>Other</b>	Tape/Media #:	
Purpose:	<b>Not Known</b>	Dia/Height:	<b>8"</b>
Use:	<b>Sanitary</b>	Material:	<b>PVC</b>
Drain Area:	<b>NA</b>	Lining:	
Category:	<b>NA</b>		
Comment:

Location Details:		Direction of Survey:	<b>Upstream</b>
US MH:	<b>M-1004-095</b>	DS MH:	<b>M-1004-057</b>
		Total Length Surveyed (ft):	<b>234.3</b>

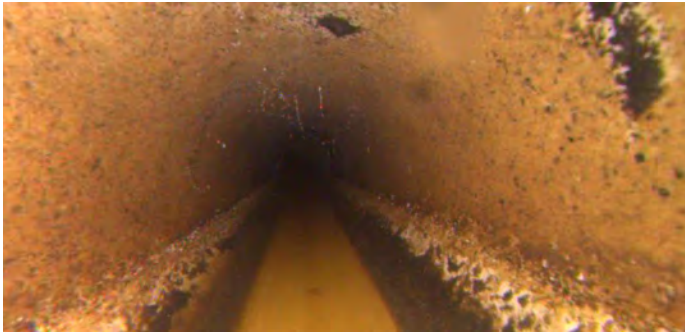
Code:	<b>MWL</b>
Description:	<b>Water Level</b>

Distance (ft):	<b>.0</b>
Structural Grade:	<b>0</b>
O&M Grade:	<b>0</b>
Clock Start/From:	
Clock To:	
1st Value:	
2nd Value:	
Value Percent:	<b>5.000</b>
Continuous Index:	
Within 8" of Joint:	<b>NO</b>
Remarks:

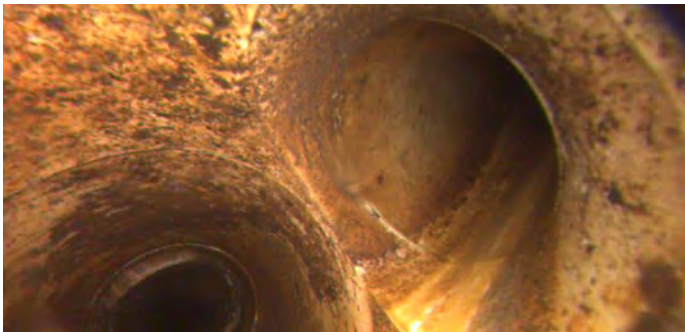
Code:	<b>TF</b>
Description:	<b>Tap Factory</b>

Distance (ft):	<b>94.8</b>
Structural Grade:	<b>0</b>
O&M Grade:	<b>0</b>
Clock Start/From:	<b>1</b>
Clock To:	
1st Value:	<b>4.000</b>
2nd Value:	
Value Percent:	
Continuous Index:	
Within 8" of Joint:	
Remarks:

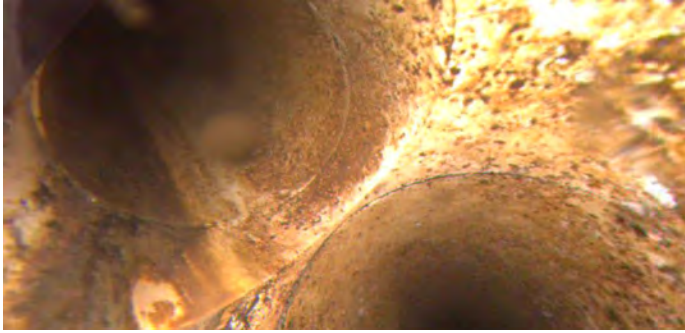
Code: **TF**  
Description: **Tap Factory**

Distance (ft): **96.5**  
Structural Grade: **0**  
O&M Grade: **0**  
Clock Start/From: **11**  
Clock To:  
1st Value: **4.000**  
2nd Value:  
Value Percent:  
Continuous Index:  
Within 8" of Joint:  
Remarks:

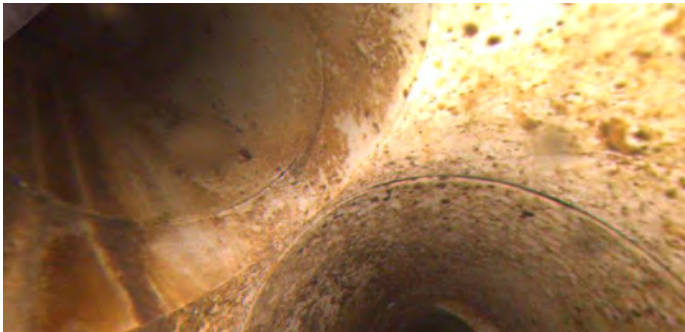
Code: **TF**  
Description: **Tap Factory**

Distance (ft): **173.9**  
Structural Grade: **0**  
O&M Grade: **0**  
Clock Start/From: **10**  
Clock To:  
1st Value: **4.000**  
2nd Value:  
Value Percent:  
Continuous Index:  
Within 8" of Joint:  
Remarks:

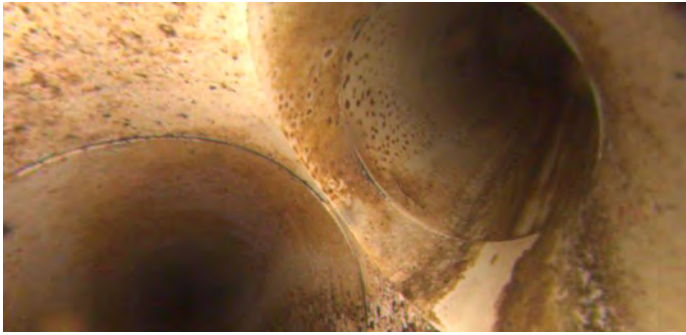
Code: **TF**  
Description: **Tap Factory**

Distance (ft): **175.5**  
Structural Grade: **0**  
O&M Grade: **0**  
Clock Start/From: **2**  
Clock To:  
1st Value: **4.000**  
2nd Value:  
Value Percent:  
Continuous Index:  
Within 8" of Joint:  
Remarks:

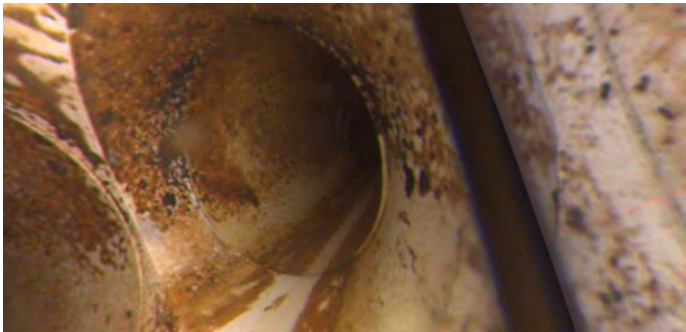
Code: **TF**  
Description: **Tap Factory**

Distance (ft): **220.3**  
Structural Grade: **0**  
O&M Grade: **0**  
Clock Start/From: **2**  
Clock To:  
1st Value: **4.000**  
2nd Value:  
Value Percent:  
Continuous Index:  
Within 8" of Joint:  
Remarks:

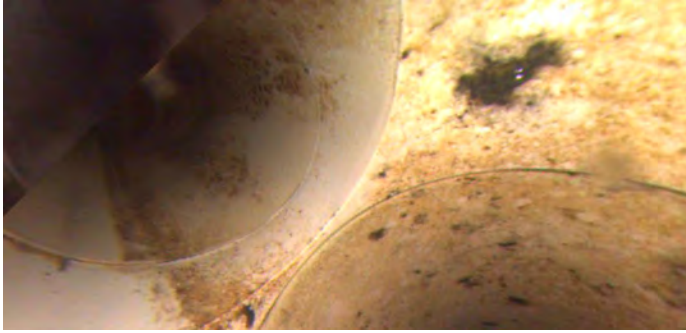
Code: **TF**  
Description: **Tap Factory**

Distance (ft): **222.2**  
Structural Grade: **0**  
O&M Grade: **0**  
Clock Start/From: **10**  
Clock To:  
1st Value: **4.000**  
2nd Value:  
Value Percent:  
Continuous Index:  
Within 8" of Joint:  
Remarks:

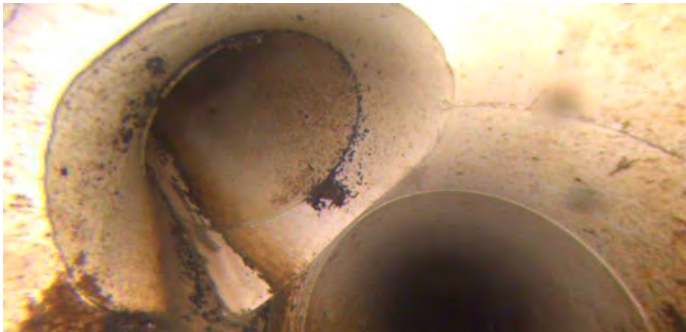
Code: **TF**  
Description: **Tap Factory**

Distance (ft): **223.5**  
Structural Grade: **0**  
O&M Grade: **0**  
Clock Start/From: **10**  
Clock To:  
1st Value: **4.000**  
2nd Value:  
Value Percent:  
Continuous Index:  
Within 8" of Joint:  
Remarks:

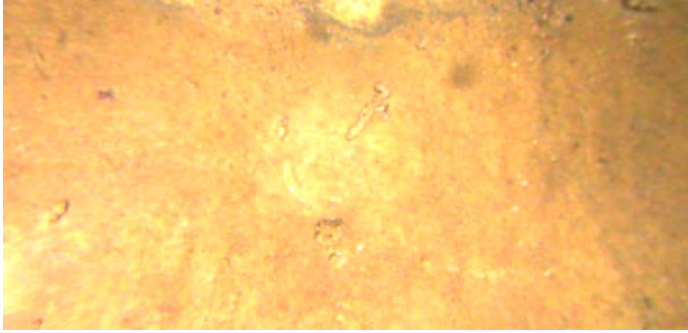
Code:	AMH
Description:	Manhole
Distance (ft):	234.3
Structural Grade:	0
O&M Grade:	0
Clock Start/From:	
Clock To:	
1st Value:	
2nd Value:	
Value Percent:	
Continuous Index:	
Within 8" of Joint:	NO
Remarks:	M-1004-095
