Profile/Photo Observation Report

Street:	Barberry Dr.	Flow Control:	Not Controlled
City:	Hobart, IN	Year Renewed:	
Location:	Other	Tape/Media #:	
Purpose:	Not Known	Dia/Height:	8"
Use:	Sanitary	Material:	PVC
Drain Area:	NA	Lining:	
Category:	NA		
Comment:

Location Details:		Direction of Survey:	Upstream
US MH:	M-1004-095	DS MH:	M-1004-057
		Total Length Surveyed (ft):	234.3

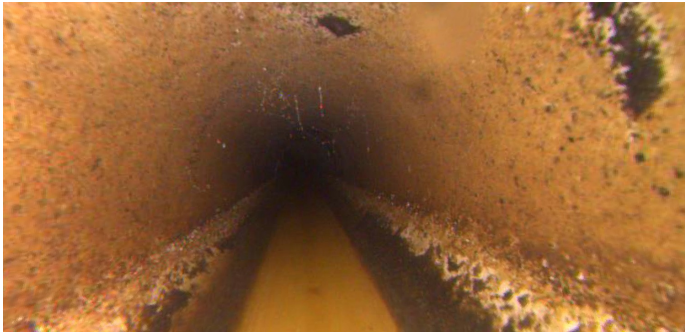
Code:	MWL
Description:	Water Level

Distance (ft):	.0
Structural Grade:	0
O&M Grade:	0
Clock Start/From:	
Clock To:	
1st Value:	
2nd Value:	
Value Percent:	5.000
Continuous Index:	
Within 8" of Joint:	NO
Remarks:

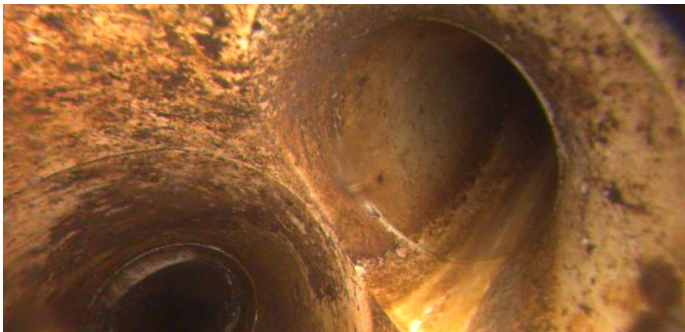
Code:	TF
Description:	Tap Factory

Distance (ft):	94.8
Structural Grade:	0
O&M Grade:	0
Clock Start/From:	1
Clock To:	
1st Value:	4.000
2nd Value:	
Value Percent:	
Continuous Index:	
Within 8" of Joint:	
Remarks:

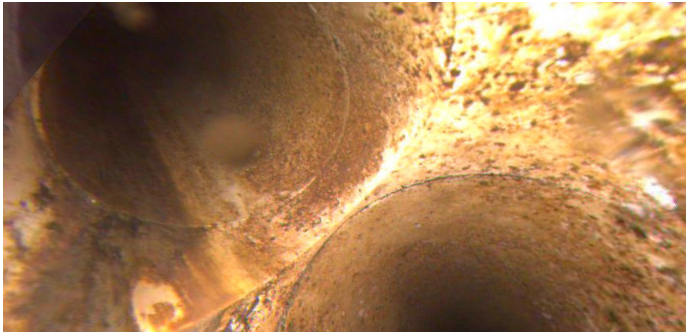
Code: **TF**
Description: **Tap Factory**

Distance (ft): **96.5**
Structural Grade: **0**
O&M Grade: **0**
Clock Start/From: **11**
Clock To:
1st Value: **4.000**
2nd Value:
Value Percent:
Continuous Index:
Within 8" of Joint:
Remarks:

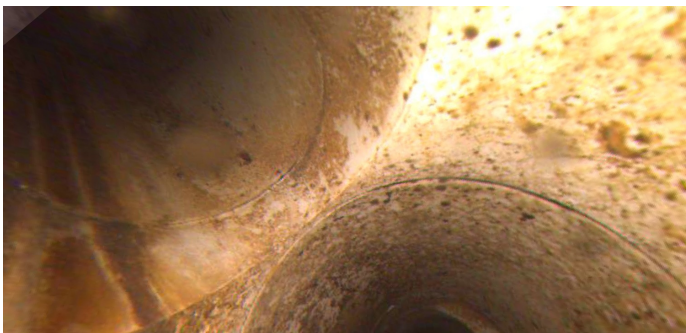
Code: **TF**
Description: **Tap Factory**

Distance (ft): **173.9**
Structural Grade: **0**
O&M Grade: **0**
Clock Start/From: **10**
Clock To:
1st Value: **4.000**
2nd Value:
Value Percent:
Continuous Index:
Within 8" of Joint:
Remarks:

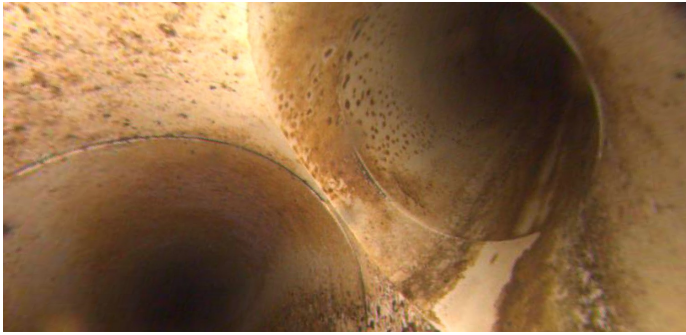
Code: **TF**
Description: **Tap Factory**

Distance (ft): **175.5**
Structural Grade: **0**
O&M Grade: **0**
Clock Start/From: **2**
Clock To:
1st Value: **4.000**
2nd Value:
Value Percent:
Continuous Index:
Within 8" of Joint:
Remarks:

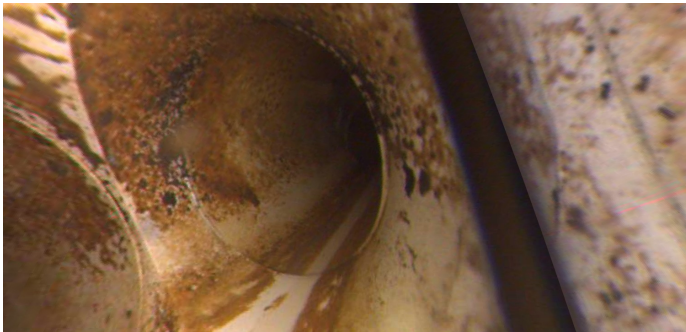
Code: **TF**
Description: **Tap Factory**

Distance (ft): **220.3**
Structural Grade: **0**
O&M Grade: **0**
Clock Start/From: **2**
Clock To:
1st Value: **4.000**
2nd Value:
Value Percent:
Continuous Index:
Within 8" of Joint:
Remarks:

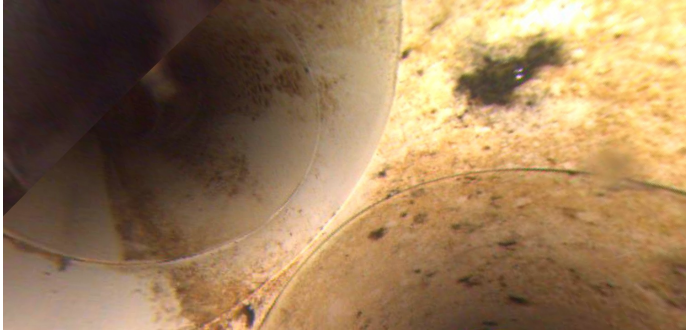
Code: **TF**
Description: **Tap Factory**

Distance (ft): **222.2**
Structural Grade: **0**
O&M Grade: **0**
Clock Start/From: **10**
Clock To:
1st Value: **4.000**
2nd Value:
Value Percent:
Continuous Index:
Within 8" of Joint:
Remarks:

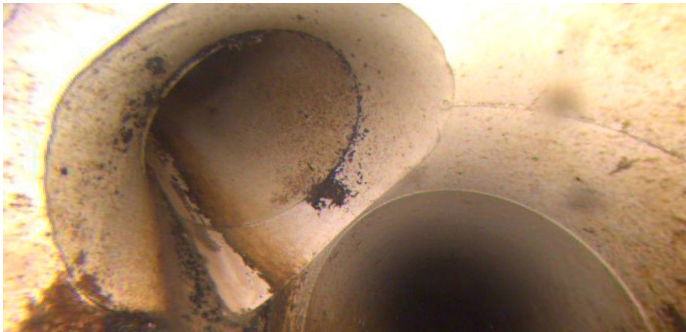
Code: **TF**
Description: **Tap Factory**

Distance (ft): **223.5**
Structural Grade: **0**
O&M Grade: **0**
Clock Start/From: **10**
Clock To:
1st Value: **4.000**
2nd Value:
Value Percent:
Continuous Index:
Within 8" of Joint:
Remarks:

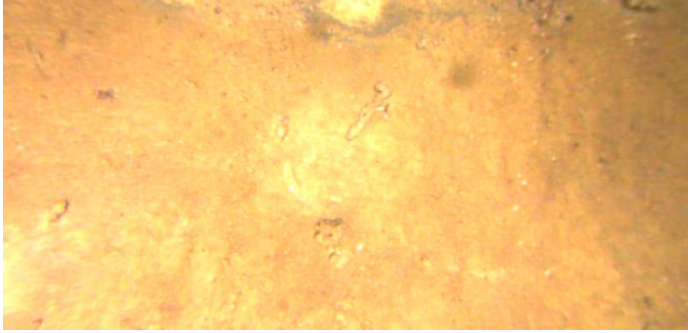
Code:	AMH
Description:	Manhole
Distance (ft):	234.3
Structural Grade:	0
O&M Grade:	0
Clock Start/From:	
Clock To:	
1st Value:	
2nd Value:	
Value Percent:	
Continuous Index:	
Within 8" of Joint:	NO
Remarks:	M-1004-095
