## Profile/Photo Observation Report

Date:	11/03/2022	Weather:		Coding:	PACP 7.0
Pipe Length (ft):	358.0	Owner:	City of Hobart	Pre Clean:	No Pre-Cleaning
P.O.#:	YES502259	Surveyor:	S. Bucklin	PSR:	M-1004-046.1-M-1004-0
Customer:	City of Hobart, IN (Red	Clean Date:		Shape:	C

Street:	Ryan Court	Flow Control:	Not Controlled
City:	Hobart, IN	Year Renewed:	
Location:	Yard	Tape/Media #:	
Purpose:	Routine Assessment	Dia/Height:	8"
Use:	Sanitary Sewage Pipe	Material:	PVC
Drain Area:		Lining:	None
Category:	NA		
Comment:			
Location Details:		Direction of Survey:	Upstream
US MH:	M-1004-046.1	DS MH:	M-1004-046
		Total Length Surveyed (ft):	358.9

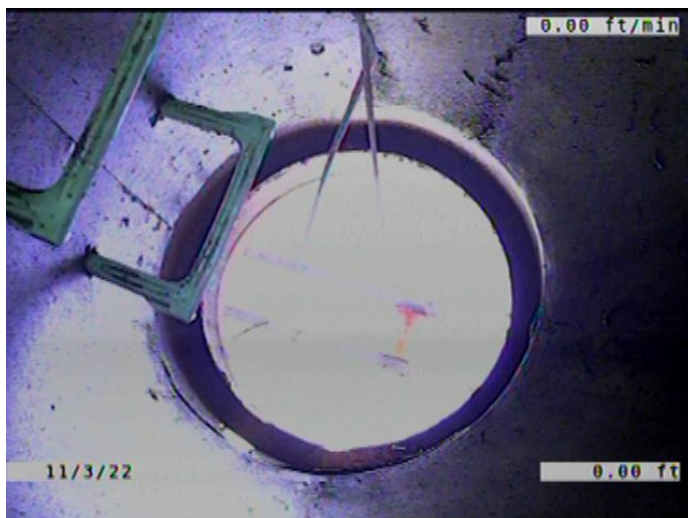
Code: **AMH**  
 Description: **Manhole**

Distance (ft): **.0**  
 Structural Grade: **0**  
 O&M Grade: **0**  
 Clock Start/From:  
 Clock To:  
 1st Value:  
 2nd Value:  
 Value Percent:  
 Continuous Index:  
 Within 8" of Joint: **NO**  
 Remarks: **M-1004-046**

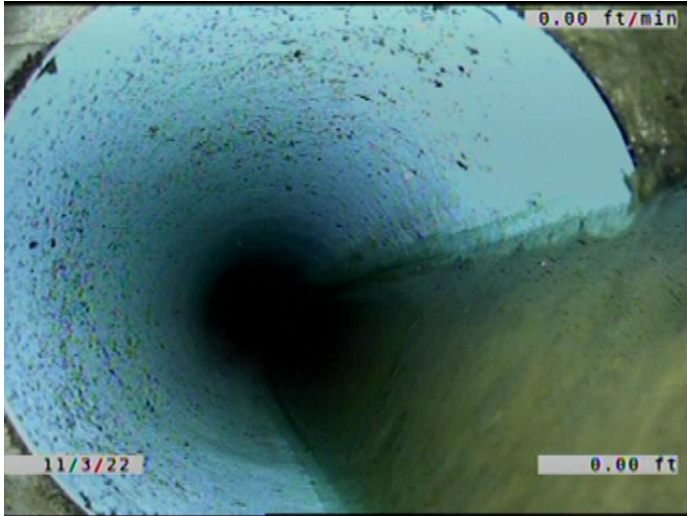
Code: **MWL**  
Description: **Miscellaneous Water Level**

Distance (ft): **.0**  
Structural Grade: **0**  
O&M Grade: **0**  
Clock Start/From:  
Clock To:  
1st Value:  
2nd Value:  
Value Percent: **10.000**  
Continuous Index:  
Within 8" of Joint: **NO**  
Remarks:

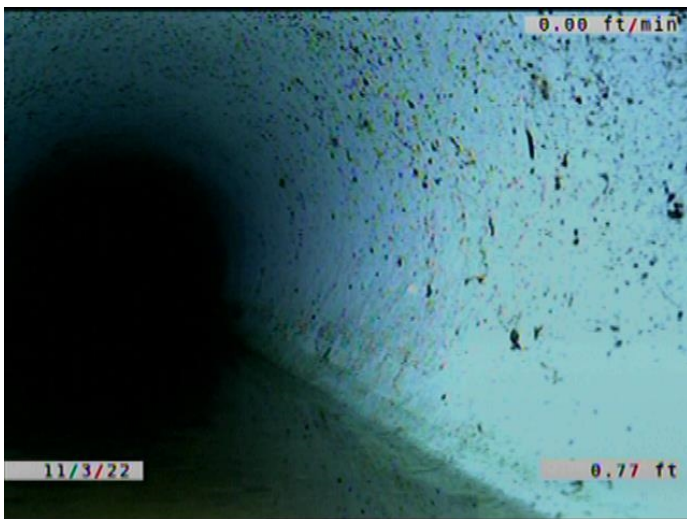
Code: **DSF**  
Description: **Deposits Settled Fine**

Distance (ft): **.8**  
Structural Grade: **0**  
O&M Grade: **2**  
Clock Start/From: **5**  
Clock To: **7**  
1st Value:  
2nd Value:  
Value Percent: **5.000**  
Continuous Index: **S01**  
Within 8" of Joint: **YES**  
Remarks:

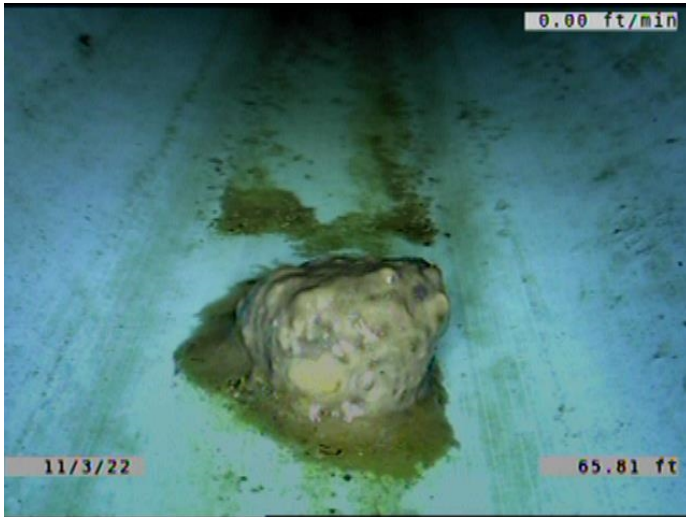
Code: **DSGV**  
Description: **Deposits Settled Gravel**

Distance (ft): **65.8**  
Structural Grade: **0**  
O&M Grade: **2**  
Clock Start/From: **6**  
Clock To:  
1st Value:  
2nd Value:  
Value Percent: **5.000**  
Continuous Index:  
Within 8" of Joint: **NO**  
Remarks:

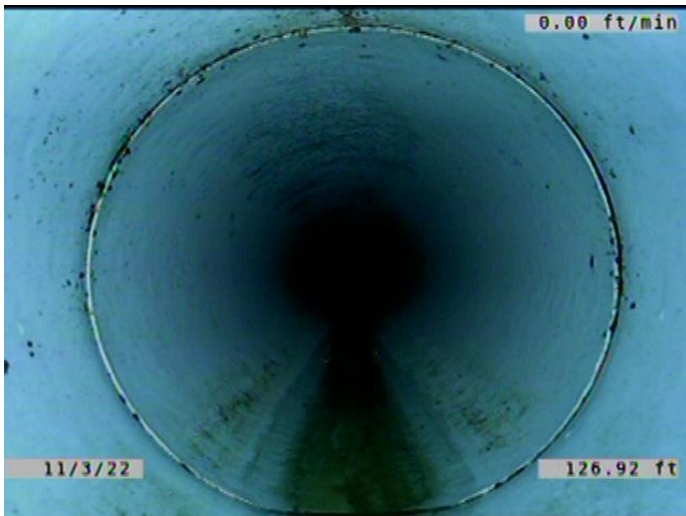
Code: **MWLS**  
Description: **Miscellaneous Water Level Sag**

Distance (ft): **126.9**  
Structural Grade: **2**  
O&M Grade: **0**  
Clock Start/From:  
Clock To:  
1st Value:  
2nd Value:  
Value Percent: **5.000**  
Continuous Index:  
Within 8" of Joint: **NO**  
Remarks:

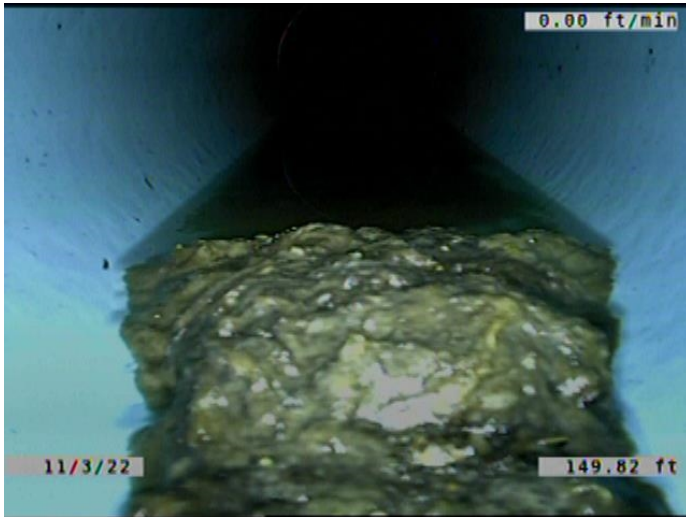
Code: **DSF**  
 Description: **Deposits Settled Fine**

Distance (ft): **149.8**  
 Structural Grade: **0**  
 O&M Grade: **3**  
 Clock Start/From: **5**  
 Clock To: **7**  
 1st Value:  
 2nd Value:  
 Value Percent: **15.000**  
 Continuous Index:  
 Within 8" of Joint: **YES**  
 Remarks:

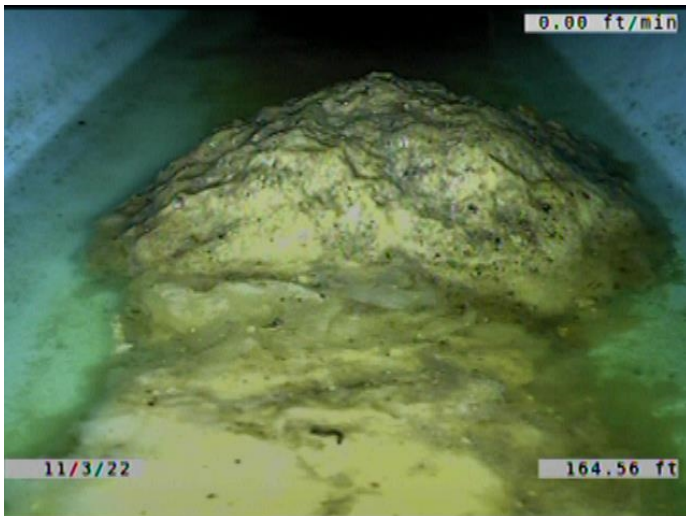
Code: **DSF**  
 Description: **Deposits Settled Fine**

Distance (ft): **164.6**  
 Structural Grade: **0**  
 O&M Grade: **2**  
 Clock Start/From: **5**  
 Clock To: **7**  
 1st Value:  
 2nd Value:  
 Value Percent: **10.000**  
 Continuous Index:  
 Within 8" of Joint: **NO**  
 Remarks:

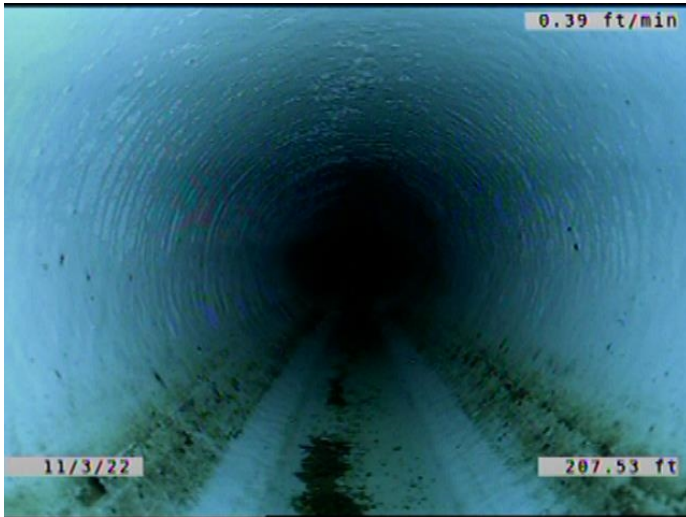
Code:	<b>MWLS</b>
Description:	<b>Miscellaneous Water Level Sag</b>
Distance (ft):	<b>207.5</b>
Structural Grade:	<b>2</b>
O&M Grade:	<b>0</b>
Clock Start/From:	
Clock To:	
1st Value:	
2nd Value:	
Value Percent:	<b>5.000</b>
Continuous Index:	
Within 8" of Joint:	<b>NO</b>
Remarks:

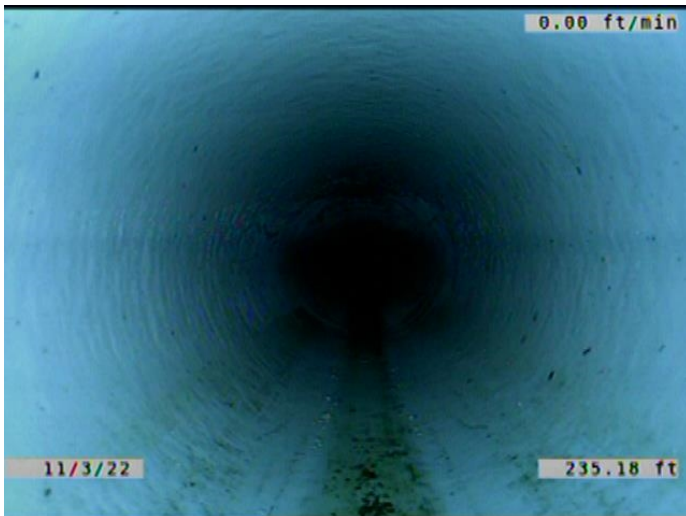
Code:	<b>MWLS</b>
Description:	<b>Miscellaneous Water Level Sag</b>
Distance (ft):	<b>235.2</b>
Structural Grade:	<b>2</b>
O&M Grade:	<b>0</b>
Clock Start/From:	
Clock To:	
1st Value:	
2nd Value:	
Value Percent:	<b>5.000</b>
Continuous Index:	
Within 8" of Joint:	<b>NO</b>
Remarks:

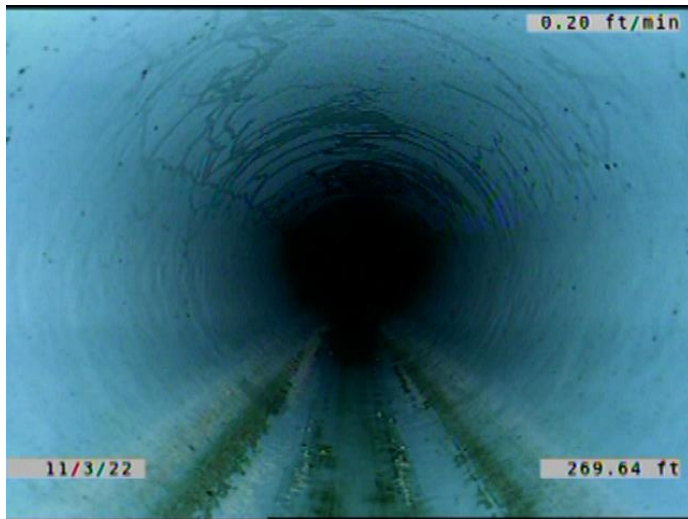
Code: **MWLS**  
Description: **Miscellaneous Water Level Sag**

Distance (ft): **269.6**  
Structural Grade: **2**  
O&M Grade: **0**  
Clock Start/From:  
Clock To:  
1st Value:  
2nd Value:  
Value Percent: **5.000**  
Continuous Index:  
Within 8" of Joint: **NO**  
Remarks:

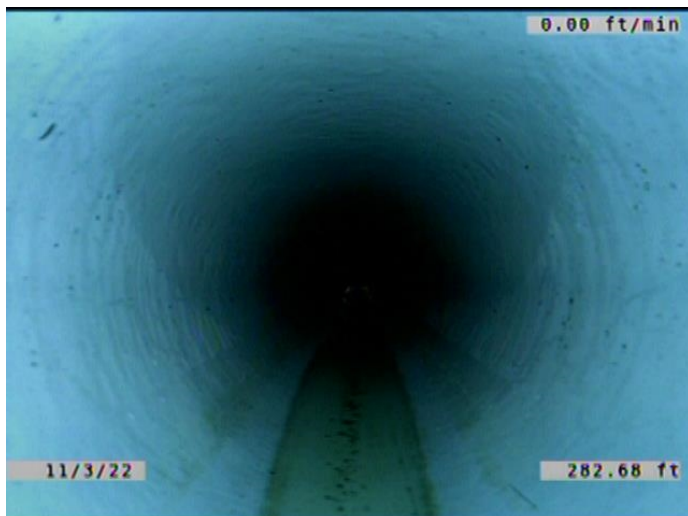
Code: **MWLS**  
Description: **Miscellaneous Water Level Sag**

Distance (ft): **282.7**  
Structural Grade: **2**  
O&M Grade: **0**  
Clock Start/From:  
Clock To:  
1st Value:  
2nd Value:  
Value Percent: **5.000**  
Continuous Index:  
Within 8" of Joint: **NO**  
Remarks:

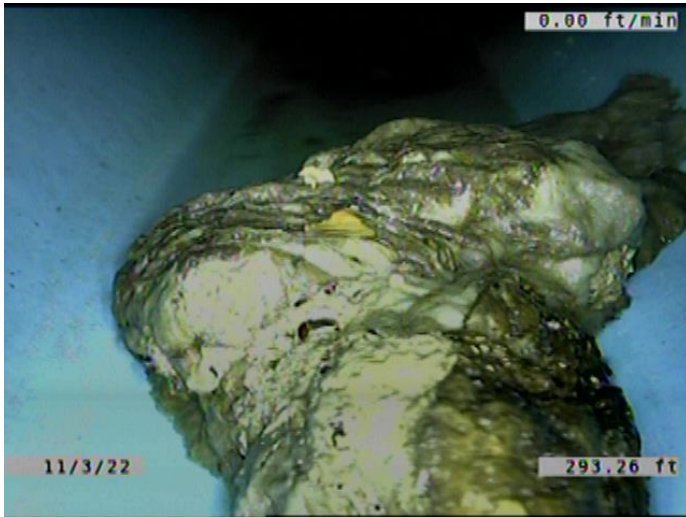
Code: **DSF**  
 Description: **Deposits Settled Fine**

Distance (ft): **293.3**  
 Structural Grade: **0**  
 O&M Grade: **3**  
 Clock Start/From: **5**  
 Clock To: **7**  
 1st Value:  
 2nd Value:  
 Value Percent: **15.000**  
 Continuous Index:  
 Within 8" of Joint: **NO**  
 Remarks:

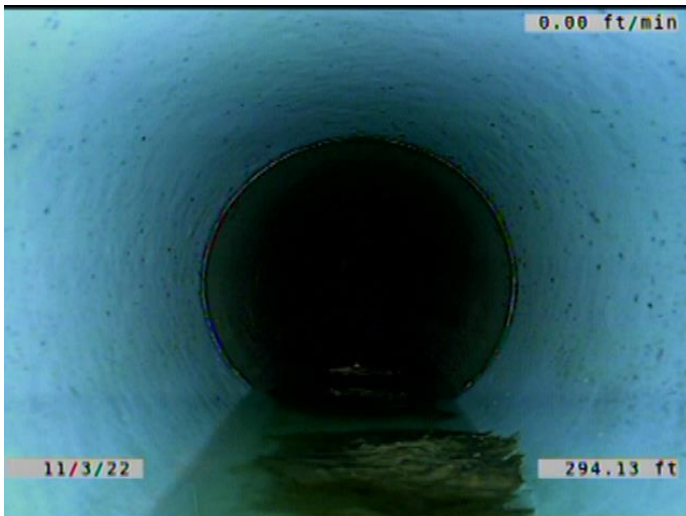
Code: **MWLS**  
 Description: **Miscellaneous Water Level Sag**

Distance (ft): **294.1**  
 Structural Grade: **2**  
 O&M Grade: **0**  
 Clock Start/From:  
 Clock To:  
 1st Value:  
 2nd Value:  
 Value Percent: **10.000**  
 Continuous Index: **S02**  
 Within 8" of Joint: **NO**  
 Remarks:

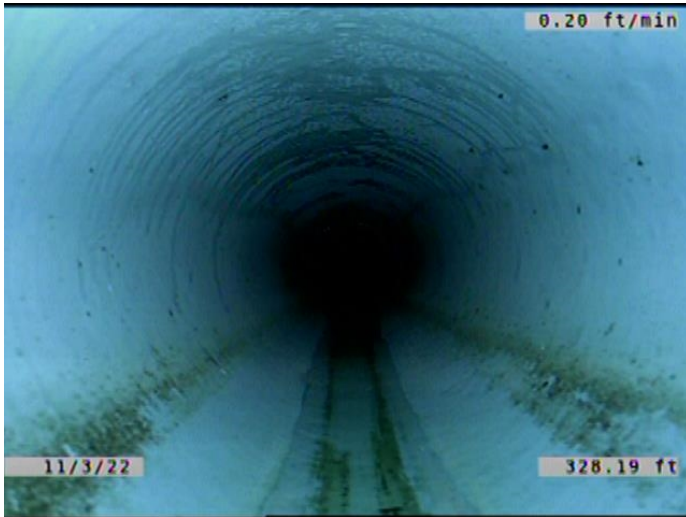
Code: **MWLS**  
Description: **Miscellaneous Water Level Sag**

Distance (ft): **328.2**  
Structural Grade: **2**  
O&M Grade: **0**  
Clock Start/From:  
Clock To:  
1st Value:  
2nd Value:  
Value Percent: **10.000**  
Continuous Index: **F02**  
Within 8" of Joint: **NO**  
Remarks:

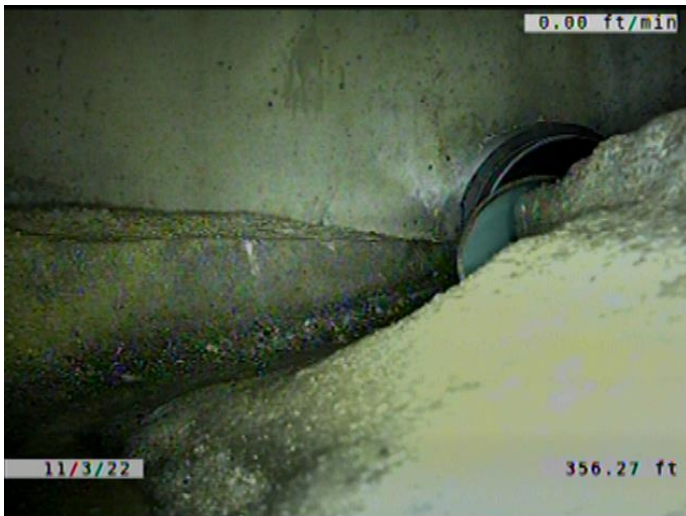
Code: **DSF**  
Description: **Deposits Settled Fine**

Distance (ft): **356.3**  
Structural Grade: **0**  
O&M Grade: **2**  
Clock Start/From: **5**  
Clock To: **7**  
1st Value:  
2nd Value:  
Value Percent: **5.000**  
Continuous Index: **F01**  
Within 8" of Joint: **YES**  
Remarks:

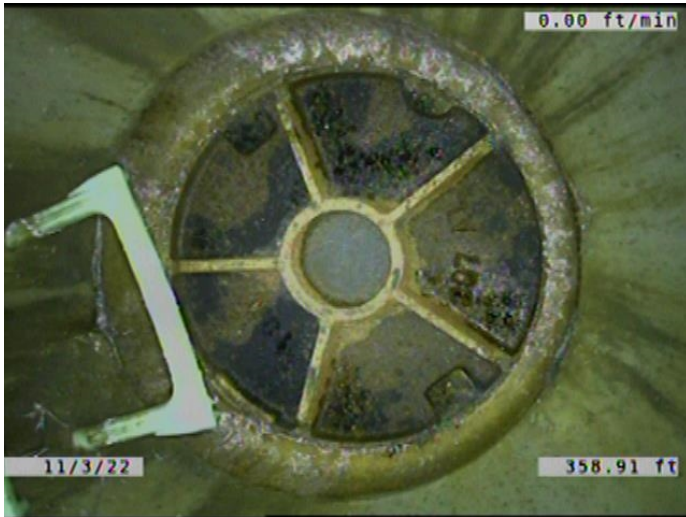
Code:	AMH
Description:	Manhole
Distance (ft):	358.9
Structural Grade:	0
O&M Grade:	0
Clock Start/From:	
Clock To:	
1st Value:	
2nd Value:	
Value Percent:	
Continuous Index:	
Within 8" of Joint:	NO
Remarks:	M-1004-046.1
